**Additional Subsurface Exploration Program and  
Geotechnical Recommendations  
University of Colorado at Boulder  
Williams Village Phase IIA – Extended Scope  
Boulder, Colorado**

**Job Number: 09-3011**

**February 23, 2010**

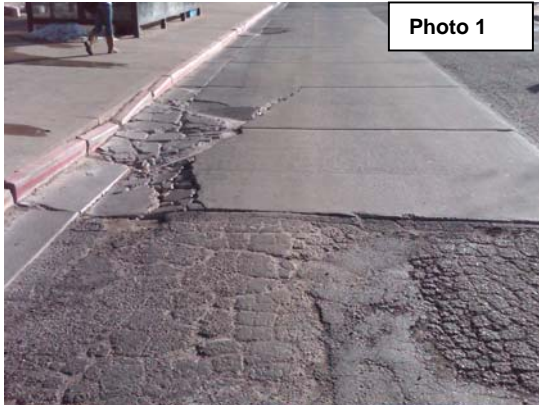
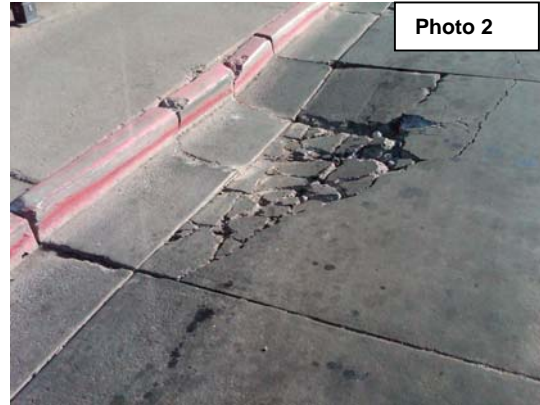
The concrete pavement section exhibited severe distress, indicative of subgrade support failure, at two separate locations. The curb and gutter adjacent to these areas were also distressed. Photos 1 and 2 show the distress of the concrete paved apron and curb and gutter. With the exception of the above-mentioned distressed areas, the concrete pavement section appeared to be in fair condition.

It appears that the subgrade failures observed are a result of excessive wetting of the subgrade materials combined with high traffic loads imposed by the buses.

Based on the extent and severity of distresses observed, the measured thickness of the asphalt pavements within the bus drive lane, desired age of the rehabilitated pavements (greater than 10 years), and our experience; sufficient rehabilitation of the pavement by commonly used rehabilitation methods, such as mill and overlay, chip-seal, fog-seal, patching, etc., will likely not provide adequate design life for the rehabilitated pavement section and are not recommended. GROUND recommends reconstruction of the existing pavement section for the 30<sup>th</sup> Street Bus Stop in addition to improving subgrade support and surface drainage. GROUND has provided geotechnical pavement section recommendations below, which can be utilized for reconstruction of the existing 30<sup>th</sup> Street Bus Stop alignment.

The Contractor should be prepared to perform additional stabilization of the subgrade during the reconstruction of the 30<sup>th</sup> Street Bus Stop pavement sections. As previously mentioned under the pavement distress observation section, several areas within the bus stop has experienced distress due to inadequate subgrade support. Our experience indicates that the subgrade materials in these areas are likely present at moisture contents that are several points above their optimum and will likely pump and deflect excessively under construction traffic load. These areas will likely need additional stabilization measures. Recommendations for stabilizing soft, wet, and unstable subgrade constructions were previously provided in GROUND's April 22, 2009 report, on Page 30. These recommendations should also be followed to stabilize the subgrade, as necessary, within the 30<sup>th</sup> Street Bus Stop and elsewhere on this site.

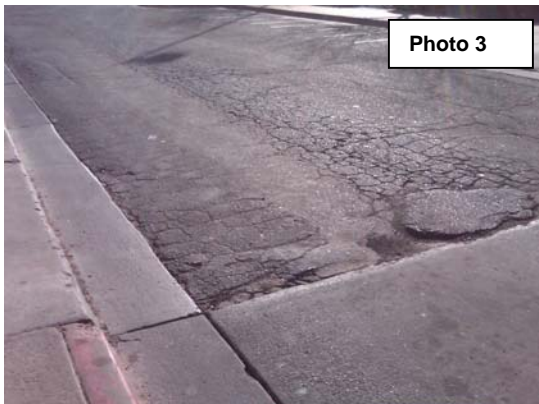
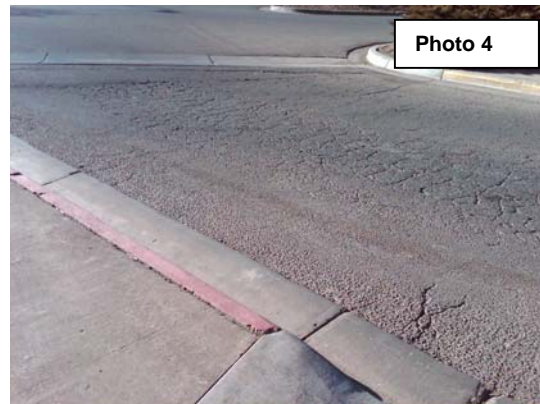
The asphalt portion of the pavement section exhibited moderate to high severity distress, including rutting, alligator cracking, fatigue cracking, potholes, etc.) Signs of some preventative maintenance observed consisted of moderate severity asphalt patching in areas of previous apparent utility work and repair of some of the higher distressed areas. The areas of patching also exhibited distress ranging from moderate to high severity. Photos 3 and 4 show the distress observed on the asphalt-paved portions of the 30<sup>th</sup> Street Bus Stop. Overall, the asphalt-paved areas were in poor condition and exhibited signs of subgrade failure and pavement failure, likely due to heavy traffic.

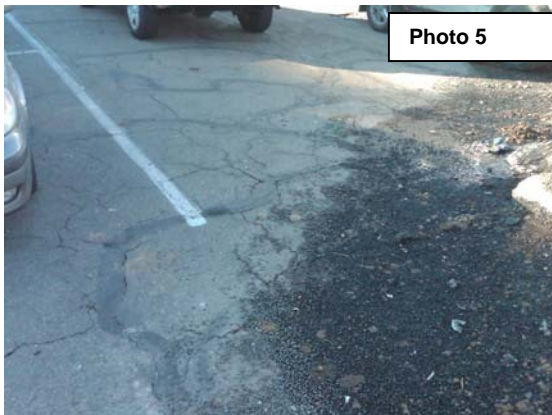
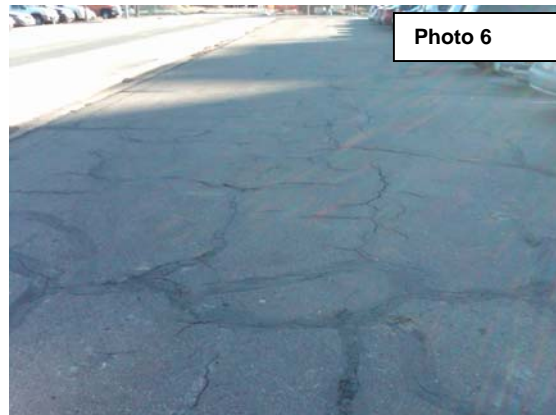
The asphalt-surfaced parking lots exhibited distresses, including fatigue, longitudinal, transverse and edge cracking, with severity levels ranging from low to high. Moderate to high severity distresses were observed primarily in the drive lanes, and low to moderate distresses were observed in the parking stalls. Signs of some preventative maintenance observed consisted of sealing of a small portion of the longitudinal and transverse cracking, moderate severity asphalt patching in areas of previous apparent utility work, and repair of some of the higher distressed areas. These areas of patching also exhibited distress ranging from low to moderate severity. Photos 5 and 6 show the distress observed on the asphalt paved portions of the paved parking areas and driveline. Overall, the asphalt-paved parking areas located to the north of the proposed building footprint were in poor condition.

Recommendations for possible rehabilitation and reconstruction of the existing asphalt pavements, as well as pavement sections for the gravel surface parking lots are provided below.

Prior to asphalt placement, all cracks in the milled surface should be sealed. The Contractor should anticipate that local areas would require more extensive repairs in areas where moderate to high severity distresses were observed. Use of a geotextile paving fabric may be beneficial to reduce reflective cracking, especially over areas where moderate to high severity fatigue cracking was observed. The Geotechnical Engineer should be retained to observe the milled surface and identify areas for greater depths of removal and replacement.

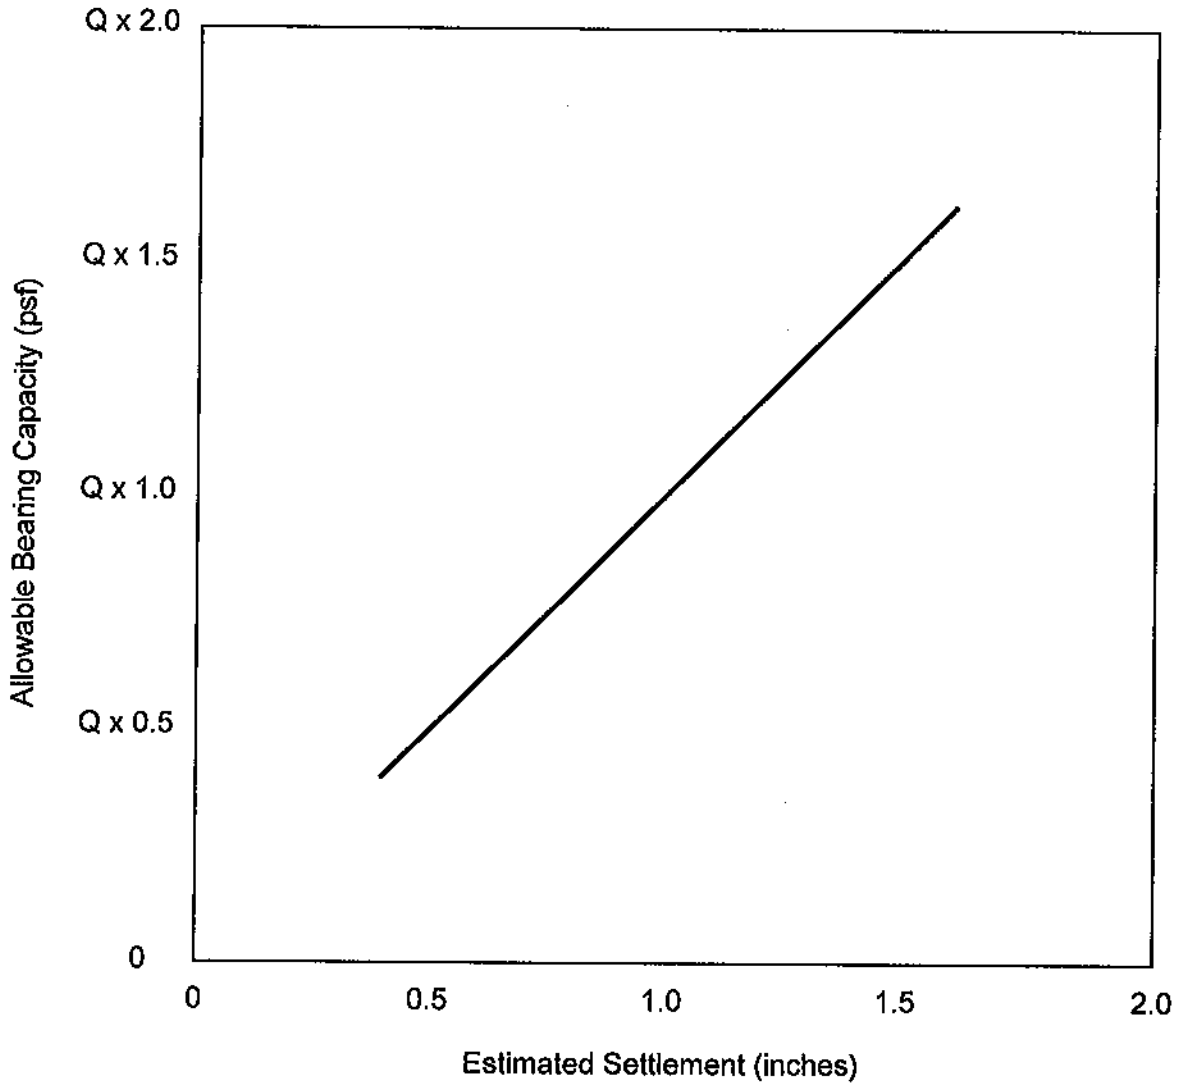
$Q = 2,500 \text{ psf}$

Note: Design should be controlled by settlement. Estimated settlement values indicated above are based on drained conditions. If foundation materials become wet, the allowable bearing capacity will be reduced and result in larger estimated settlement. This relationship is based on footing widths of 1 to 4 feet. If the footing width is to be greater than 4 feet, we should be notified to reevaluate these recommendations.
