Dam Failure

John T. Christian¹ and Gregory B. Baecher²

[September 9, 1999 DRAFT]

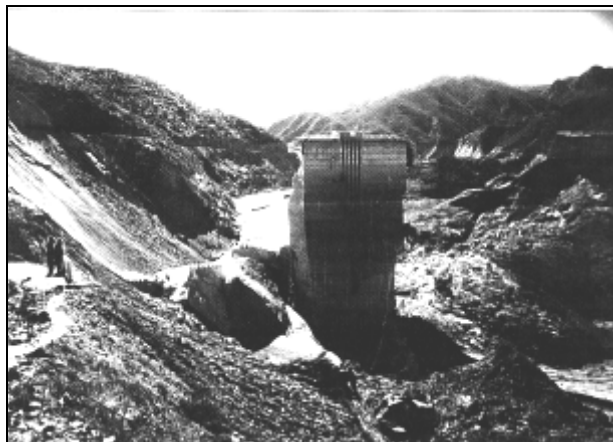
At about midnight of March 12 to 13, the dam had failed catastrophically. So rapid was the failure and so devastating the damage caused by the rushing waters that the details of the failure and the mechanisms that caused it remain controversial to this day. As it was filled to capacity, there were 38,000 acre-feet (12.4 billion gallons) of water in the reservoir. This water roared down the canyon of the San Francisquito River into the Santa Clara River and reached the Pacific Ocean near Ventura over four hours later. The initial height of the wave must have been nearly 180 feet, and, at a power-house about a half-mile downstream of the dam, the wave height was measured as 110 feet.

St. Francis Dam after failure, looking downstream. Concrete monolith at center was all that remained of the dam.

Recently, J. David Rogers (1995), an engineering geologist practicing in California, has re-examined the records of the St. Francis Dam failure. He concludes that the failure actually started at the left abutment. He shows that the left abutment was composed of the debris of a massive pre-historic landslide that had dammed the river and then been cut through by the river. When the water rose in the reservoir it entered the slide debris, and the resulting uplift pressures reactivated the ancient landslide. The enormous mass of the slide pushed on the left end of the dam, forcing it to bend and crack. The pressure of the water in the reservoir then destroyed the cracked dam. Rogers' arguments are based on geological investigations, mechanical analyses of

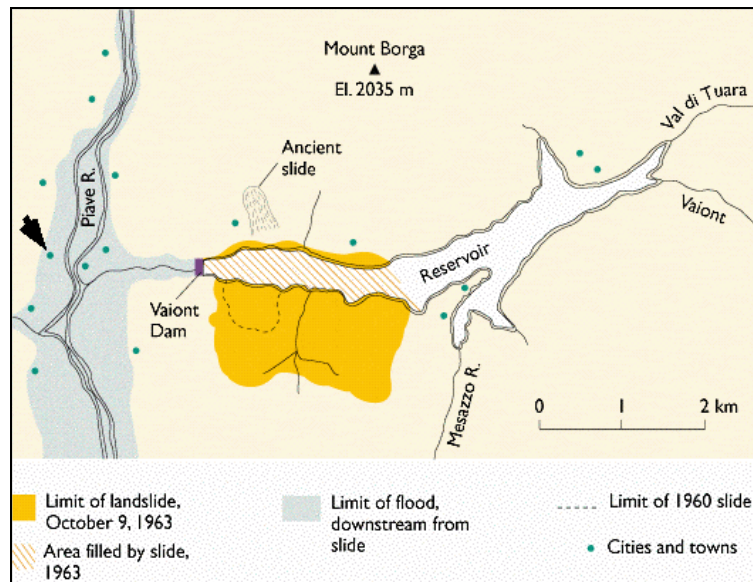
Landslide and area of flooding downstream of Vaiont Dam

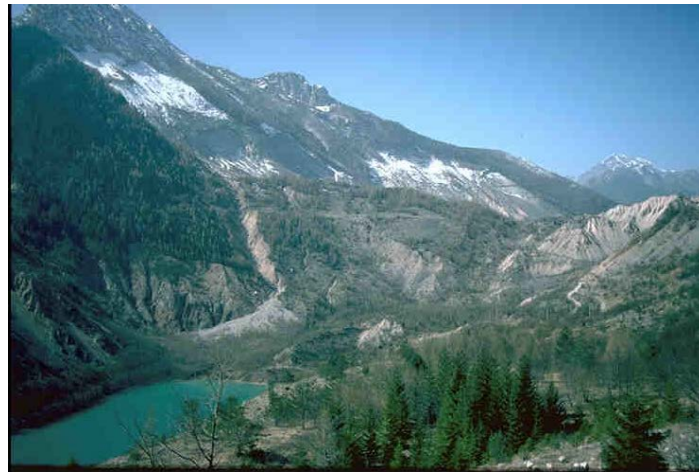
Vaiont reservoir after slide, looking downstream. Flat rock surface to the upper left is the sliding plane, approximately 2 km along the reservoir slope.

Movement of the southern (left hand) slope was observed in the first few months of operation. Various combinations of remedial measures, control of the water level, and observations were employed to follow and understand the mechanics of the movement. On November 4, 1960, the first, and by later comparison small, slide occurred. Cracking above the scarp of this first slide slowly propagated to encircle an enormous mass of earth. The lake level was lowered,

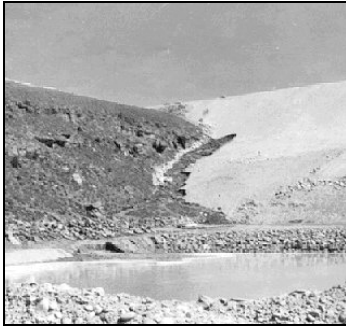
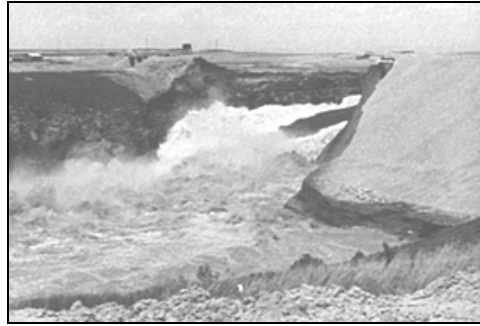
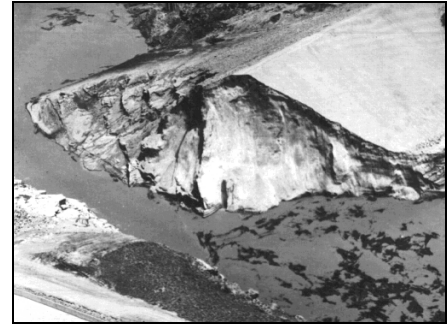
Teton Dam, Idaho failing by internal erosion on June 5, 1976. Left, initial breakout of seepage on face of dam. Middle, wave pouring through eroded opening. Right, after wave passed through.

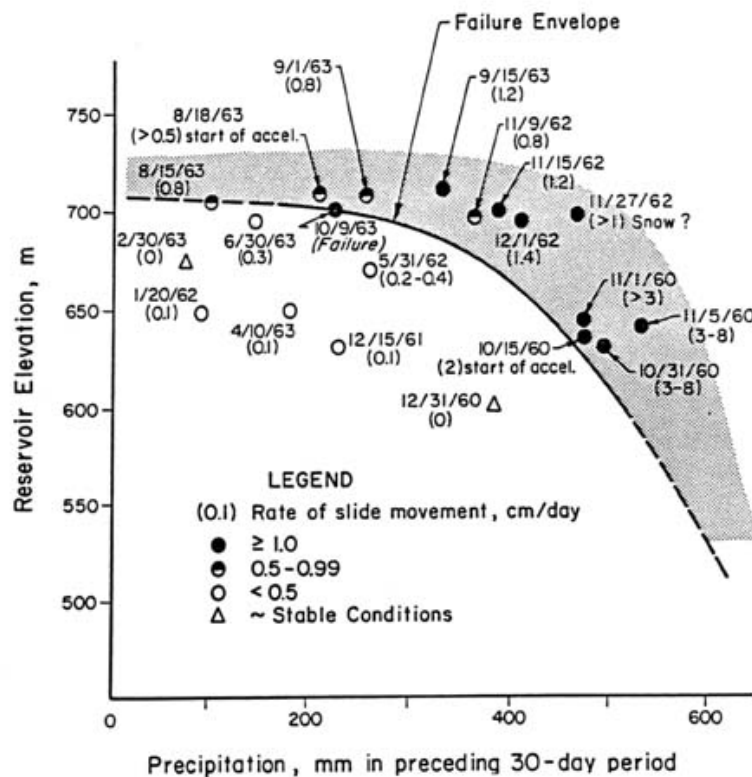
stress drops. The accompanying figure from Hendron and Patton's paper, gives the history of water level, rainfall, and slope movement. The horizontal axis is precipitation, in millimeters, for the preceding 30-day period. The vertical axis is the elevation of the water in the reservoir, in meters. Each point represents an observation, with the corresponding date written next to it. Triangles represent conditions with no observed movement, and open circles stand for cases with movement less than 0.5 centimeters per day. Points that are half-black and half-white correspond to observed motions between 0.5 and 0.99 centimeters per day. Solid black points indicate movements in excess of 1 centimeter per day. The black points and the half-black points are clearly in a different region than the open points. A line separating them is labeled the failure envelope. Conditions in the shaded area lead to large movements and eventual failure. Previous investigators had tried to tie the movement to the water level or the rainfall but not to both; the movements are actually related to both. Hendron and Patton analyzed the slope with the low frictional coefficients for the clay and showed that the onset of serious movement was predictable if the analysis incorporated both contributions to the pore water pressure. This was a welcome development, for engineers dealing with similar slopes need to have analytical tools that work for actual slides.

Failure and non-failure conditions for Vaiont reservoir slope (from Hendron and Patton, 1985)
