VAIONT RESERVOIR DISASTER

*Geologic causes of tremendous
landslide accompanied
by destructive flood wave*

GEORGE A. KIERSCH, F. ASCE

Professor of Engineering Geology, Cornell University, Ithaca, N.Y.

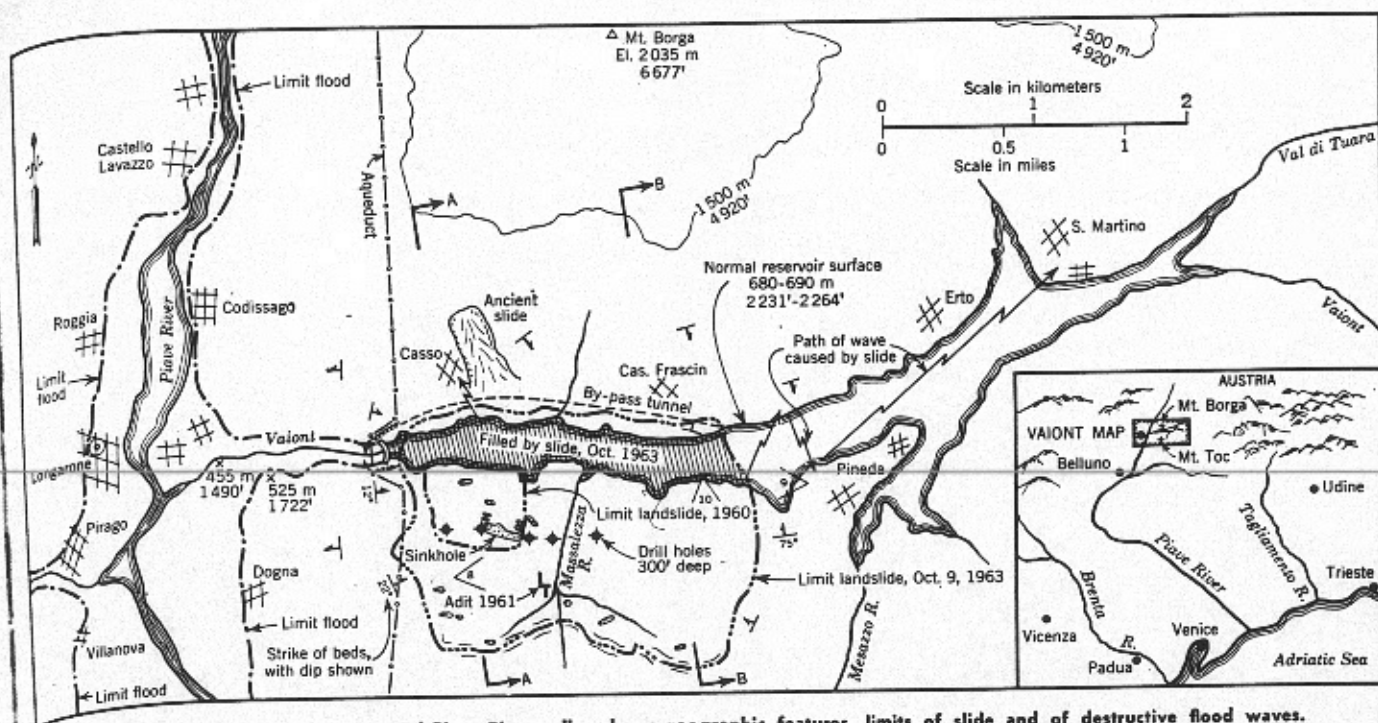
The quick sliding of the tremendous rock mass created an updraft of air accompanied by rocks and water that climbed up the right canyon wall a distance of 260 m (850 ft) above reservoir level. (References to right and left assume that the observer is looking downstream.) Subsequent waves of water swept over both abutments to a height of some 100 m (328 ft) above the crest of the dam. It was over 70 m (230 ft) high at the confluence with the Piave valley, one mile away. Everything in the path of the flood for miles downstream was destroyed (Fig. 1).

FIG. 1. Map of Vaiont Dam area and Piave River valley shows geographic features, limits of slide and of destructive flood waves.

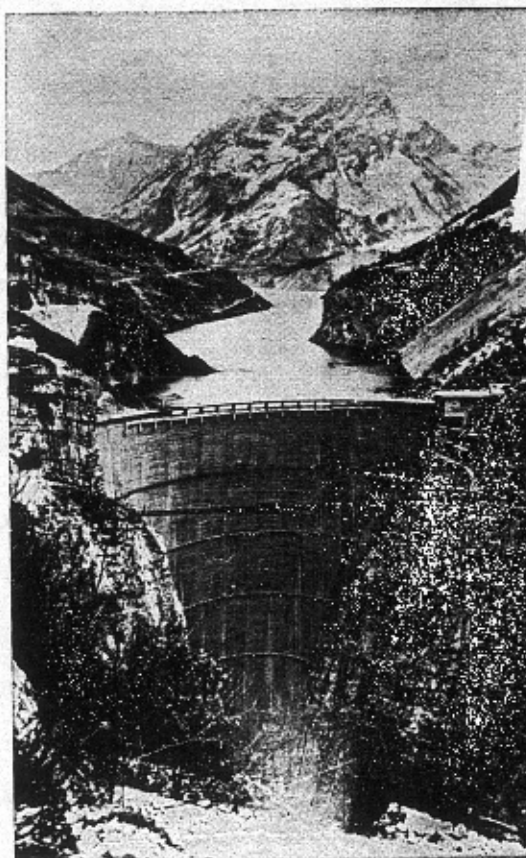
FIG. 2. Completed Vaiont Dam is seen with reservoir at about El. 680 m. On the right of the photograph, the white slope near the dam marks the 1960 slide. All the steep slope beyond was involved in the 1963 slide. (Wide World photo)

In 1960, a slide of some 1 million cu m (1.3 million cu yd) occurred on the left bank of the reservoir near the dam. (See Figs. 1, 2, and 3.) This movement was accompanied by creep over a much larger area; a pattern of cracks developed upslope from the slide and continued eastward.¹⁰ These fractures (Fig. 1) ultimately marked the approximate limits of the October 9 slide. The slopes of Mt. Toc were observed to be creeping and the area showed many indications of instability.⁹

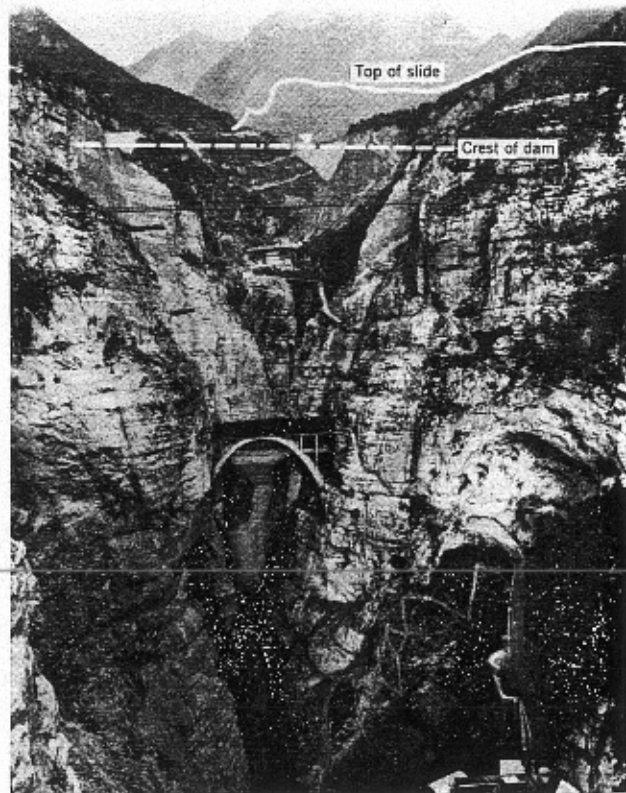
FIG. 3. Vaiont canyon is seen looking toward the reservoir site during early construction and stripping of abutments. Terrain of 1960 and 1963 slides is shown at right, with the steep cliff of Malm formation. The overtopping flood wave scoured the abutments above the dam, destroying the aqueduct and bridge (black) and stripped away the highway, lower right. Photo courtesy of Water Power.

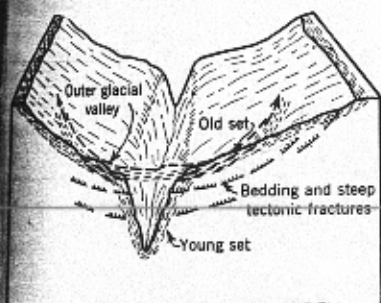
The development of rebound joints beneath the floor and walls of the outer valley is shown in Fig. 4. This destressing effect creates a weak zone of highly fractured and "layered" rock, accentuated by the natural dip of the rock units. This weak zone is normally 100 to 150 m (330 to 500 ft) thick. Below this a stress balance is reached and the undisturbed rock has the natural stresses of mass.

ner valley (Fig. 4). This sector of the canyon walls, weakened by overlapping rebound joints, along with abundant tectonic fractures and inclined bedding planes, is a very unstable rock mass and prone to creep until it attains the proper slope.

FIG. 4. On sketch of inner Vaiont canyon and remnants of the outer glacial valley, are shown rebound joints—old and young set—form stress relief within the walls of the valley to depths of 100 to 150 m (330 to 500 ft).

Two sets of strong rebound joints, combined with inclined bedding planes and tectonic and natural fracture planes, created a very unstable rock mass throughout the upper part of the inner canyon (Fig. 4).

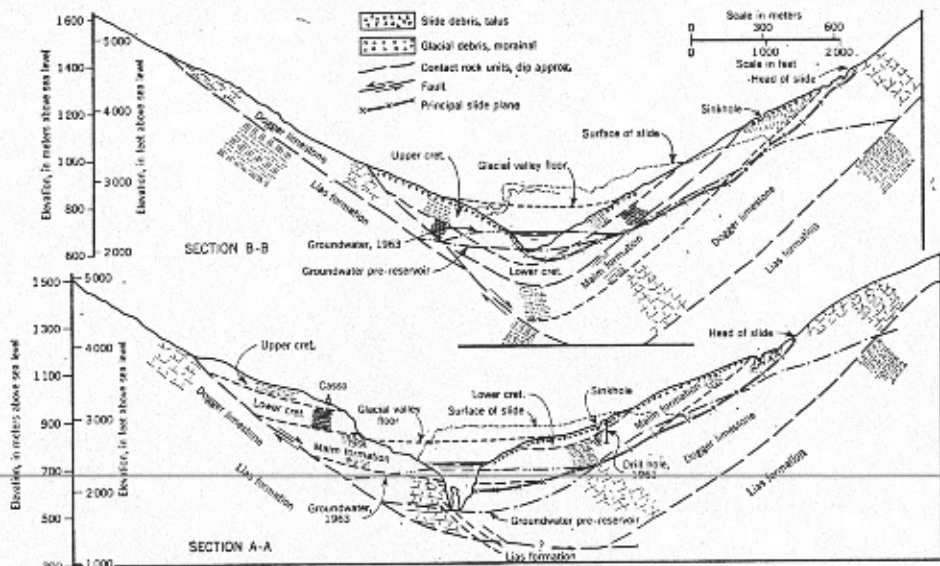
Steep dip of beds changes northward to Vaiont canyon, where rock units flatten along the synclinal axis: in three dimensions the area is bowl-shaped (Fig. 5). The down-dip toe of the steep slopes is an escarpment offering no resistance to gravity sliding.

FIG. 5. On geologic cross-sections of slide and reservoir canyon, running from north to south, principal features of the slide plane, rock units and water levels are shown. For location of Sections A-A and B-B, see Fig. 1.

Heavy rains for two weeks before October 9th produced an excessive inflow of ground-water from the drainage area on the north slopes of Mt. Toc. This recharge raised the natural ground-water level through a critical section of the slide plane (headward part) and subsequently raised the level of the induced water table in the vicinity of their junction (critical area of tensional action). The approximate position of both water levels at the time of the slide is shown in Fig. 5.

beds created additional uplift and contributed to sliding. The upstream sector (Fig. 5, Section B-B) is composed largely of marl and thin beds of limestone with clay partings—a rock sequence that is inherently less stable than the downstream sector (Fig. 5, Section A-A).

Construction of Vaiont Reservoir created an induced ground-water level which increased the hydrostatic uplift pressure throughout a triangular subsurface mass (Fig. 5) aided by fractures and the interconnected system of solution openings in the limestone.

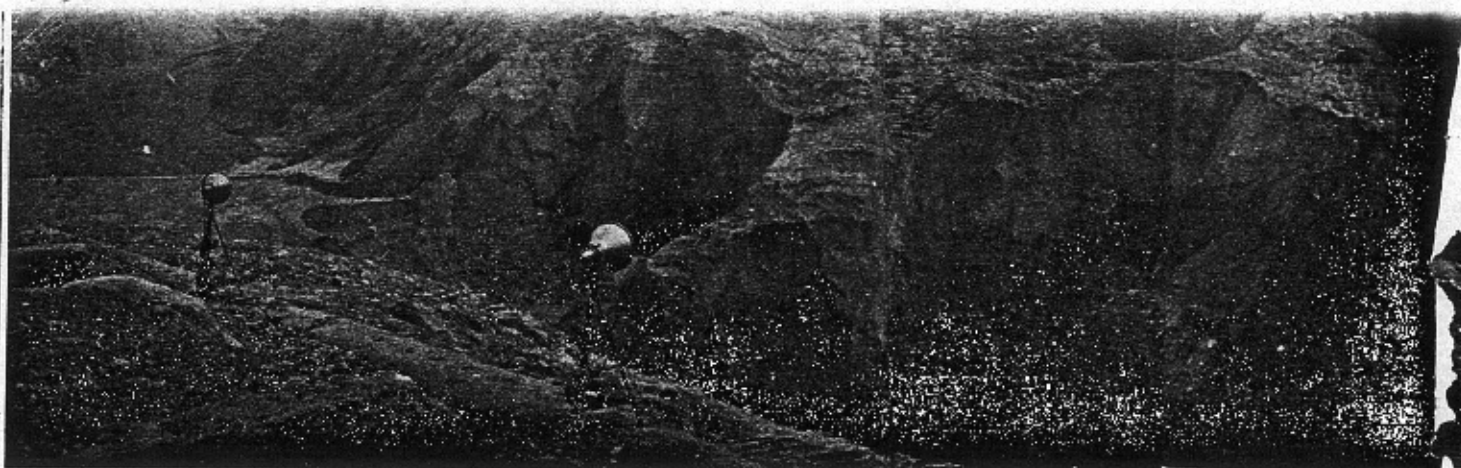
FIG. 6. Slide area following the disaster is seen from right dam abutment. Note wave-scoured area at right. Holes, or funnel-like craters, appeared in the slide as it underwent adjustment. Damaged

(Fig. 6) for some hours after the slide, strongly the next morning, and during this time also displaced water drained from pools scattered over the slide surface.

Strong funneling craters developed during the first days after the slide in the soil and glacial debris concentrated near the toe of the slide (Fig. 6). This cratering was of concern to some as indicating large-scale movement to come, but other conditions are the probable causes of the surface subsidence. Large blocks of rock, with some bridging action, fill the canyon and create much void space in the lower mass. Some of these spaces are filled by normal gravity shifting of fines, and ground-water circulation also distributes fines into these void spaces. Formation of craters is restricted to the section of the slide that fills the former canyon, and craters appear at intervals along its entire length. They are most extensive in the slope behind the dam.

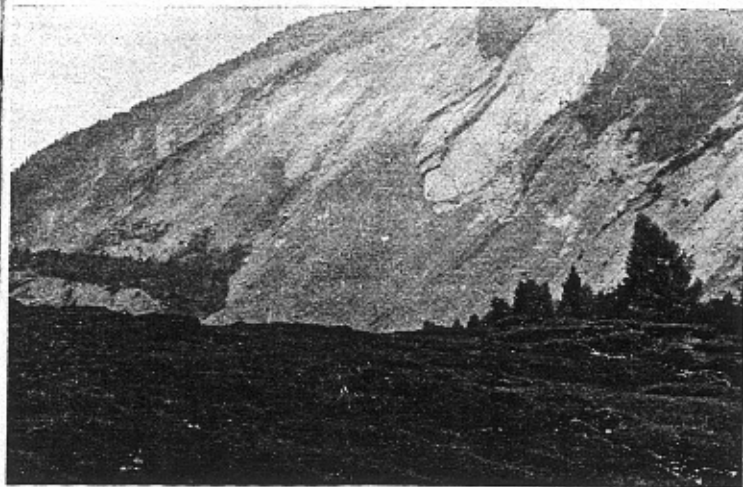
FIG. 7. Top of main slide is seen along cross section A-A of Fig 5. Typical talus runs and step-like blocks are shown moving down the surface of the slip plane. The coherent grass and soil, characteristic of a large part of the surface of the slide mass, appear in foreground.

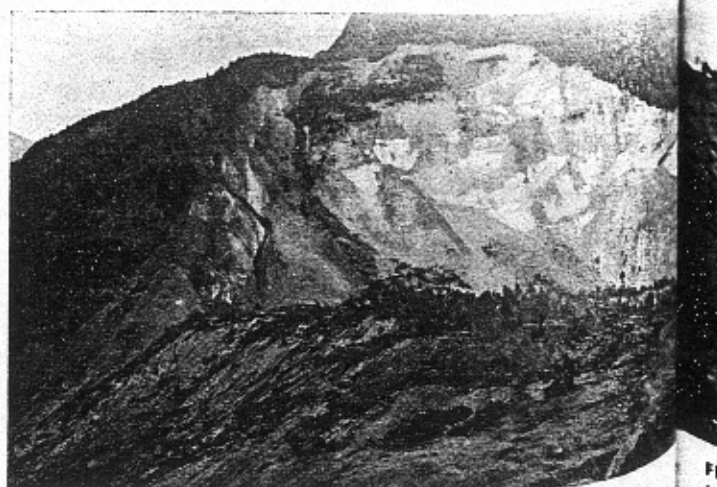
FIG. 8. Slip plane and eastern limit of the slide are seen looking south from a point above the former reservoir. A typical slide mass is in foreground, with talus runs and step-like blocks moving down the slip plane.

main slip plane (Fig. 8). These blocks were loosened by the movement on October 9 and have since moved slowly down the slip plane, some to the bottom of the escarpment. Talus runs are common from small V-notched canyons along the edge of the steep eastern sector of the slide.

The steeply dipping beds along the head of the slide will undoubtedly fail from time to time as a result of gravitational creep. Ultimately the uppermost part of the slip plane (Fig. 8) will be flattened and thereby will attain a stable natural slope.

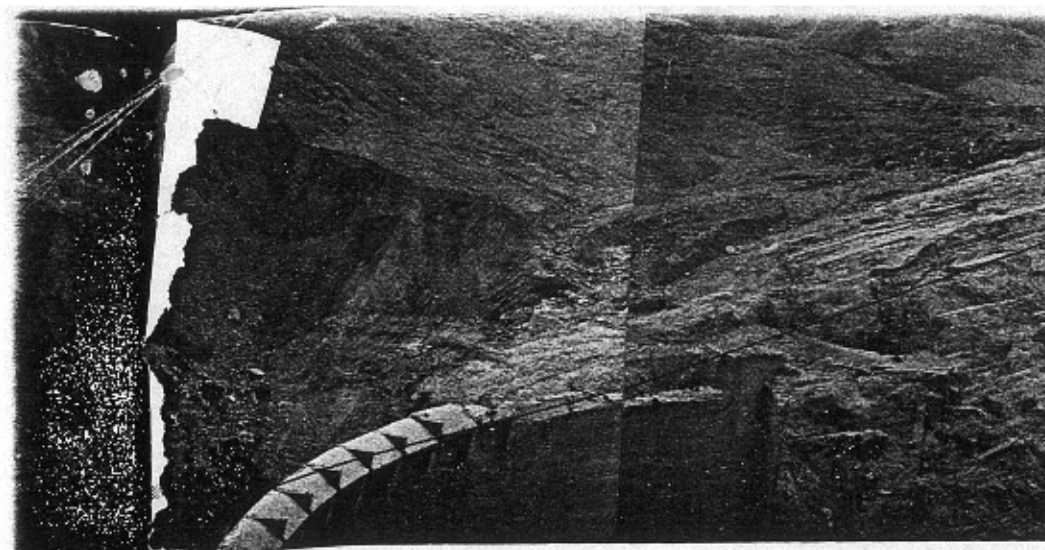
ured area
Damaged

crest, from which the roadway was torn away, is the only apparent structural damage to the dam. Front of slide (see Fig. 8) is the high cliff on the left, extending into the distance.

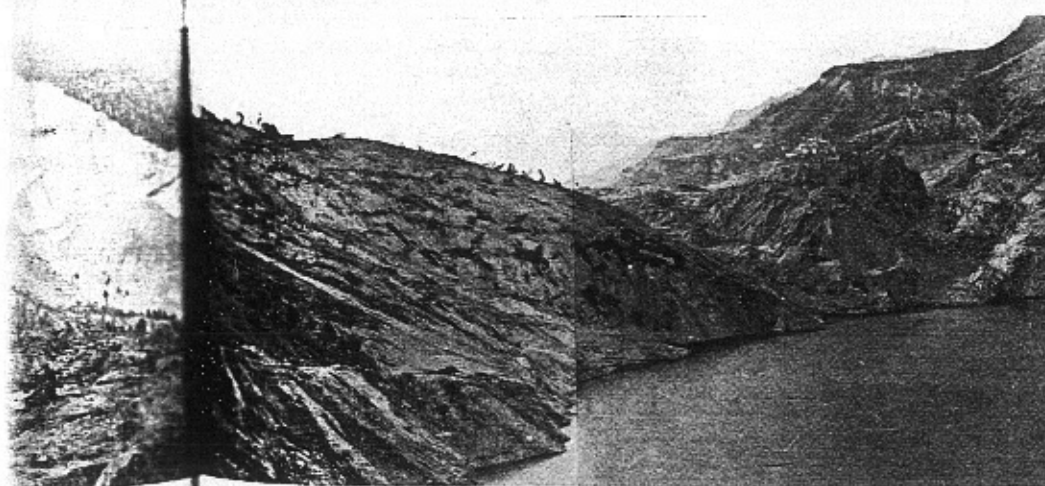
of the slide are
the former reser-
vair, with talus
in the slip plane.

Fig. 9. Upstream side of slide "dam" and impounded reservoir are seen looking westward from near Pineda. Note village of Casso at upper right corner (El. 960 m). Low "rift" valley in center of photo is due to settling and lateral slipping of slide mass within the reservoir canyon.
