# Axial Capacity of C900 PVC Pipe with Reinforced Gasketed Joints

Final Report

Katie Ross  
Denver Water

August 2020

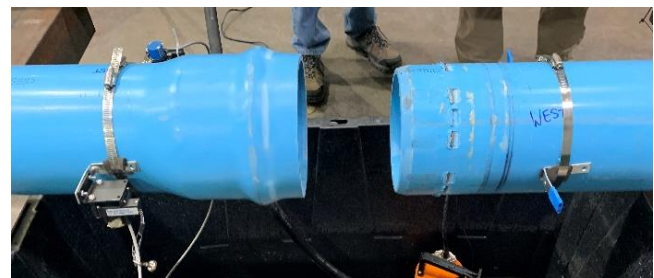
Figure 3.1. Images of PT17, (a) before testing and (b) after failure

The joint failed by the gripping teeth of the gasket gouging out material from the spigot pipe as can be seen in Figure 3.1(b). No cracks or breaks in the pipes were observed.

Two different failure mechanisms are observed for the RieberLok specimens. In general, as the stainless locking segments (Figure 1.4) begin to indent the pipe spigot at significant levels of displacement (Figure 3.1(b)), they rotate and bend. Once one or more segments begin to buckle, the axial force begins to decrease under additional displacement. At 1.8 in. (45.7 mm) of imposed actuator displacement, softening of the axial load response of the RieberLok specimens can be observed (Figure 5.1 & 5.2). This reduction in load with additional displacement is associated with the joint failure mechanism. PT17 resulted in failure of the gasket, without fracture of the spigot or bell (Figure 3.1(b)), while PS19 failed similarly to the Diamond Lok-21 specimens, by circumferential fracture of the spigot. One explanation of this difference could be the use of two different PVC pipe manufacturers (NAPCO vs. B-Vinyl). More likely, the authors hypothesize cyclic loading caused these indentations to deepen, leading to propagation of circumferential fracture of PS19. Further evaluation and repeat tests may recommend reducing the maximum RieberLok joint displacement to the point of maximum load (~25% reduction of maximum joint displacement), rather than the instance of pressure containment loss (significant leakage under tension) reported herein.

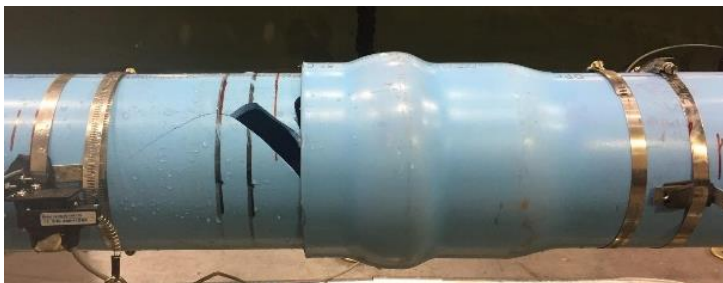
Diamond Lok-21 PVC pipe with the as-received restraining-gasketed bell and spigot joint at the midpoint was used for this test. Joint displacement was measured using two spring pots located on the north and south pipe spring lines, as shown in Figure 3.7. The string pots and the string anchor points were fixed to the pipe approximately 3 - 6 inches (75 - 150 mm) on either side of the ends of the bell section. Water pressure was held at approximately 66 psi (460 kPa) during the application of load until failure. Tensile load was applied until the spigot pipe broke suddenly. An image of the joint after failure is shown in Figure 3.8 and Figure 3.9.

Figure 3.8. Post-test image of failure PT18 joint

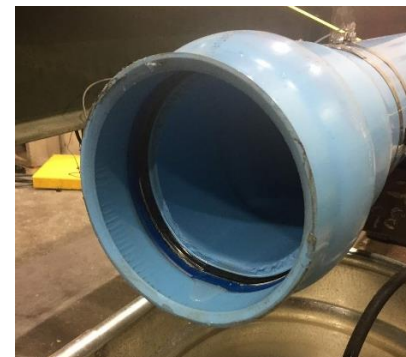
Figure 3.10 shows the actuator force, internal pressure, and actuator displacement relative to time. The maximum force was 32.6 kips (145 kN) at an actuator displacement of 2.11 in. (53.6 mm). Figure 3.11 shows the actuator force relative to actuator displacement. Figure 3.12 shows the actuator force relative to joint displacement. The average joint displacement was 0.37 in. (9.4 mm) at the time of failure. Failure occurred when the spigot pipe broke at the gasket with cracks propagating outwards from the joint. Figure 3.9 shows the failure of the spigot pipe inside the joint.

Figure 3.9. PT18 failure (note section of spigot circumferentially fractured inside joint)

(Figure 3.9 and Figure 4.10). This failure mechanism indicates that a significant portion of the pipe barrel strength is mobilized before failure, generally a positive result, despite some minor longitudinal cracking of the spigot that might hinder repair efforts in the field.

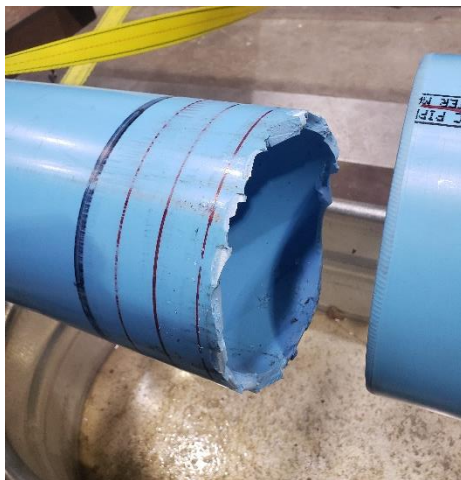
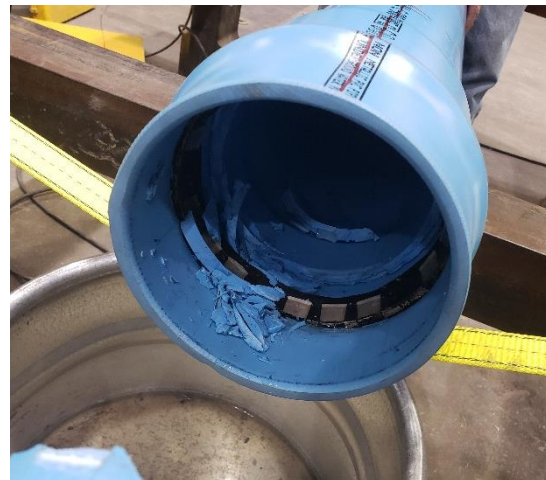
Figure 4.3 shows the joint after failure. Failure occurred by circumferential fracture of the spigot at the location where the metal RieberLok teeth dig into the pipe. This failure is indicative of most/full mobilization of the pipe strength.

Figure 4.3. PS19 joint after failure, (a) broken spigot pipe, (b) inside bell

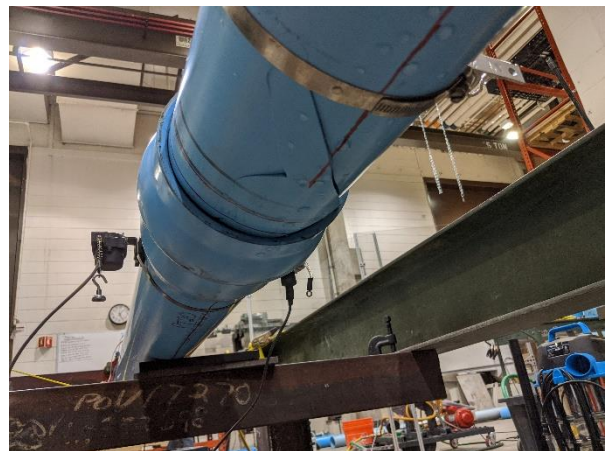
After cyclic loading, tensile load was applied until the pipe failed by breaking of the spigot pipe at the joint. Failure was indicated by a loud sound, a sudden increase in joint displacement and decrease in force, and significant water leakage from the joint. Images of the joint before and after the test are shown in Figure 4.7. Figure 4.8 shows the pressure, actuator force, and actuator displacement relative to time during the test. The maximum force was 30.2 kips (134 kN), which occurred just prior to the failure of the joint. The displacement of the actuator at failure was 1.78 in. (45.2 mm). Figure 4.9 shows the actuator force vs. the actuator displacement and the average joint displacement. The average joint displacement was 0.197 in. (5.00 mm) at the time of failure. The joint failed by circumferential fracture of the spigot at the location of the metal gasket teeth digging into the pipe as shown in Figure 4.10.

Figure 4.7. Images of PS20, (a) before testing and (b) after failure.

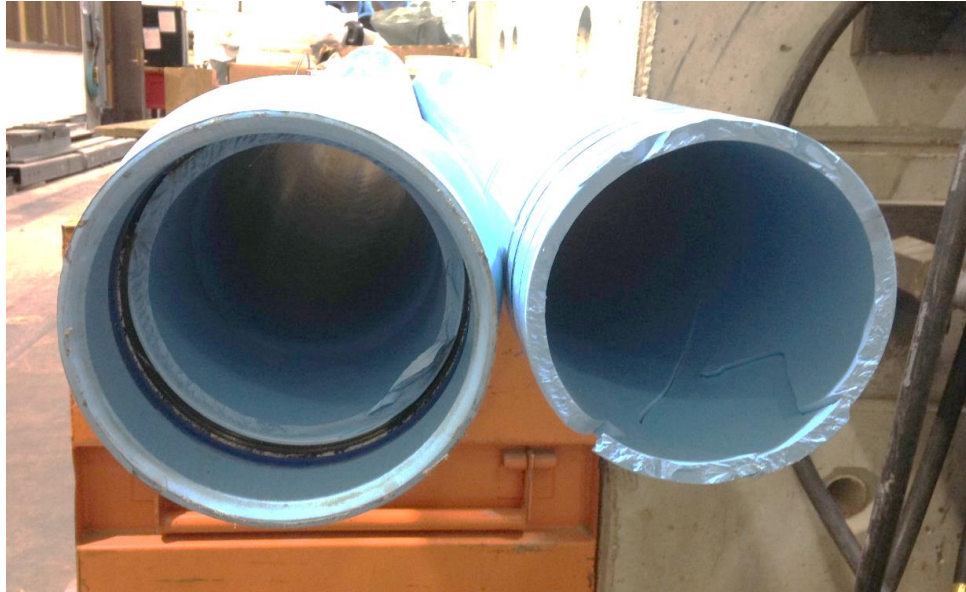
Figure 4.10. PS20 joint failure.
