# Experimental Assessment of PVC Pipe Joint with RieberLok Gasket under Axial Loading

## Testing Report

Timothy C. Lango  
Northern Pipe Products

September 2024

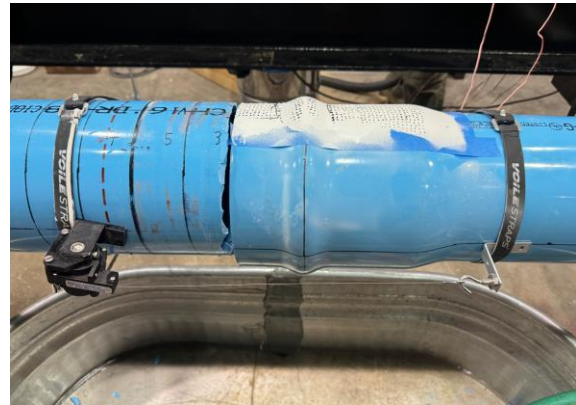
Images of bell-and-spigot connection before and after the test are shown in Figure 3.6. The dot marks are for digital image correlation (DIC) measurement on the white surface. While the DIC measurements captured 3D displacement and strain fields that correlated well with standard measurement techniques, this measurement technique is beyond this project report scope. Joint displacement was measured using two string potentiometers located 3 in. (75 mm) away from the joint on both ends of the coupling, shown in Figure 3.6 (a). The reported joint displacement does include the elongation of the pipe barrel over 3 inches (75 mm) on either side of the joint, which is practically negligible compared to the displacement between bell and spigot in these tests. Failure occurred on the West side (spigot) of the bell-and-spigot connection. Fracture occurred in the spigot section of pipe at the location where the gasket teeth penetrated into the pipe barrel, as shown in Figure 3.6 (b).

Figure 3.6. Image of PT44 (a) before the start of testing and (b) after failure

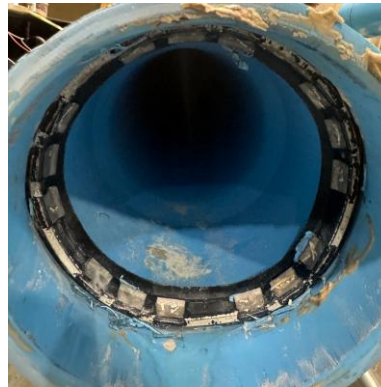
Figure 3.11. Failure at the gasket for PT45

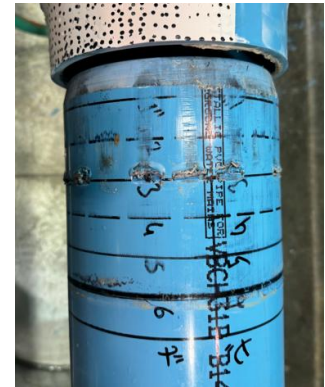
The material and instrumentation used for this test were consistent with the previous test (PT44). Figure 3.7 shows the relationship among actuator force, internal pressure, and actuator displacement relative to time. A constant internal water pressure of  $63 \pm 2$  psi ( $434 \pm 13$  kPa) was provided during the test. At  $t=120$  sec, displacement was applied at a rate of 1.0 in./min. (25 mm/min.), and the force feedback of the load cell was recorded. When the specimen lost its force capacity ( $t=260$  sec), the pressure dropped to about 30 psi and then increased again to 65 psi (448 kPa). After pausing to confirm the capacity of the specimen to sustain the target internal pressure, application of axial displacement was continued. At an applied axial displacement of a substantial leak occurred as the spigot pulled out of the bell and the specimen lost pressure integrity. Figure 3.8 shows that the maximum force recorded in the load cell was 25.9 kips (115.3 kN) at an actuator displacement of 2.25 in. (57.2 mm). Figure 3.9 shows the actuator force relative to joint displacement. Joint displacement was measured using two string pots located on the north and south spring lines of the specimen as shown in Figure 3.10. The joint displacement reached an average of about 0.8 in. (20.3 mm) at the maximum force and reached a total of about 0.99 in (25.1 mm) just before failure (23.0 kips). Figure 3.11 shows damage to the gasket post-test, where several of the metal teeth were deformed, reducing the force capacity of the joint, but allowing the gasket to continue to provide containment after the force dropped. Figure 3.12 shows marks of the metal teeth on spigot after the test.

Figure 3.12. The spigot after the test

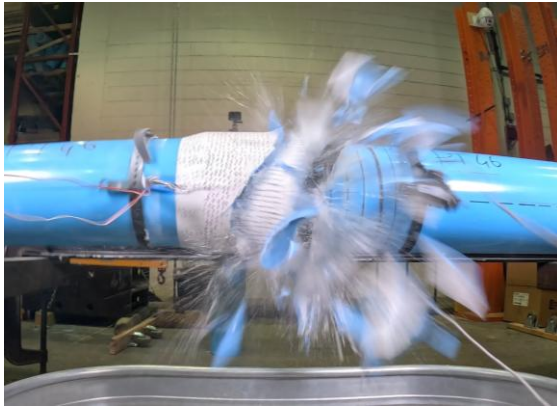
Figure 3.18. Failure moment at the joint for PT46

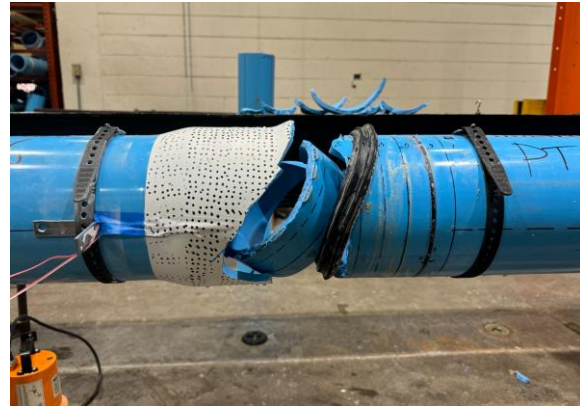
The third tension test performed on PVC pipe manufactured by VnyilTech was PT46. Figure 3.15 shows the relationship between actuator force, internal pressure, and actuator displacement relative to time. Displacement was applied at a rate of 1.0 in./min. (25 mm/min.), and the force feedback of the load cell was recorded. Figure 3.16 shows that the maximum force recorded in the load cell was 27.6 kips (122.7 kN) at an actuator displacement of 2.36 in. (59.9 mm). A constant internal water pressure of  $65 \pm 2$  psi ( $448 \pm 13$  kPa) was applied. Figure 3.17 shows the actuator force vs the joint displacement. The joint displacement reached an average of about 0.8 in. (20.32 mm) just before failure. Figure 3.18 shows failure moment at the joint. Fracture occurred on the east and west sides of the joint at the maximum force (27.6 kips). The circumferential fracture occurred where the teeth of the gasket penetrate the spigot. On the bell side, a fracture occurred at an angle of almost 45 degrees, starting from the crown and reaching the inverts, as shown in Figure 3.19.

Figure 3.19. Failure at the west and east sides for PT46

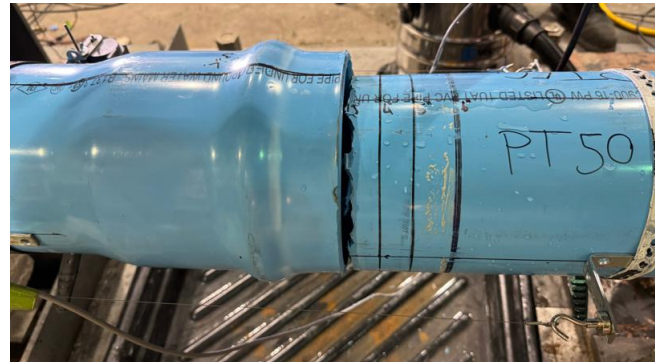
Figure 3.22 shows the relationship among actuator force, internal pressure, and actuator displacement relative to time for the first PVC pipe tension test produced by Northern Pipe. Displacement was applied at a rate of 1.0 in./min. (25 mm/min.), and the force feedback of the load cell was recorded. Figure 3.23 shows that the maximum force recorded in the load cell was 26.2 kips (116.6 kN) at an actuator displacement of 2.46 in. (62.5 mm). A constant internal water pressure of  $65 \pm 2$  psi ( $448 \pm 13$  kPa) was applied during loading. Figure 3.24 shows the actuator force vs the joint displacement. The joint displacement reached an average of about 1.02 in. (25.9 mm) just before failure. Figure 3.25 shows the bell and spigot connection before the test. A circumferential fracture occurred where the gasket teeth penetrate on the spigot side of the joint, shown in Figure 3.26.

Figure 3.26. Fracture at the spigot for PT50

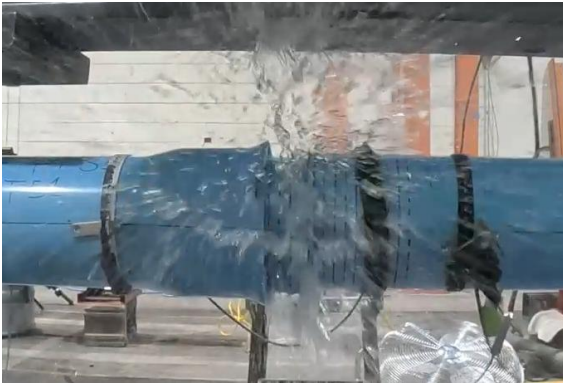
Figure 3.32. Failure moment at joint for PT51

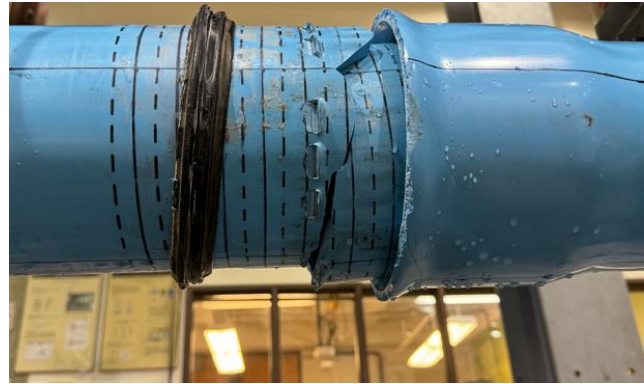
Figure 3.29 also shows the relationship between actuator force, internal pressure, and actuator displacement relative to time for second tension test of Northern Pipe. Displacement was applied at a rate of 1.0 in./min. (25 mm/min.), and the force feedback of the load cell was recorded during the test. A constant internal water pressure of  $65 \pm 2$  psi ( $448 \pm 13$  kPa). When the specimen lost its force capacity ( $t=390$  sec), the pressure dropped to about 35 psi and then the joint kept the pressure approximately 20 seconds after that the pressure dropped to 0 ( $t=410$  sec). Figure 3.30 shows that the maximum force recorded in the load cell was 25.7 kips (114.4 kN) at an actuator displacement of 2.31 in. (58.7 mm). Figure 3.31 shows the actuator force vs joint displacement. The joint displacement reached an average of about 0.81 in. (20.6 mm) just before failure. Figure 3.32 shows failure moment at the joint. Failure occurred on the west side (Spigot) of the joint. A circumferential fracture was observed between the end of the spigot and where gasket teeth penetrate on the spigot, as shown in Figure 3.33.

Figure 3.33. Fracture at the spigot for PT51

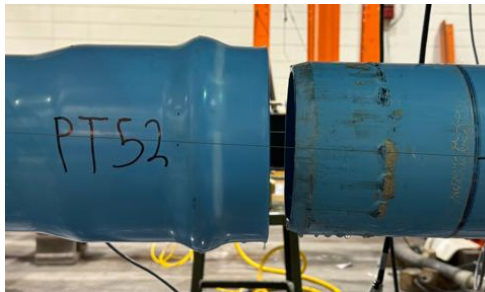
was recorded. A constant internal water pressure of  $65 \pm 2$  psi ( $448 \pm 13$  kPa) was applied during the test. Figure 3.37 also shows that the maximum force recorded in the load cell was 25.2 kips (111.9 kN) at an actuator displacement of 2.20 in. (55.9 mm). Figure 3.38 shows the actuator force vs the joint displacement. The joint displacement reached an average of about 0.7 in. (17.8 mm) at the max force and reached a total of about 0.92 in (23.4 mm) just before failure (22.47 kips). Figure 3.39 shows the bell and spigot connection before the test for PT52. Damage occurred on the gasket, and gasket teeth slipped, as shown in Figure 3.40. Figure 3.41 shows the damage of the RieberLok gasket teeth after the test.

Figure 3.40. After failure for PT52

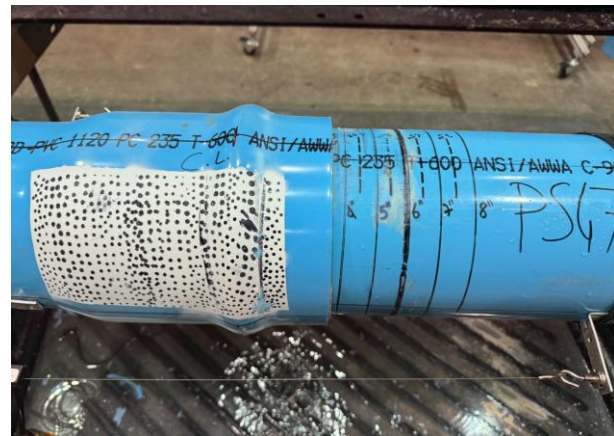
Figure 4.7. PS47 joint failure

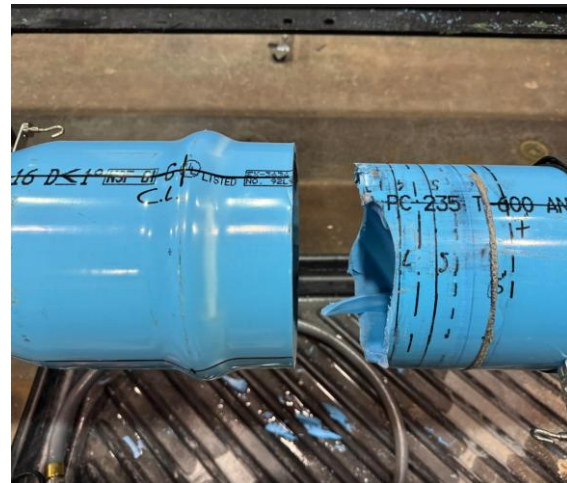
Figure 4.14. PS48 joint fracture at the west side

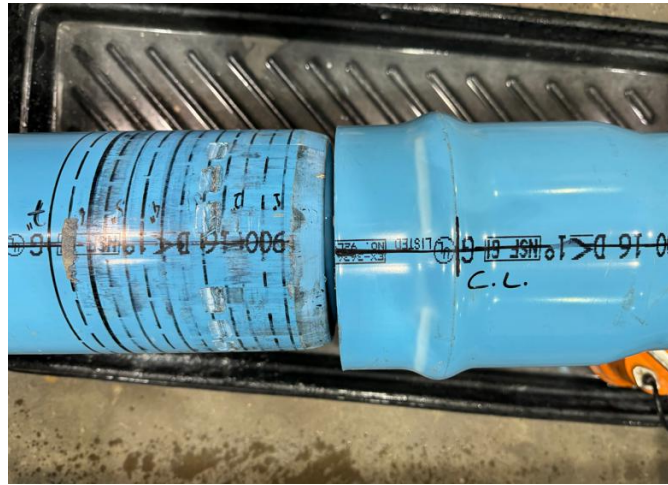
Figure 4.21. PS49 joint failure

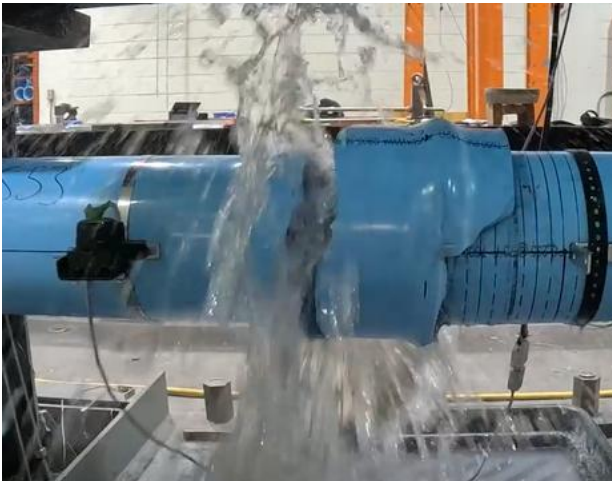
Figure 4.27. PS53 failure moment (The close-up view of North side)

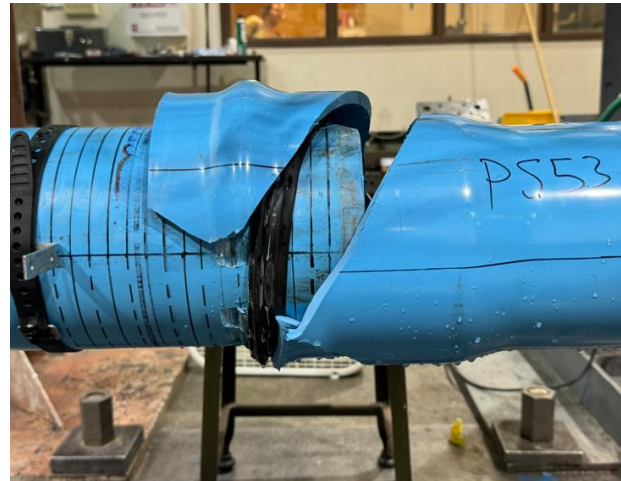
Figure 4.28. PS53 fracture at the bell side of the joint (The close-up view of South side)

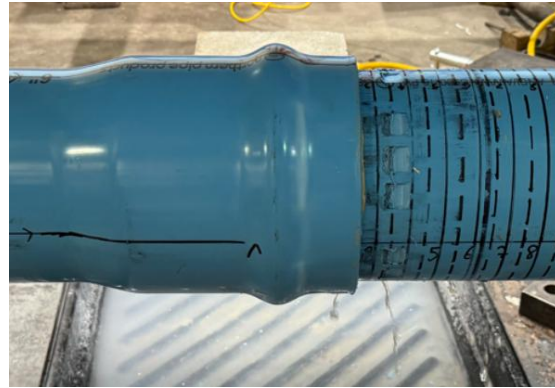
Figure 4.36. PS54 joint failure

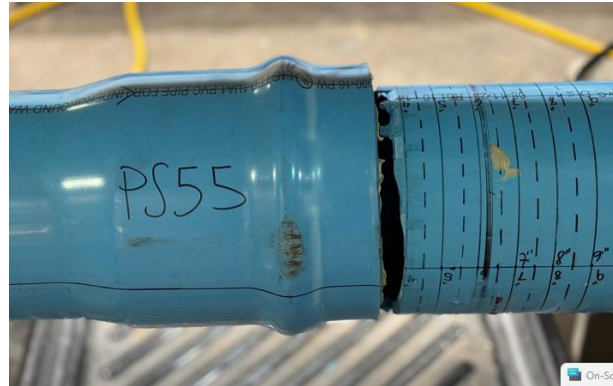
Figure 4.41 and Figure 4.42 show the axial and average circumferential strains for the duration of the test, respectively. At the start of the test, the system was fully pressurized, and an increase in circumferential strain was observed. The maximum axial strain was 0.69% and the maximum circumferential strain was -0.15%. Figure 4.43 and Figure 4.44 show the joint before testing and after failure, respectively. The failure was caused by circumferential fracture of the spigot where the RieberLok gasket teeth engage with the pipe.

Figure 4.44. PS55 joint failure due to fracture on the spigot
