# **Household Perceptions of Shelter Safety in Typhoons and Earthquakes: Takeaways from Leyte and Eastern Samar Six Years After Typhoon Yolanda**

**March 2020**

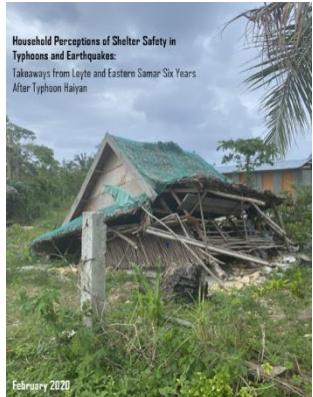
## Cover

A shelter in Eastern Samar which collapsed during Typhoon Ursula in December 2019.

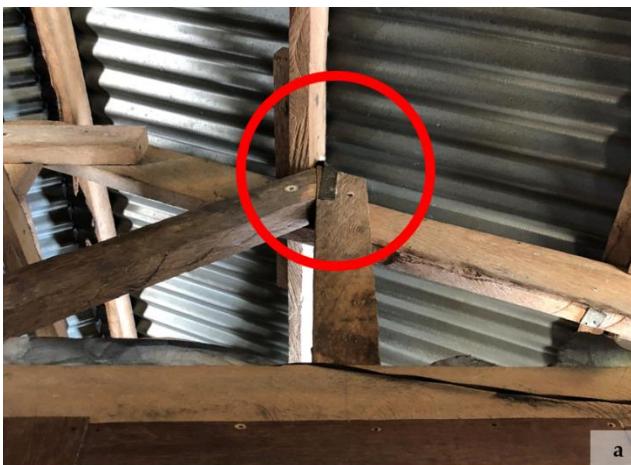
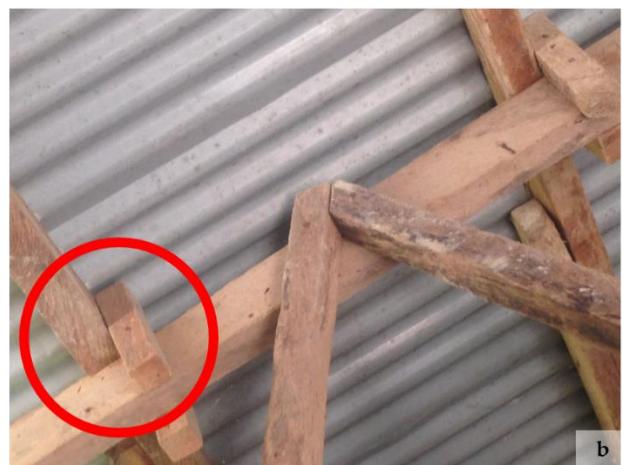
**Figure 10: Examples of purlin-truss connections.** a) A wind strap is used to connect the purlins to the truss. b) Wooden cleats are used to connect the purlins to the truss.

With the exception of Community B and the wooden shelter in Community C, the expected roof failure mechanism is the failure of the purlin-truss connections (see Figure 11). This is the second-most preferred type of failure, for the failure of these connections and subsequently the CGI panels will save the rest of the roof system, mainly the truss. In Community B, the CGI panel-purlin connections are expected to be the first failure of the roof components, also leading to the removal of the CGI panels. In the case of the wooden shelter in Community C, the failure of the truss-wall connection first is not preferred and is likely to lead to the damage and potential collapse of the entire roof system, significantly decreasing the safety of these shelters. Compared to the other shelter designs, the trusses in the wooden shelters in Community C are connected to the wall using only small wooden cleats (see Figure 10) – a weak and vulnerable connection that should be replaced with either bolts or wind straps.

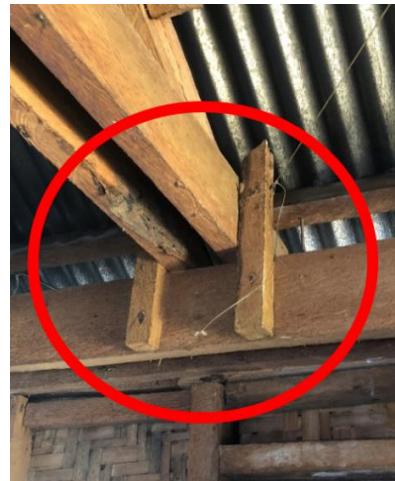
**Figure 11: Truss-wall connection in Community C wooden shelter.**

In Community B, the shape of the roof and the use of wind straps in connecting the purlins to the truss and the truss to the wall makes the roof strong compared to the walls. Thus, the wind speed at which the first wall failure occurs is less than the wind speed where any of the roof components fail, resulting in the least desired failure mode. The failure of the walls before any of the roof elements can

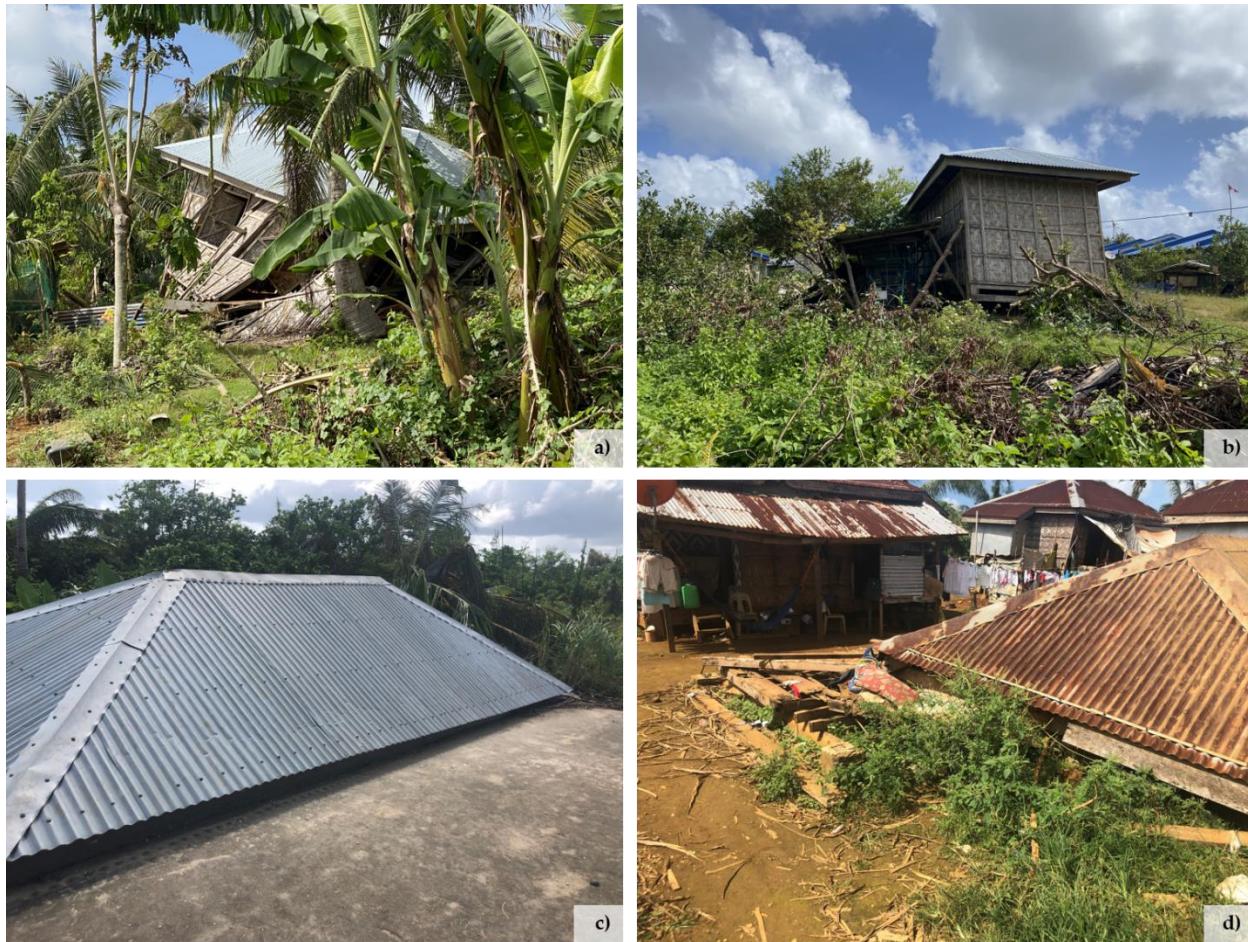
lead to considerable tilting and complete collapse (see Figure 12) – outcomes experienced by nearly 50 of the shelters in Community B during Typhoon Ursula, which struck Guiuan and Tacloban on December 24, 2019, with wind gusts up to 120 mph.

**Figure 12:** Examples of shelters that experienced wall failure due to failure of the column-foundation connection. a-b) Wall racking led to tilt and partial collapse. c-d) Wall racking led to complete collapse with roofs landing on the shelter. (Photos a & b by Abbie Liel).

While worries with the walls most often dealt with the durability of the wall panel material, it is a failure of the wall frame at the connection between the column and roof beam and the column and concrete foundation, that leads to wall damage and collapse. In Community B, our field reconnaissance indicates that it was a deterioration of the column at the connection with the foundation and a failure of the metal strap connecting the wooden column and concrete footing (see Figure 14) that led to collapse.

While households expressed concern with both the amakan wall material and the column-foundation connection, they were most concerned with and most likely to change the wall material. Only strengthening the wall panels could increase the forces on the wall frames and make the shelter more vulnerable to collapse. Organizations should discuss these consequences with households during training and encourage strengthening of the column-foundation connection.
