Civil Utility Master Plan Final Report CU Work Order #422523

University of Colorado at Boulder

Boyle Engineering Corporation

October 2003

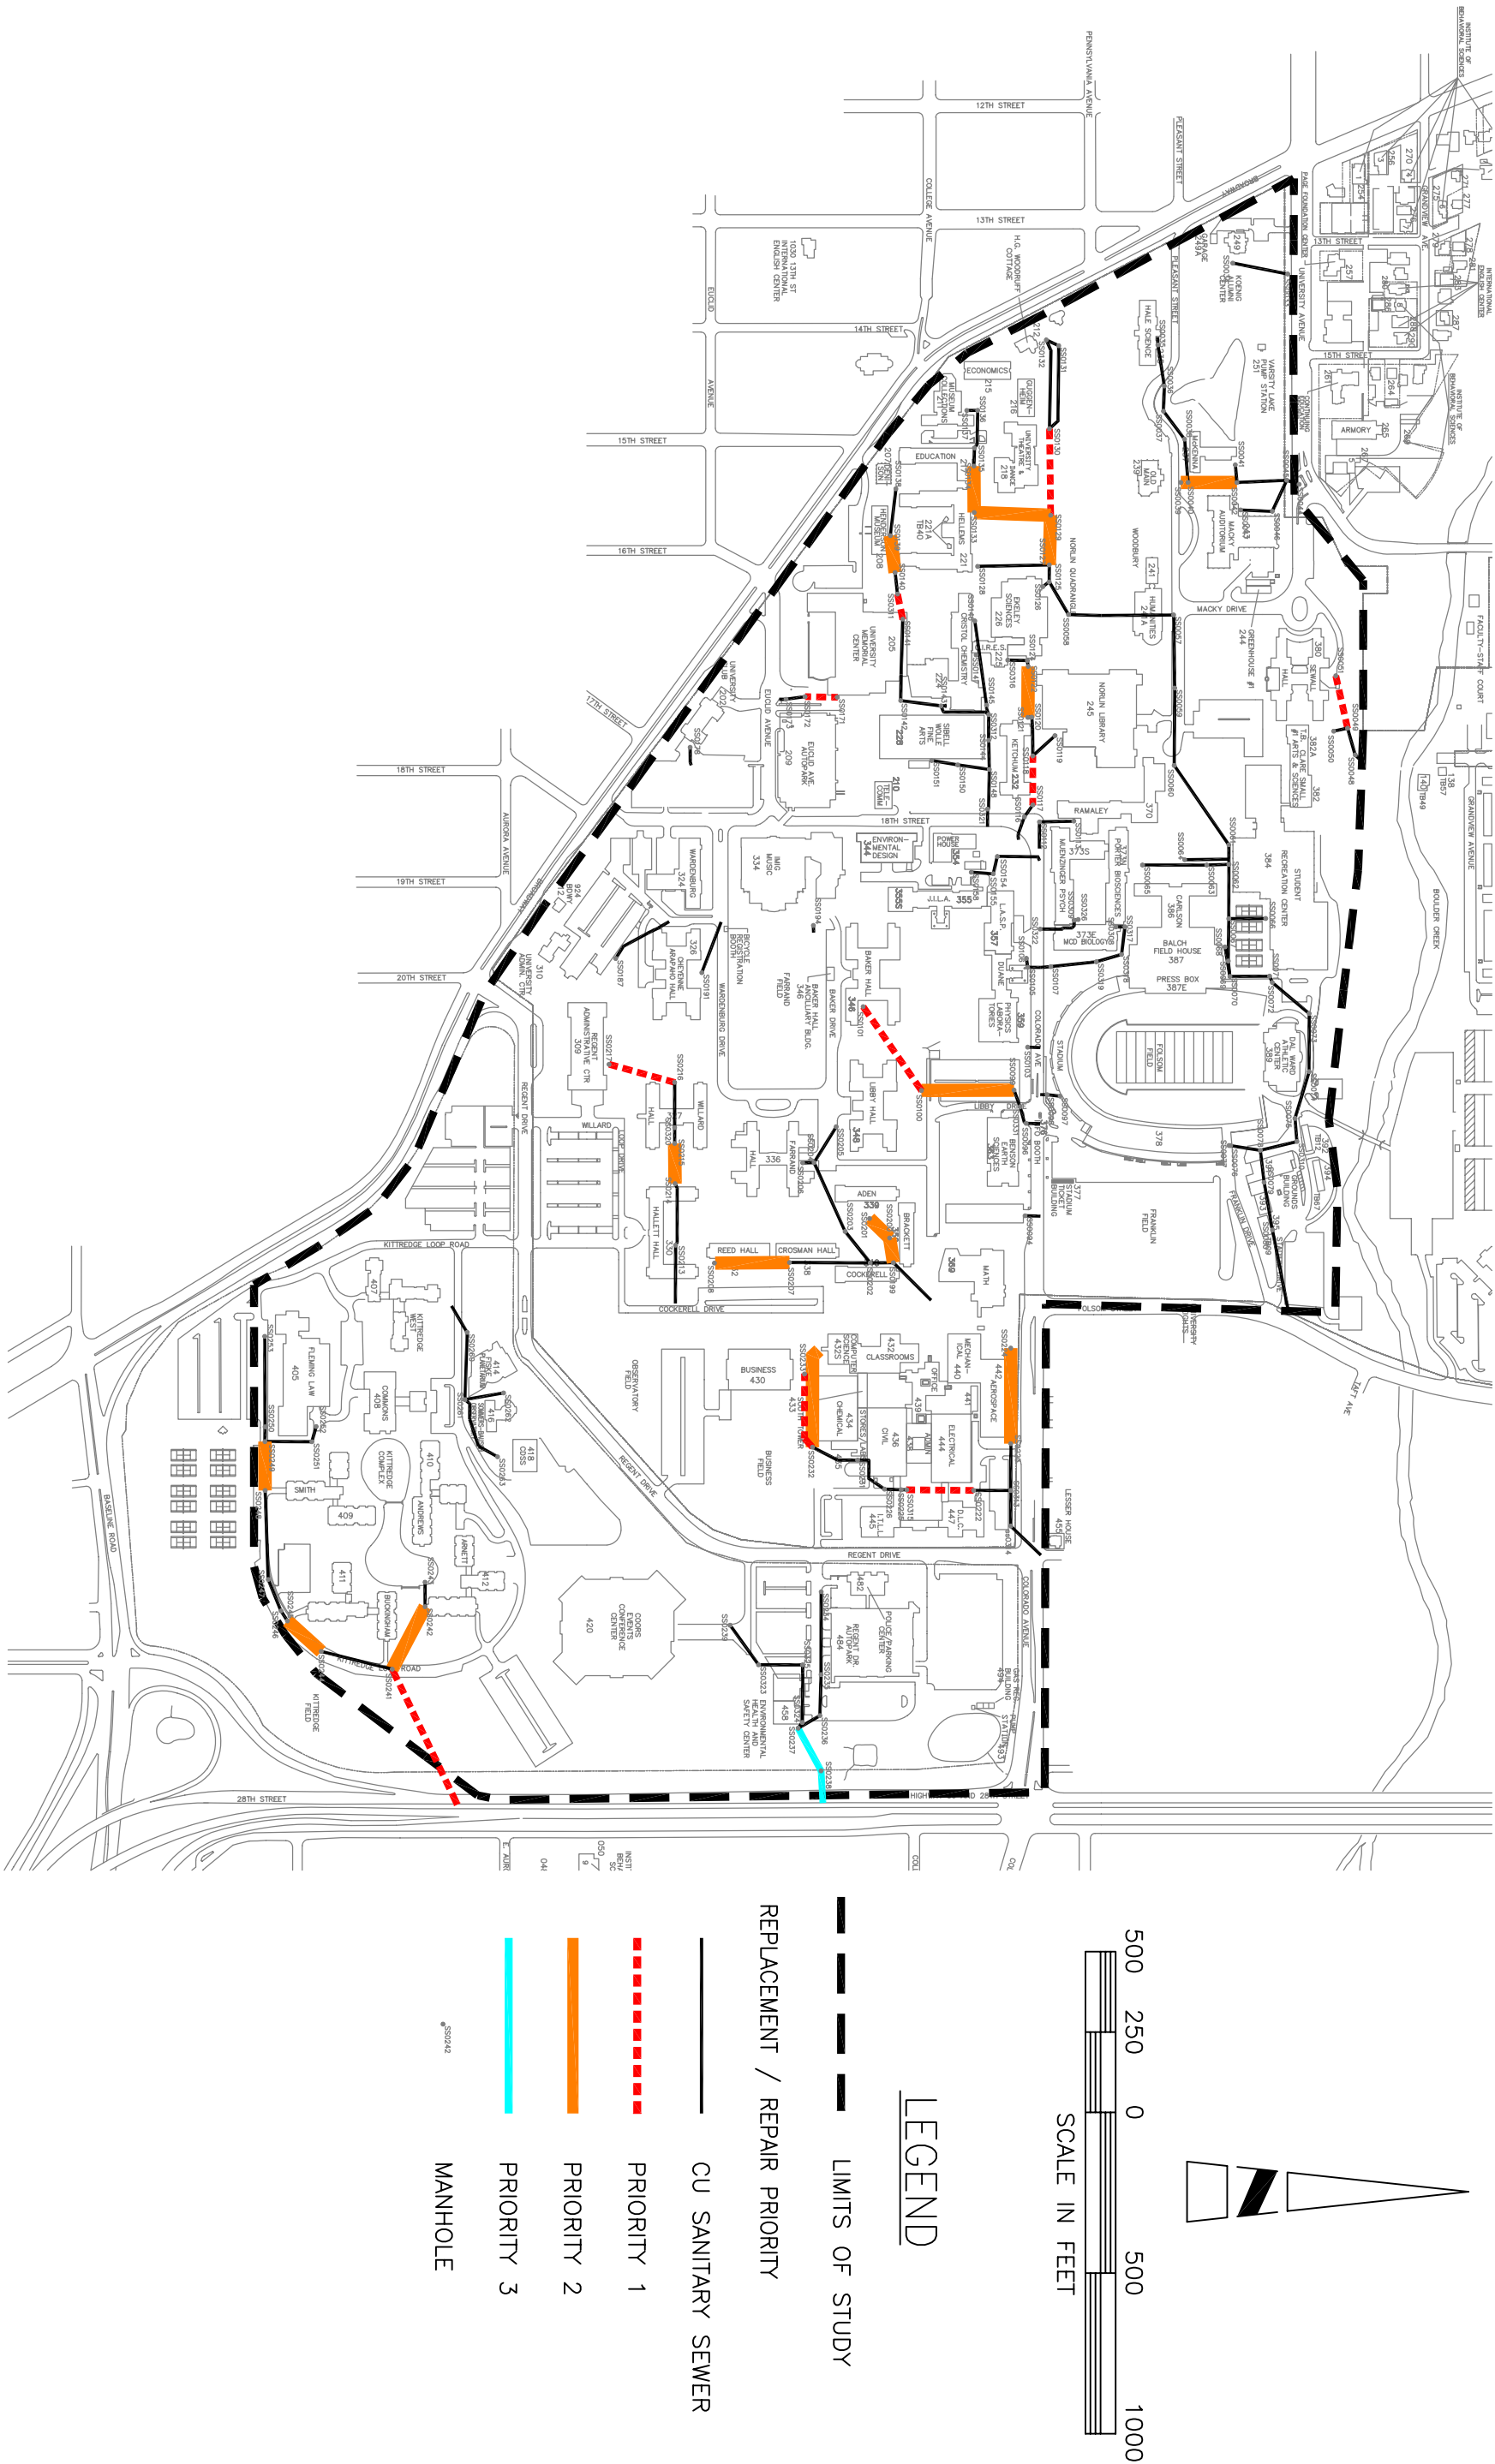
FIGURE-25

MAIN CAMPUS - SANITARY SEWER
REPAIR PRIORITY

The estimated costs for improvements to the sanitary sewer in priority groups 1, 2, and 3 are \$321,000, \$100,000, and \$100,000 respectively, which all represent pipe replacement.

In addition to the improvements identified in this study a maintenance program is presented for the sanitary sewer. It consists of a cleaning and inspection program and a repair and replacement program. The cleaning and inspection program would encompass one-third of the campus sewer every year. The estimated annual cost is \$7,000. The estimated annual cost of the repair and replacement program is shown in Table ES-4.

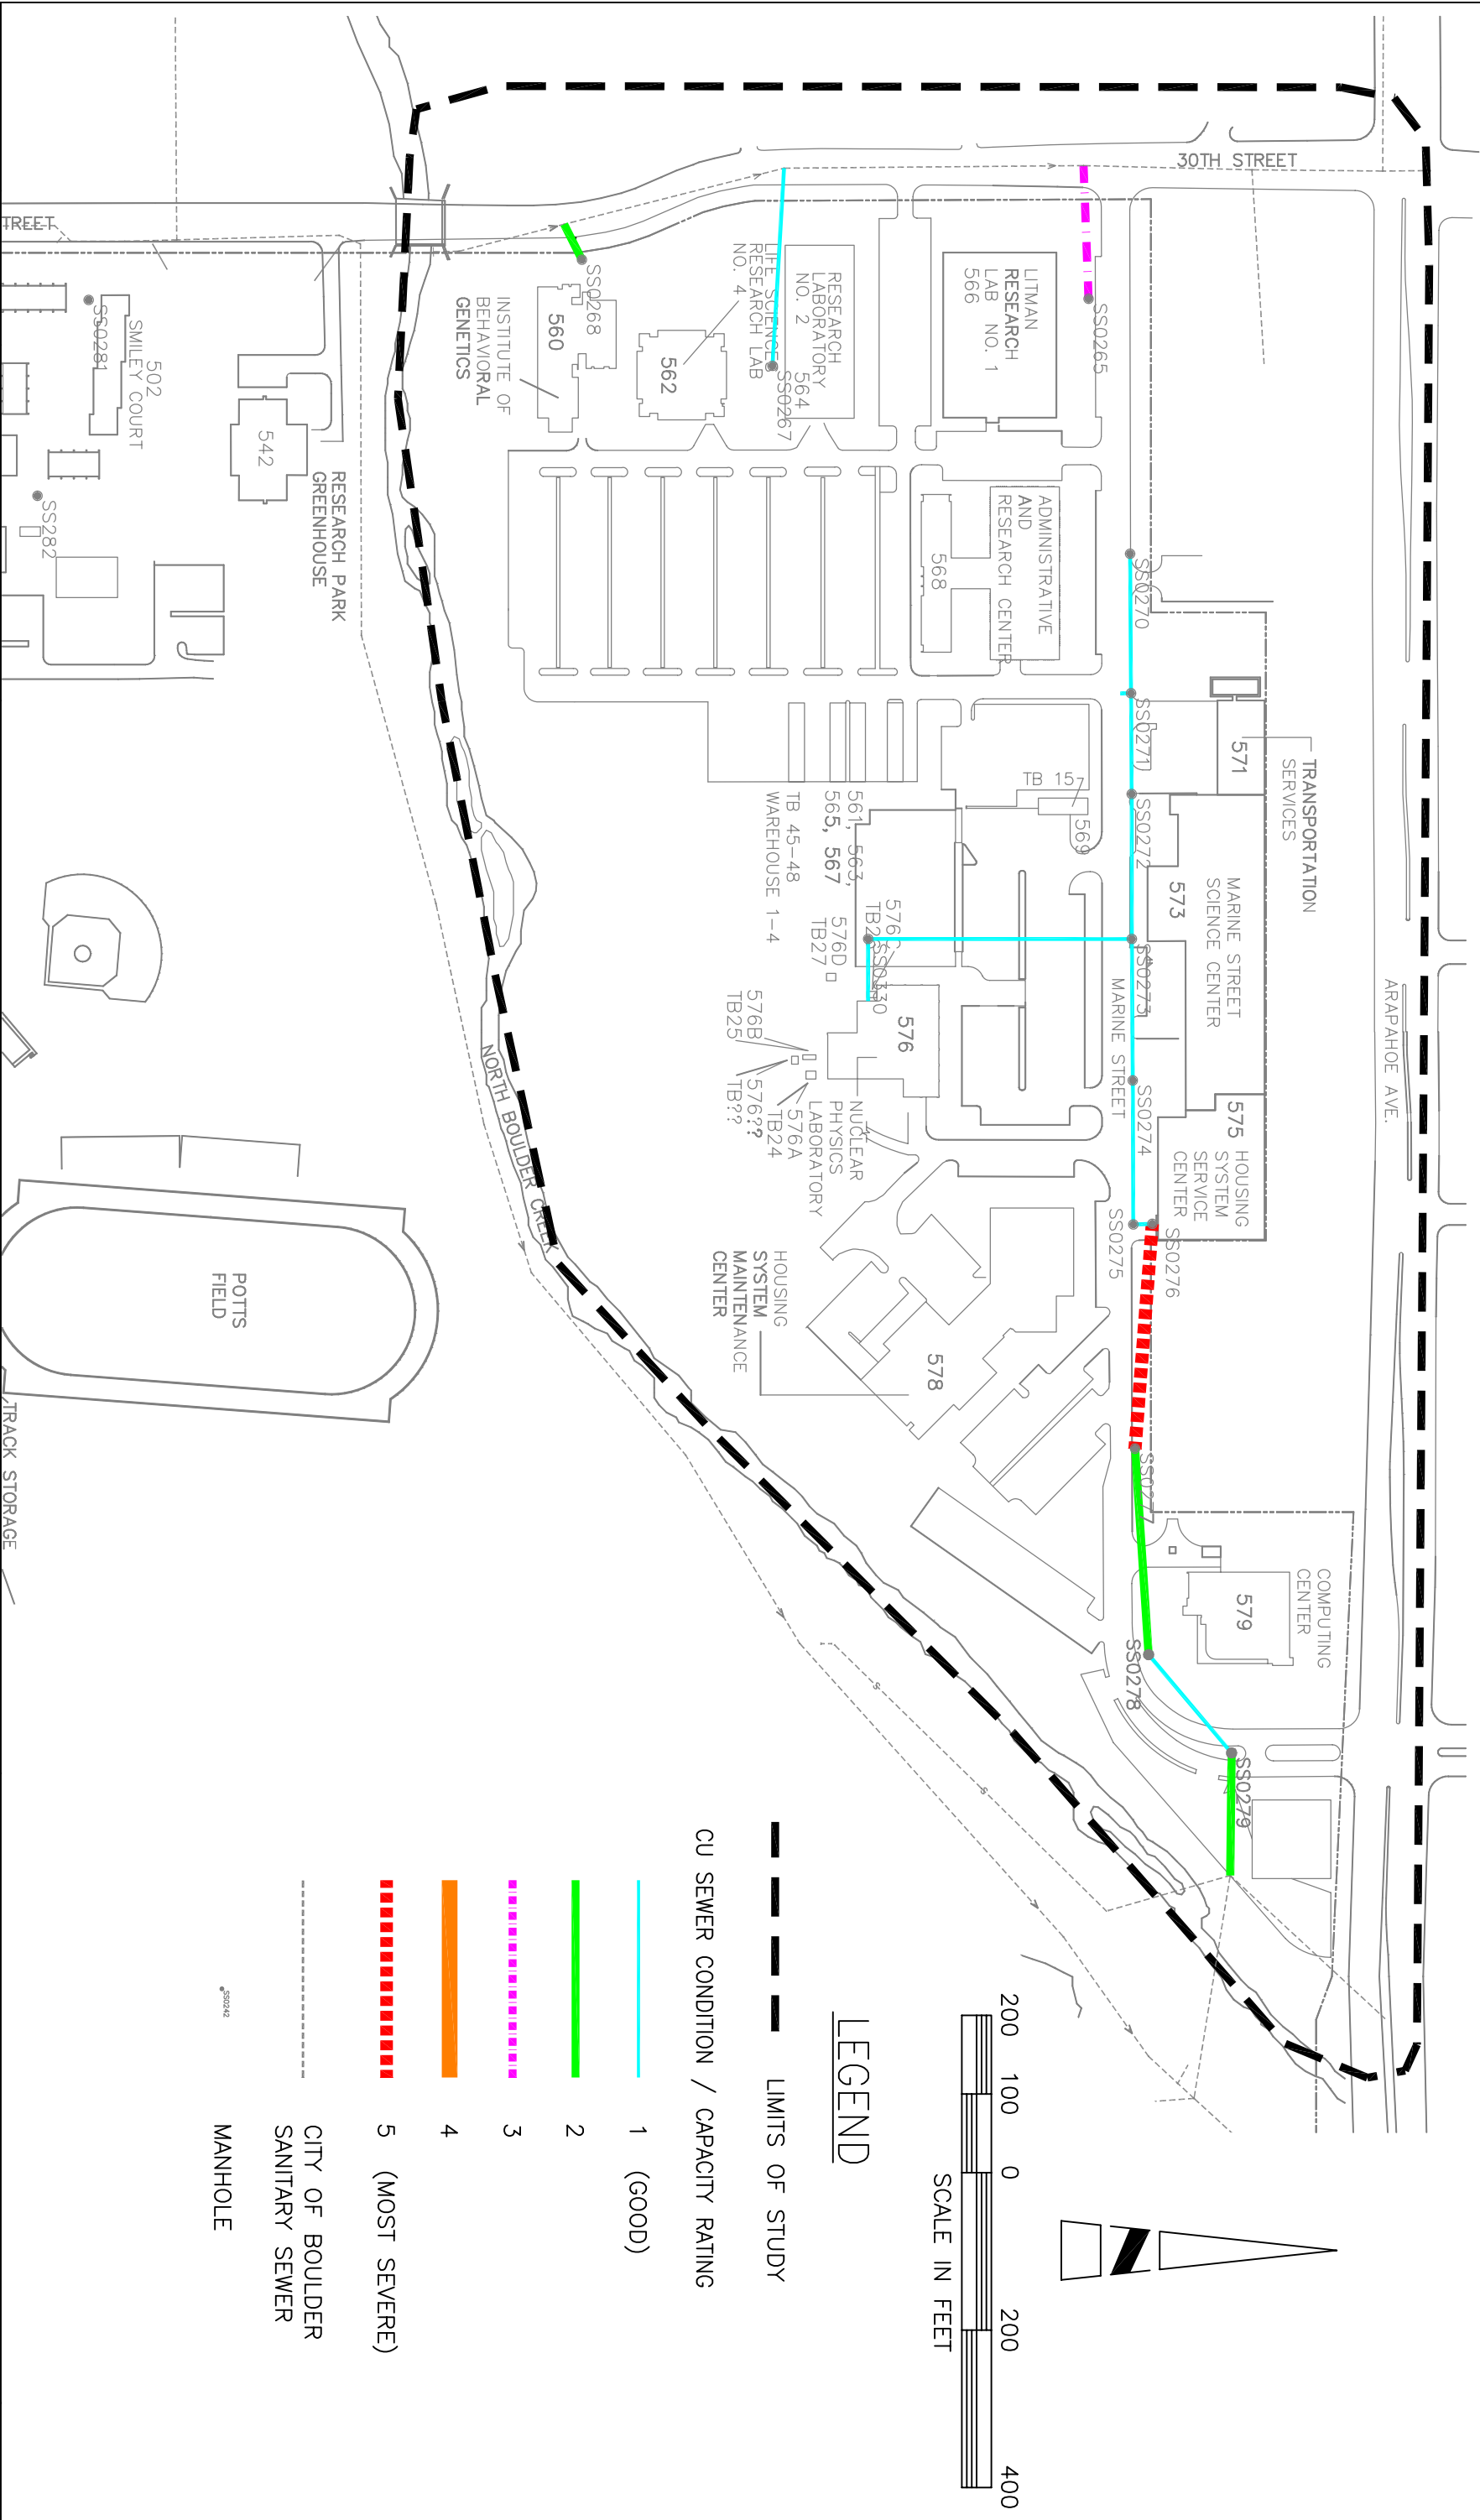
FIGURE-22

EAST CAMPUS – SANITARY SEWER
EXISTING CONDITIONS RATING

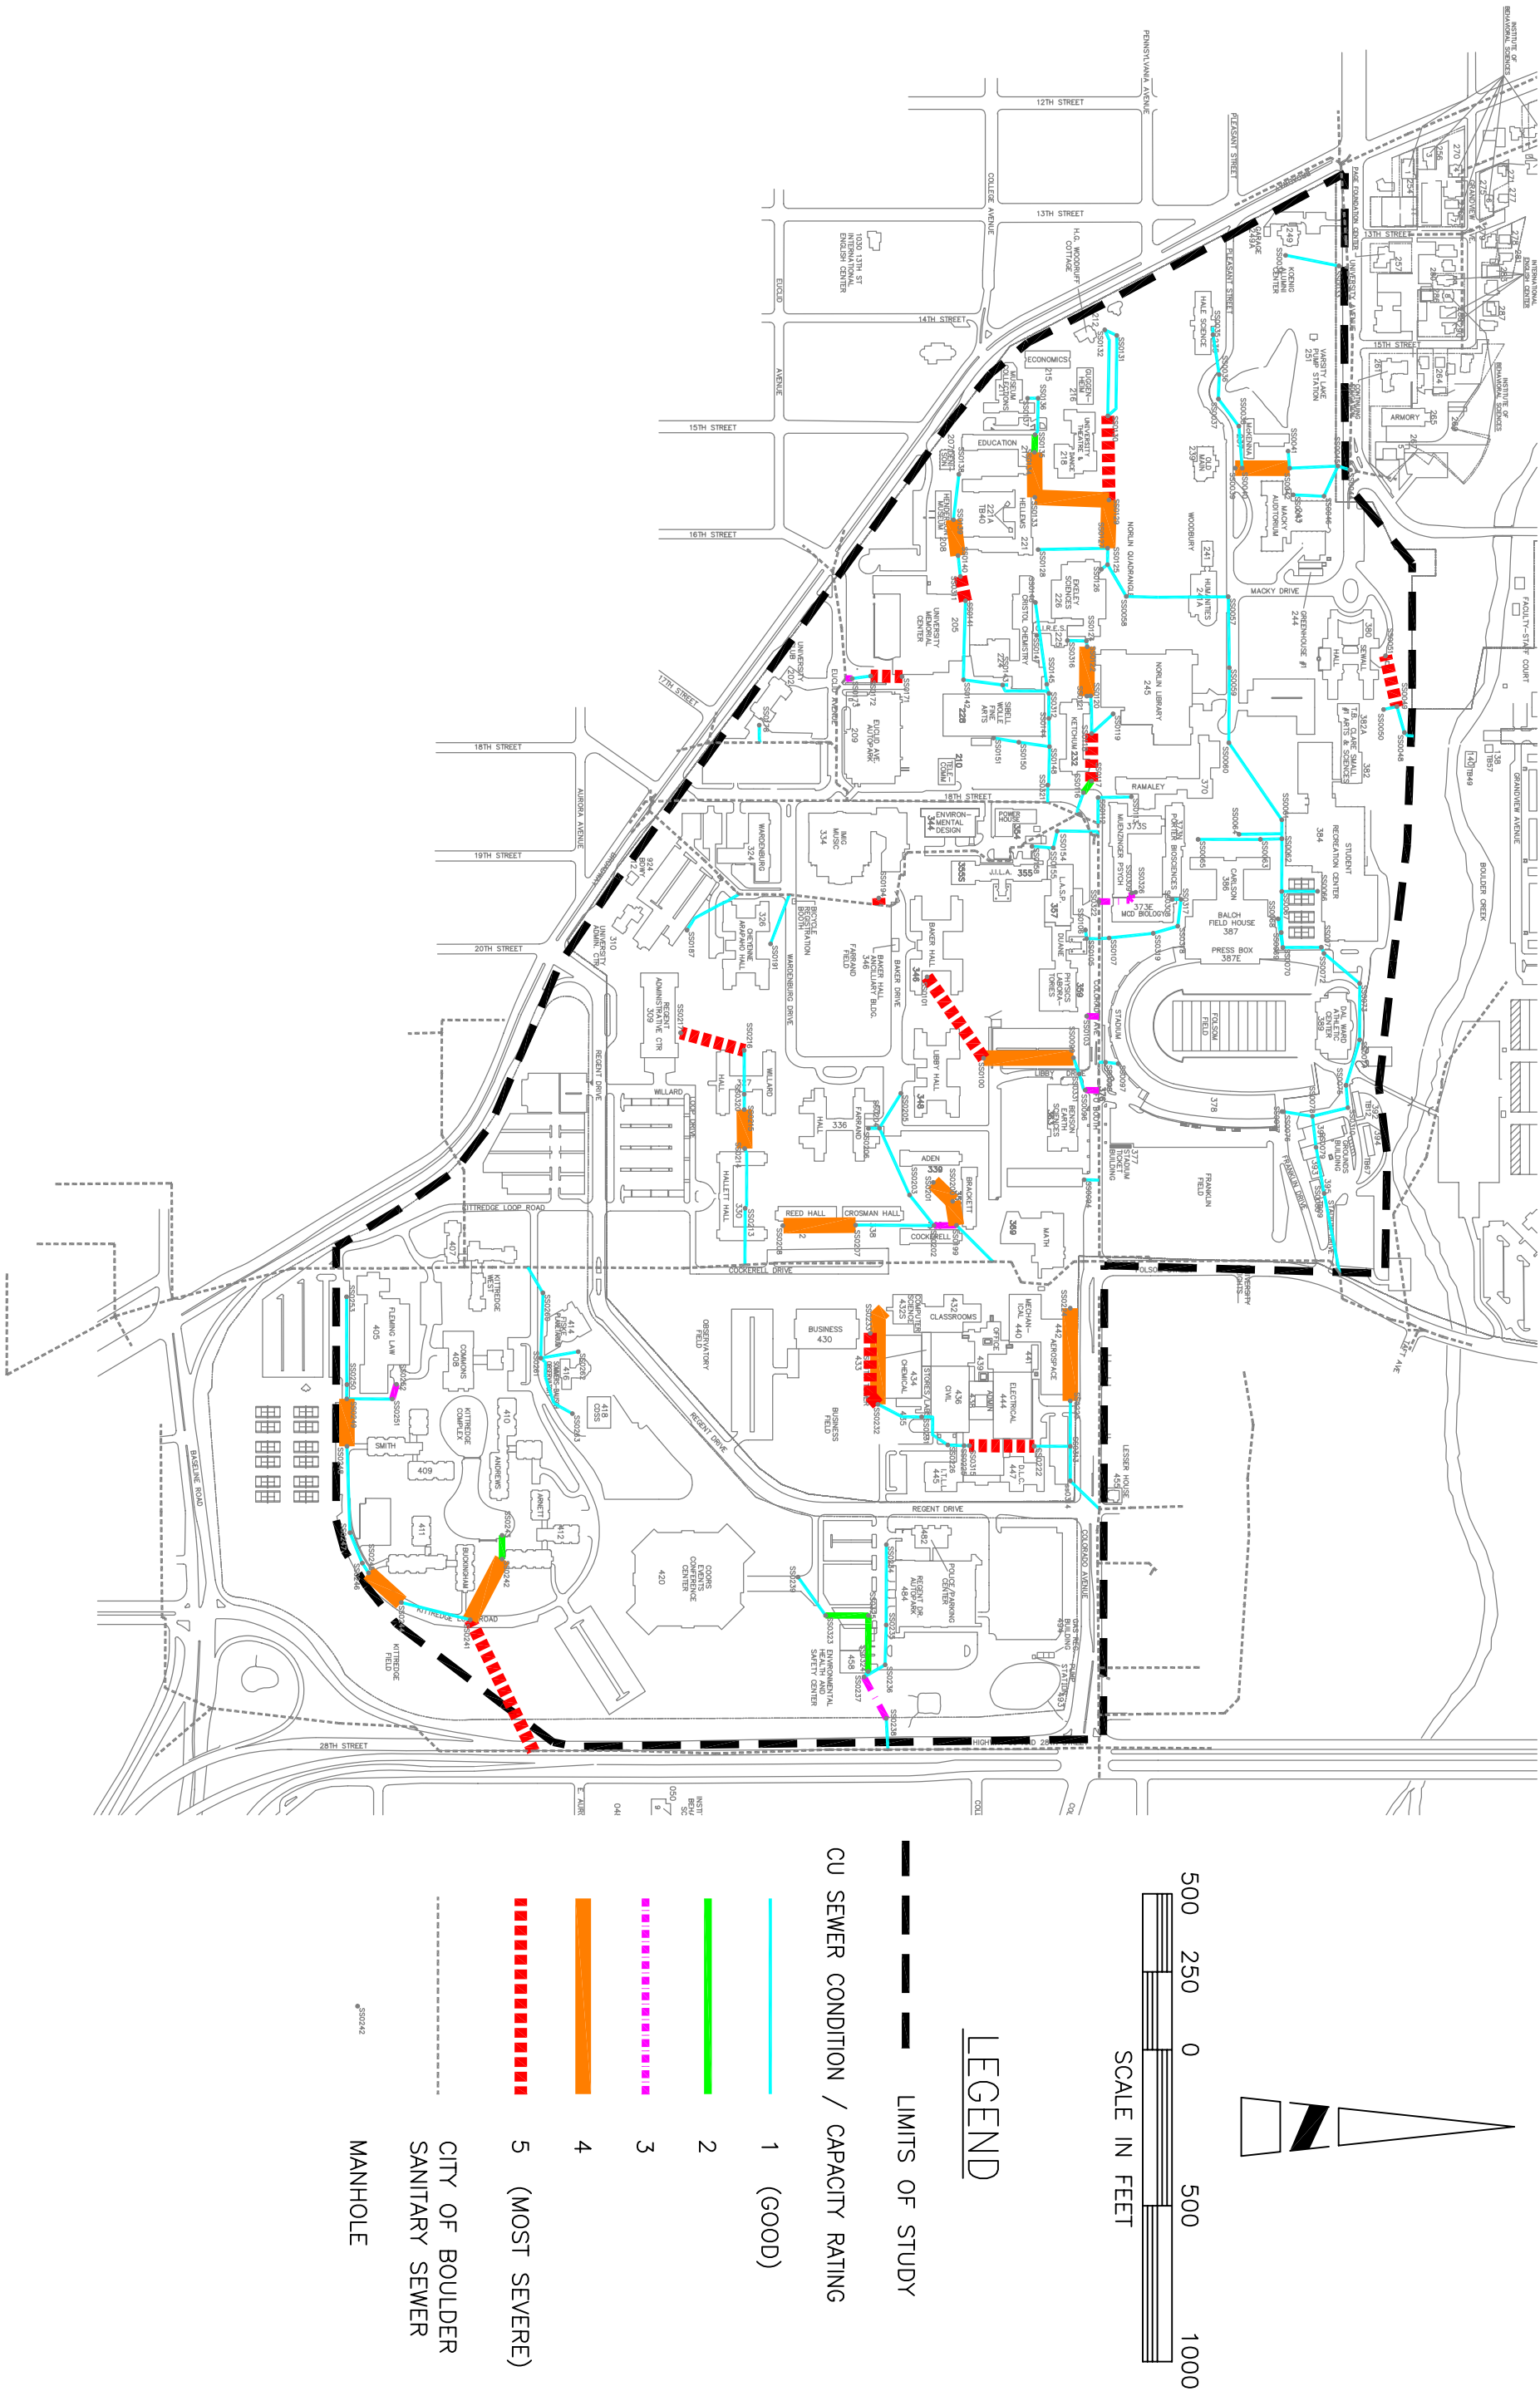
FIGURE-21

The physical condition assessment was developed by applying a rating method to known problems in the system. These problems were identified by viewing CCTV videotapes (taken 7/02 to 8/02) and the corresponding summary sheets that detailed conditions of the pipe.

MAIN CAMPUS - SANITARY SEWER
EXISTING CONDITIONS RATING

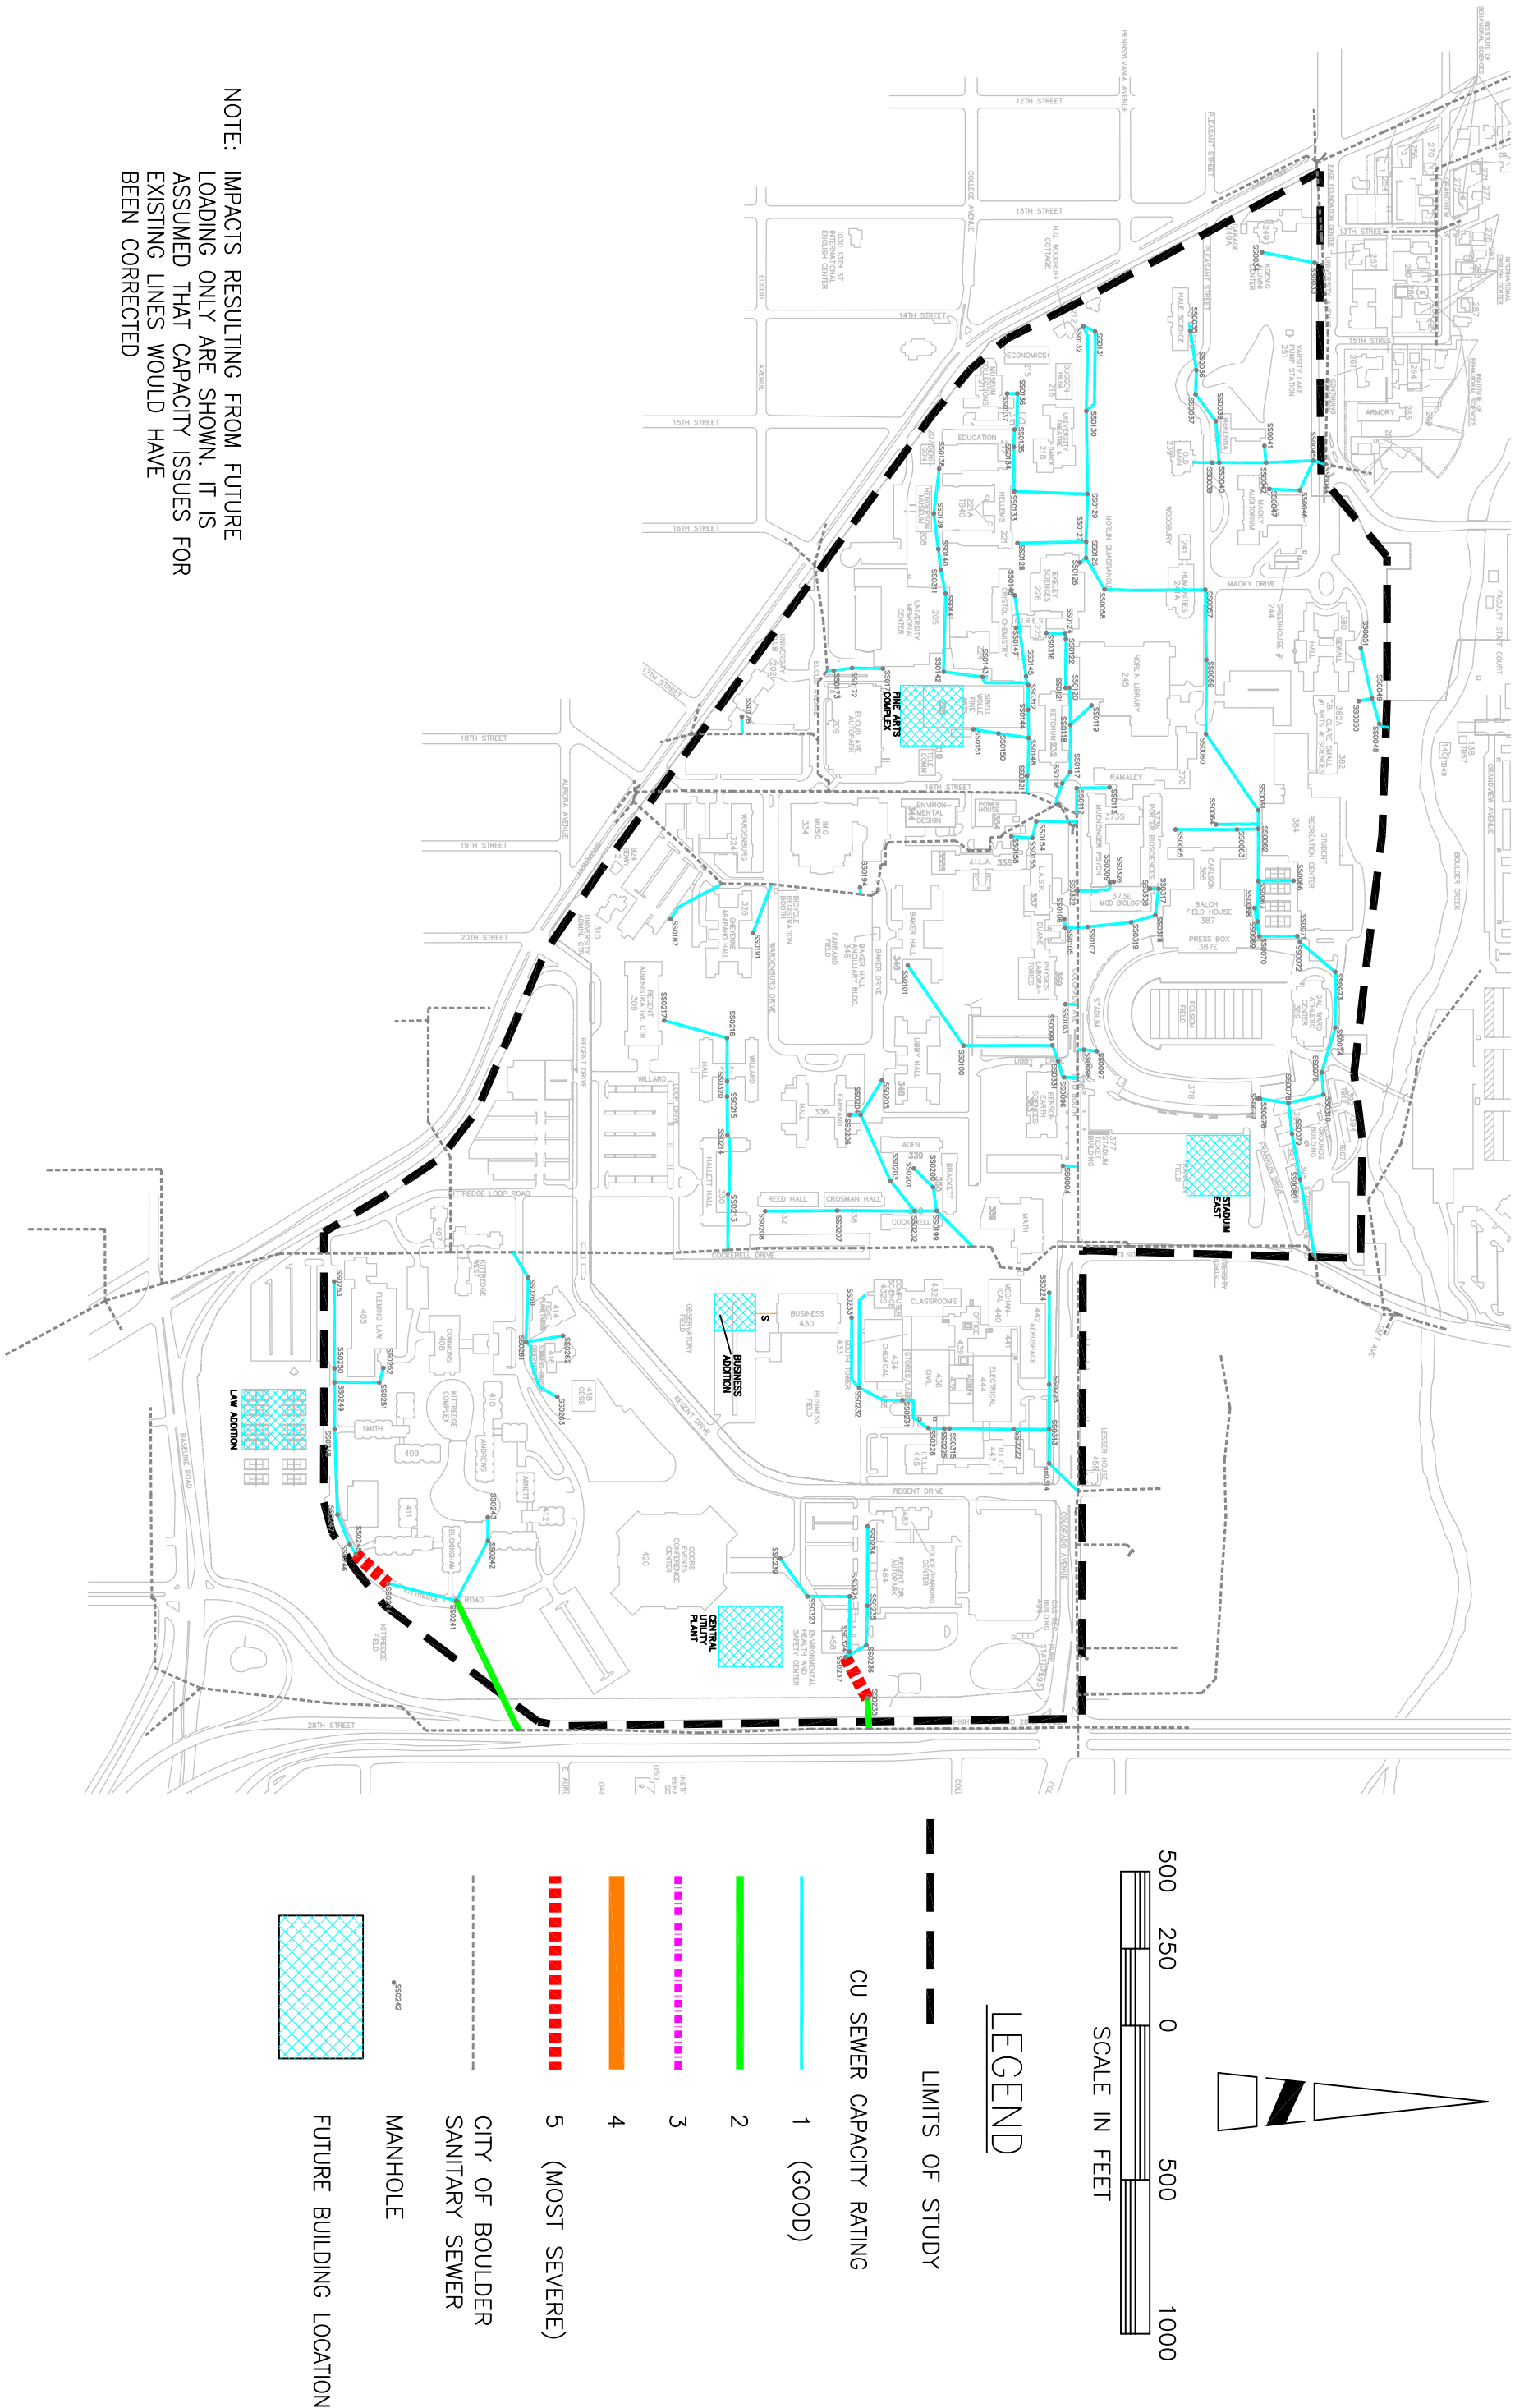
FIGURE-20

NOTE: IMPACTS RESULTING FROM FUTURE
LOADING ONLY ARE SHOWN. IT IS
ASSUMED THAT CAPACITY ISSUES FOR
EXISTING LINES WOULD HAVE
BEEN CORRECTED

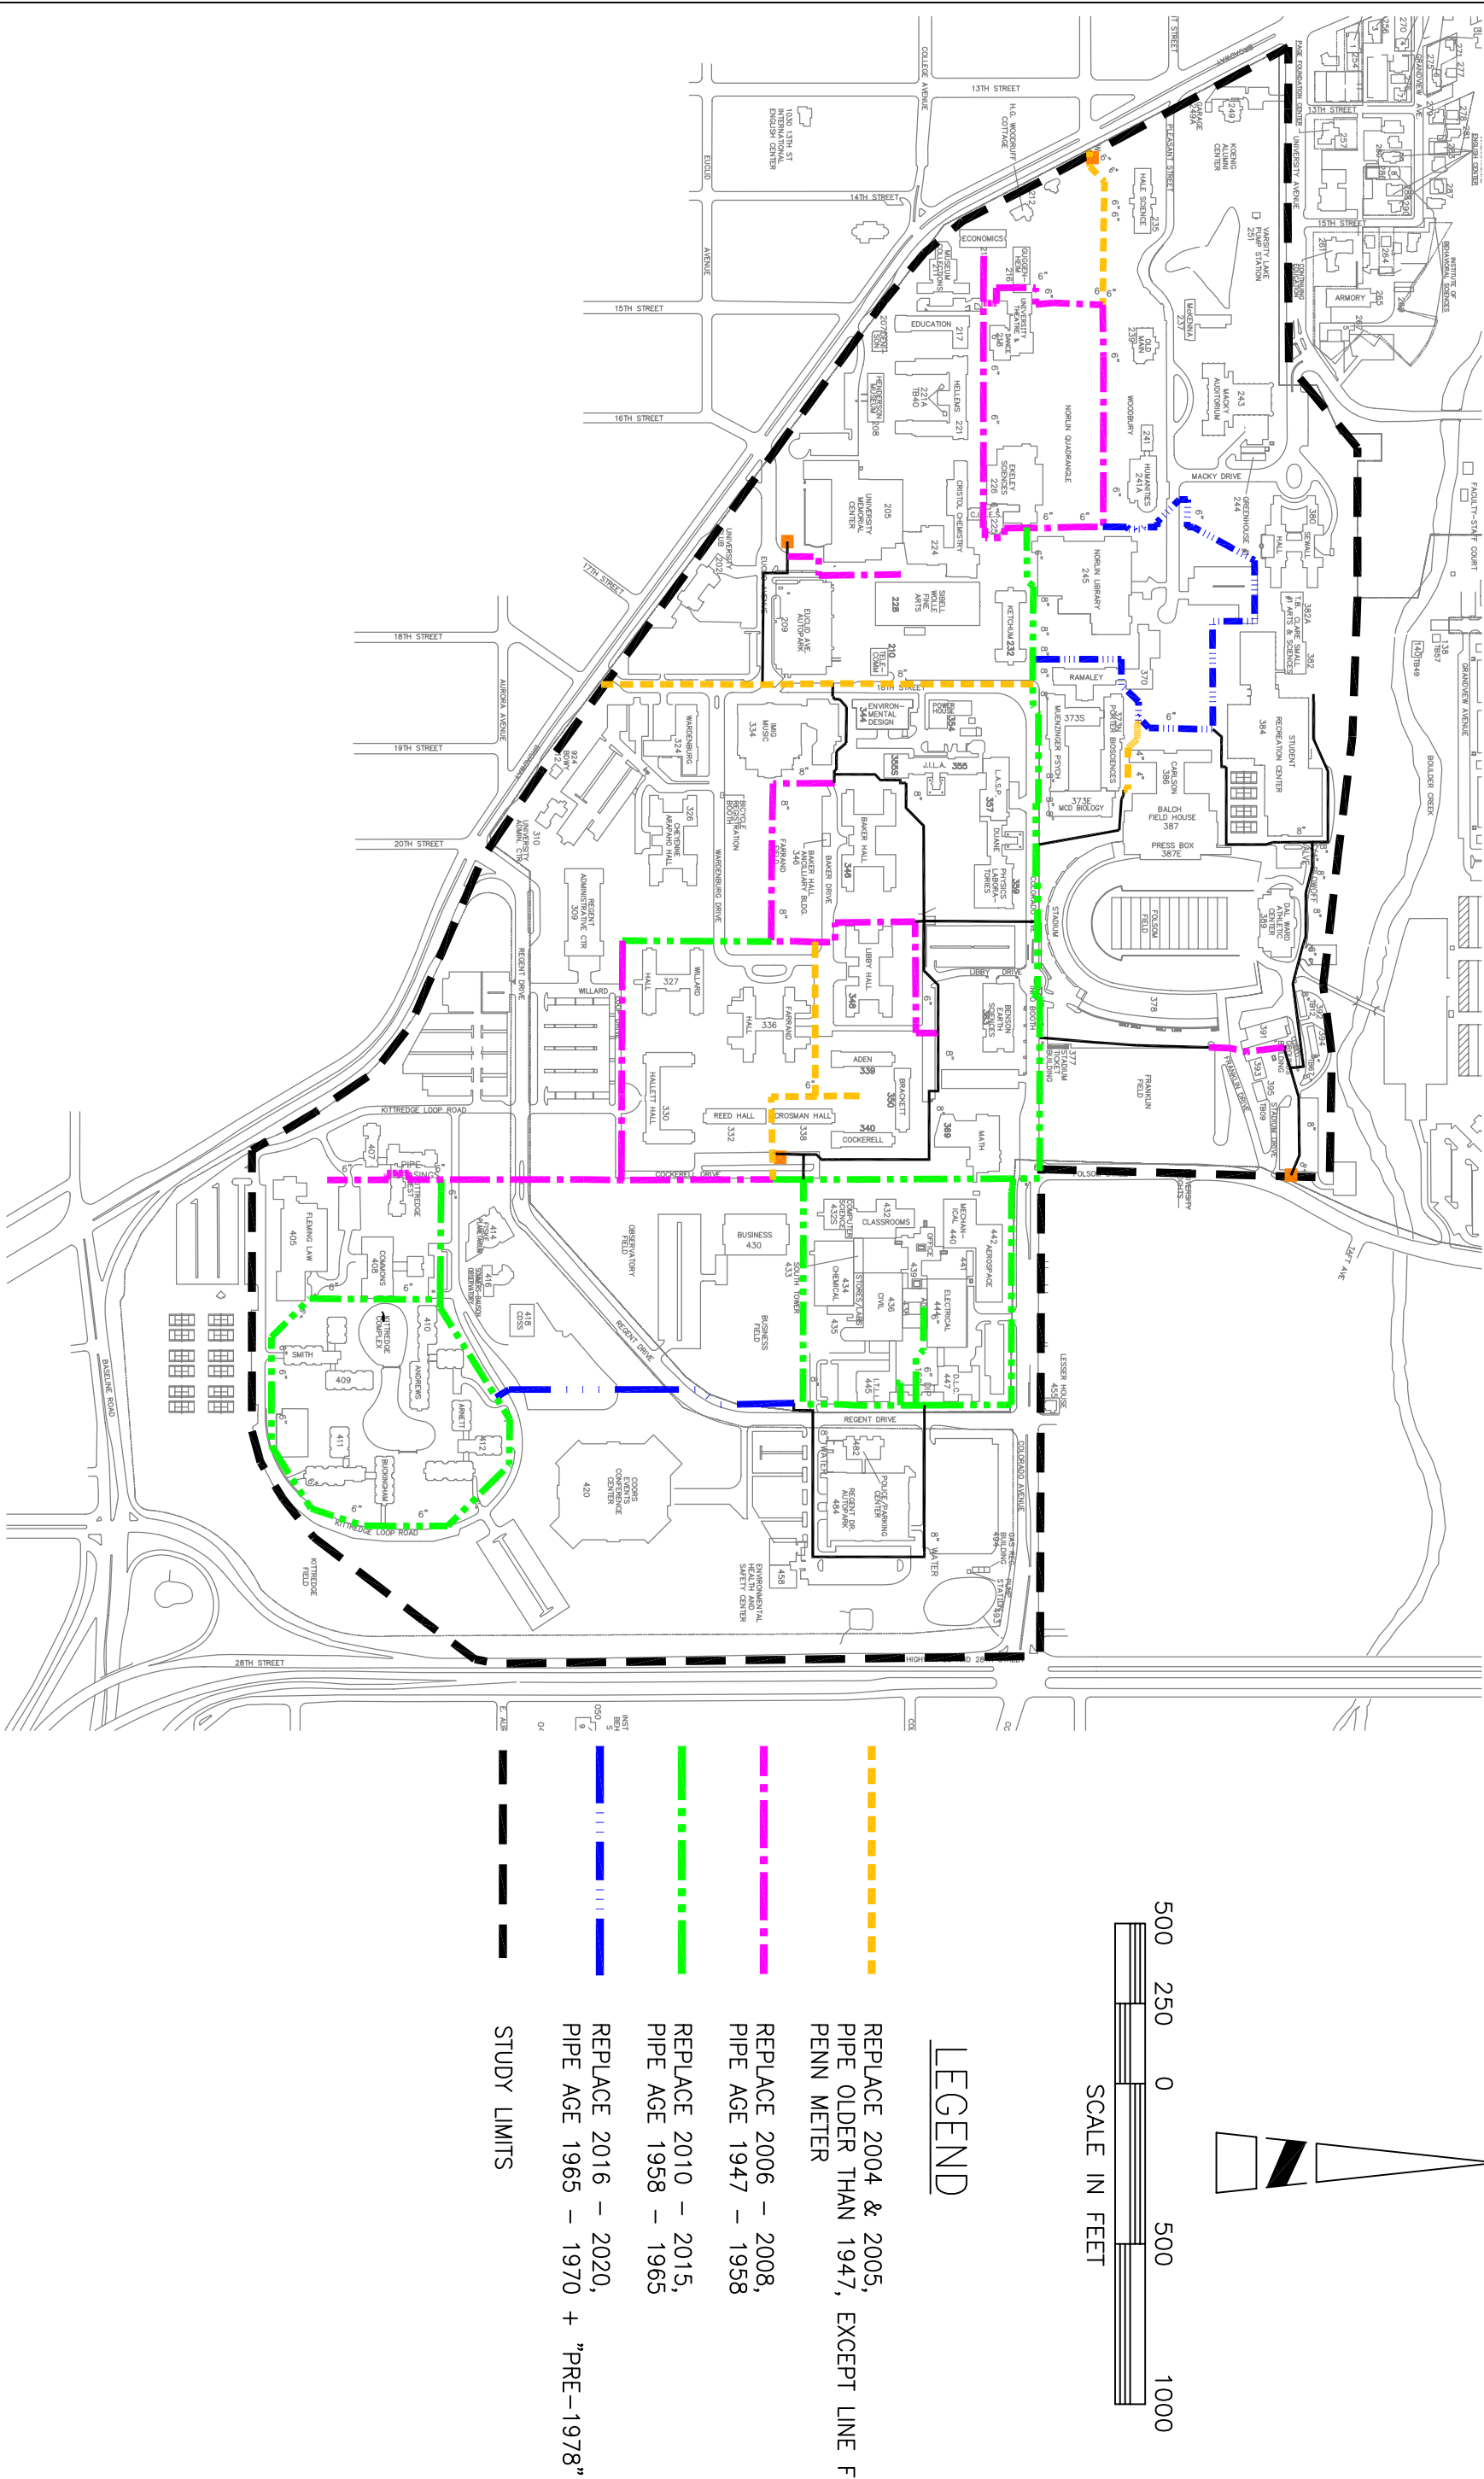
FIGURE 14

In addition, as noted above, many pipes have reached the end of their useful life. A replacement program was developed as shown in Table ES-2.

MAIN CAMPUS
PROPOSED REPLACEMENT PROGRAM

Year	Length to Replace per Year	Estimated Cost per Year (inflated at 4%/yr)
2004 – 2005	1,700 feet	\$265,000
2006 – 2010	1,500 feet	\$274,000
2011 – 2015	1,700 feet	\$378,000
2016 – 2020	1,800 feet	\$486,000

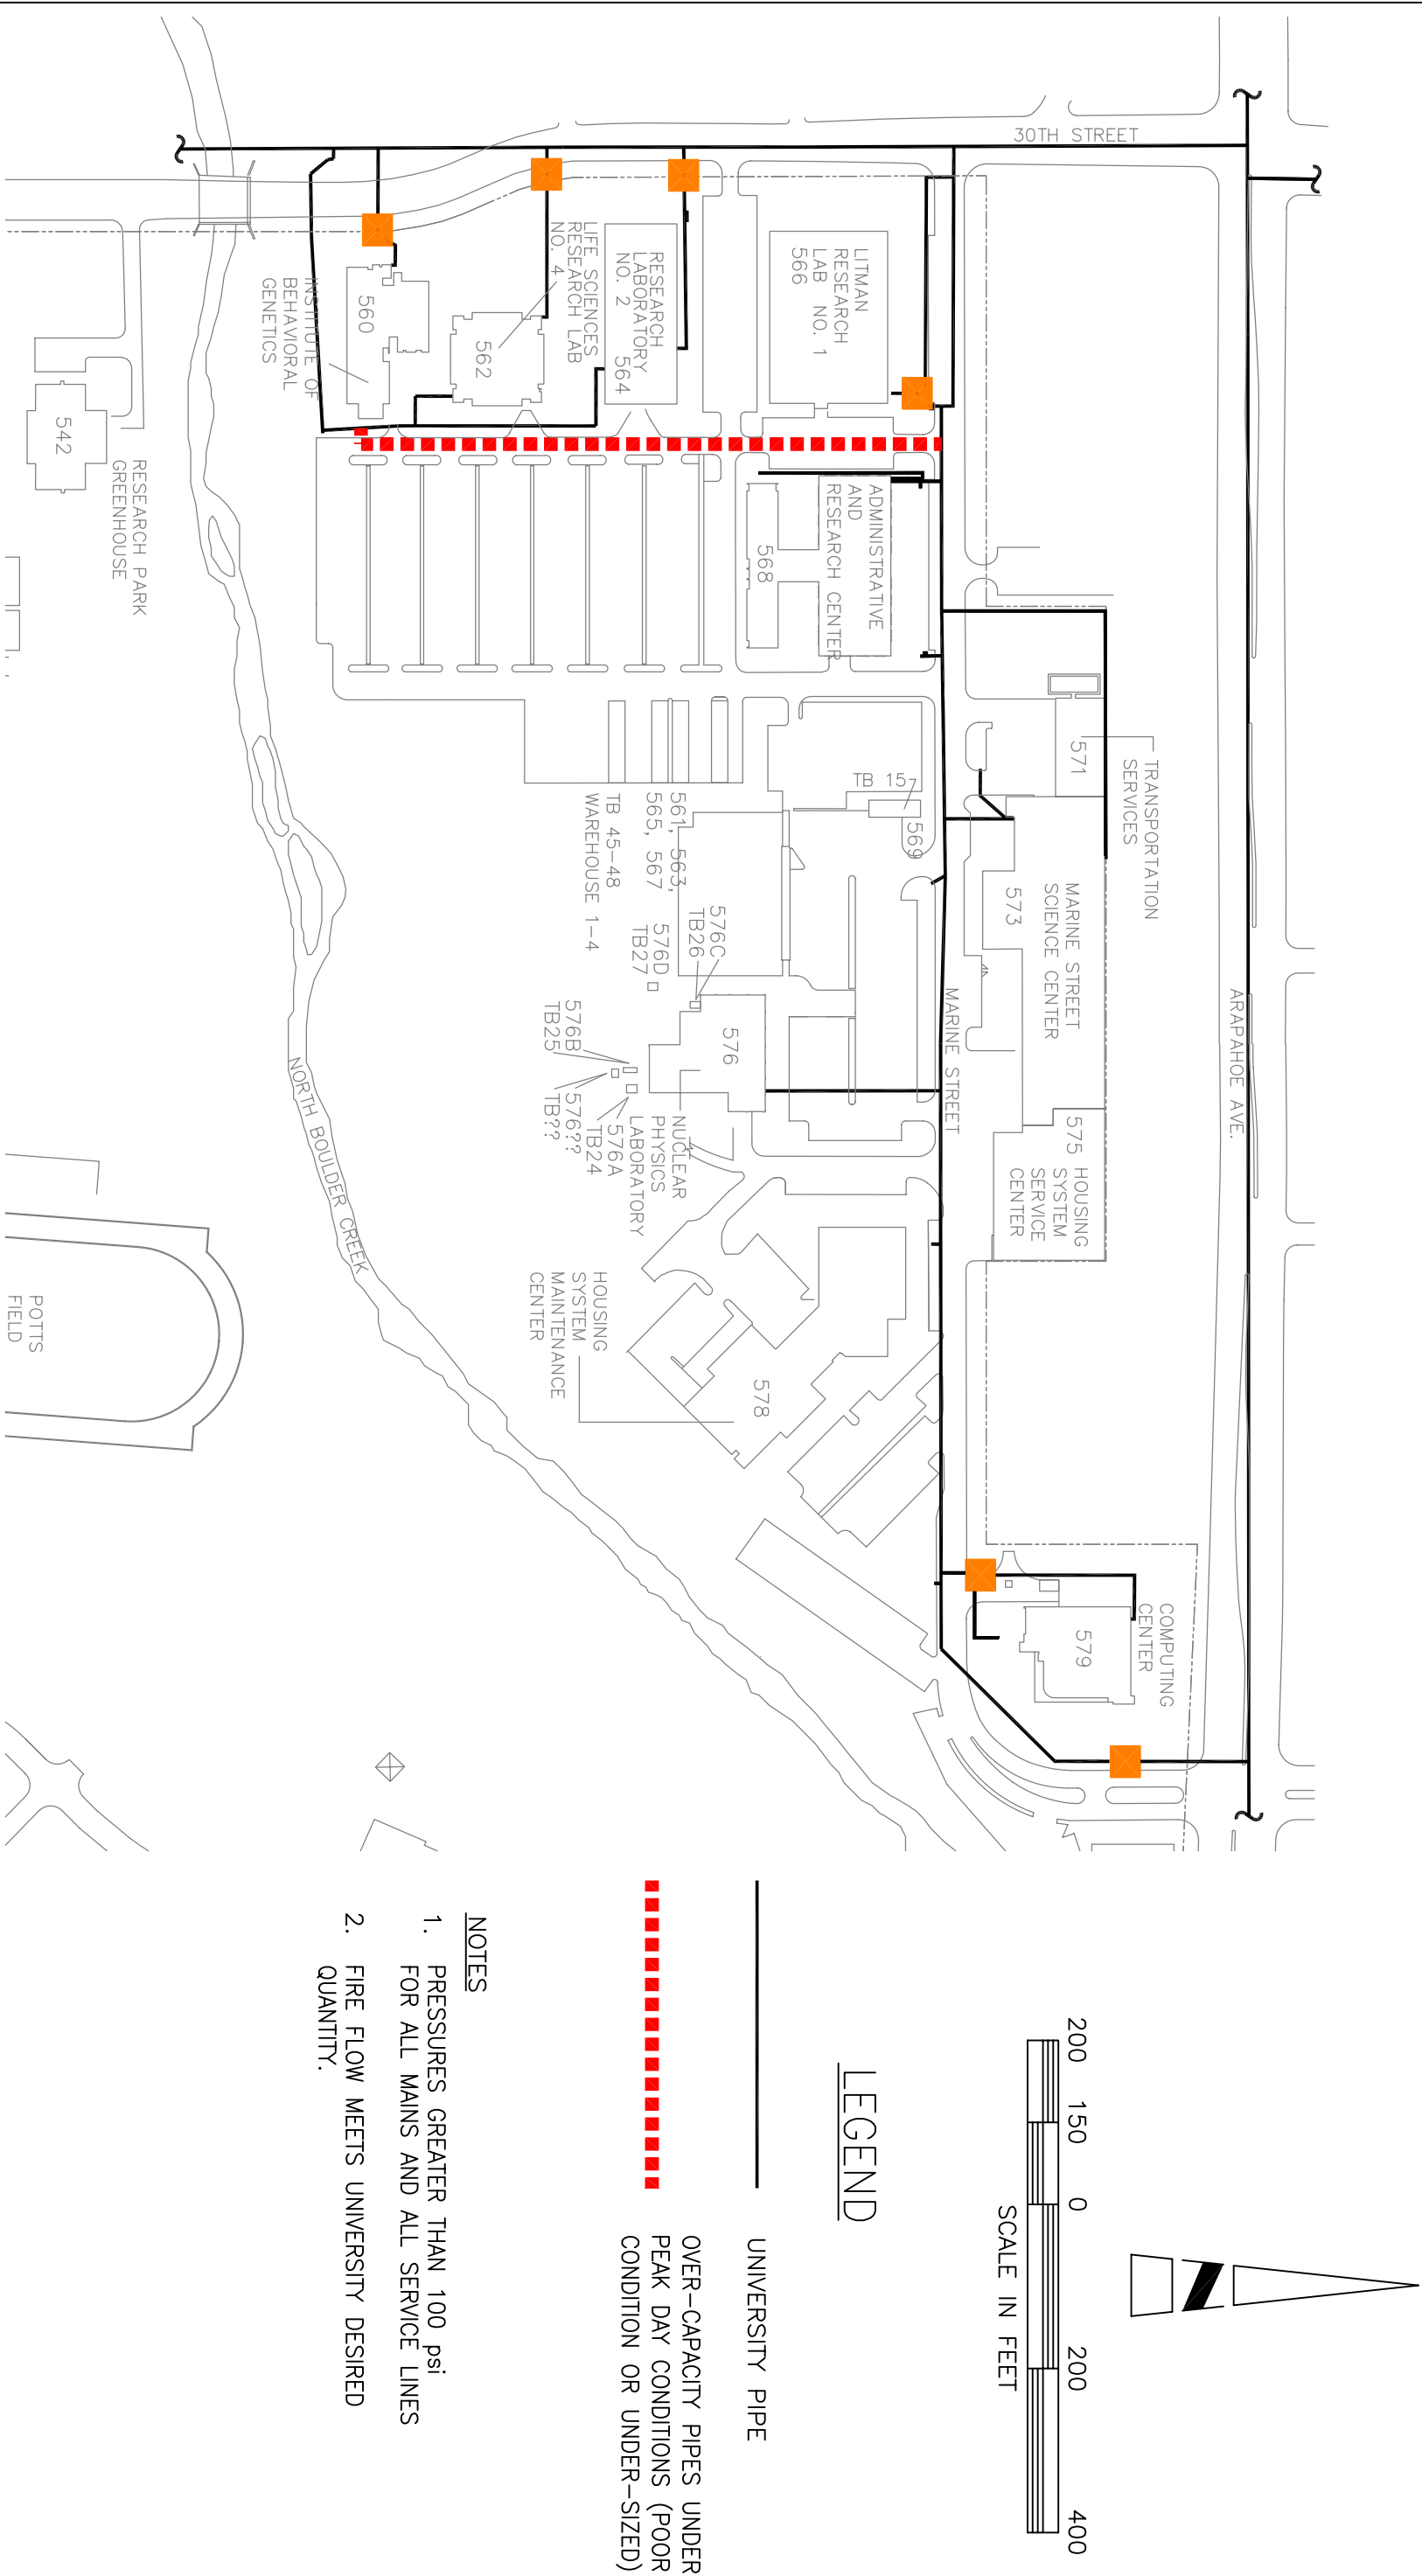
FIGURE-5

The potable water system on the East Campus was determined to provide acceptable service for existing and Build-out conditions. This is due primarily to the high pressures provided by the City to the East Campus and the fact that many buildings are served domestically and/or for fire directly from City mains.

EAST CAMPUS - EXISTING CONDITIONS
EXISTING, 10-YEAR, AND BUILD-OUT
