Civil Utility Master Plan Final Report CU Work Order #422523

University of Colorado at Boulder

Boyle Engineering Corporation

October 2003

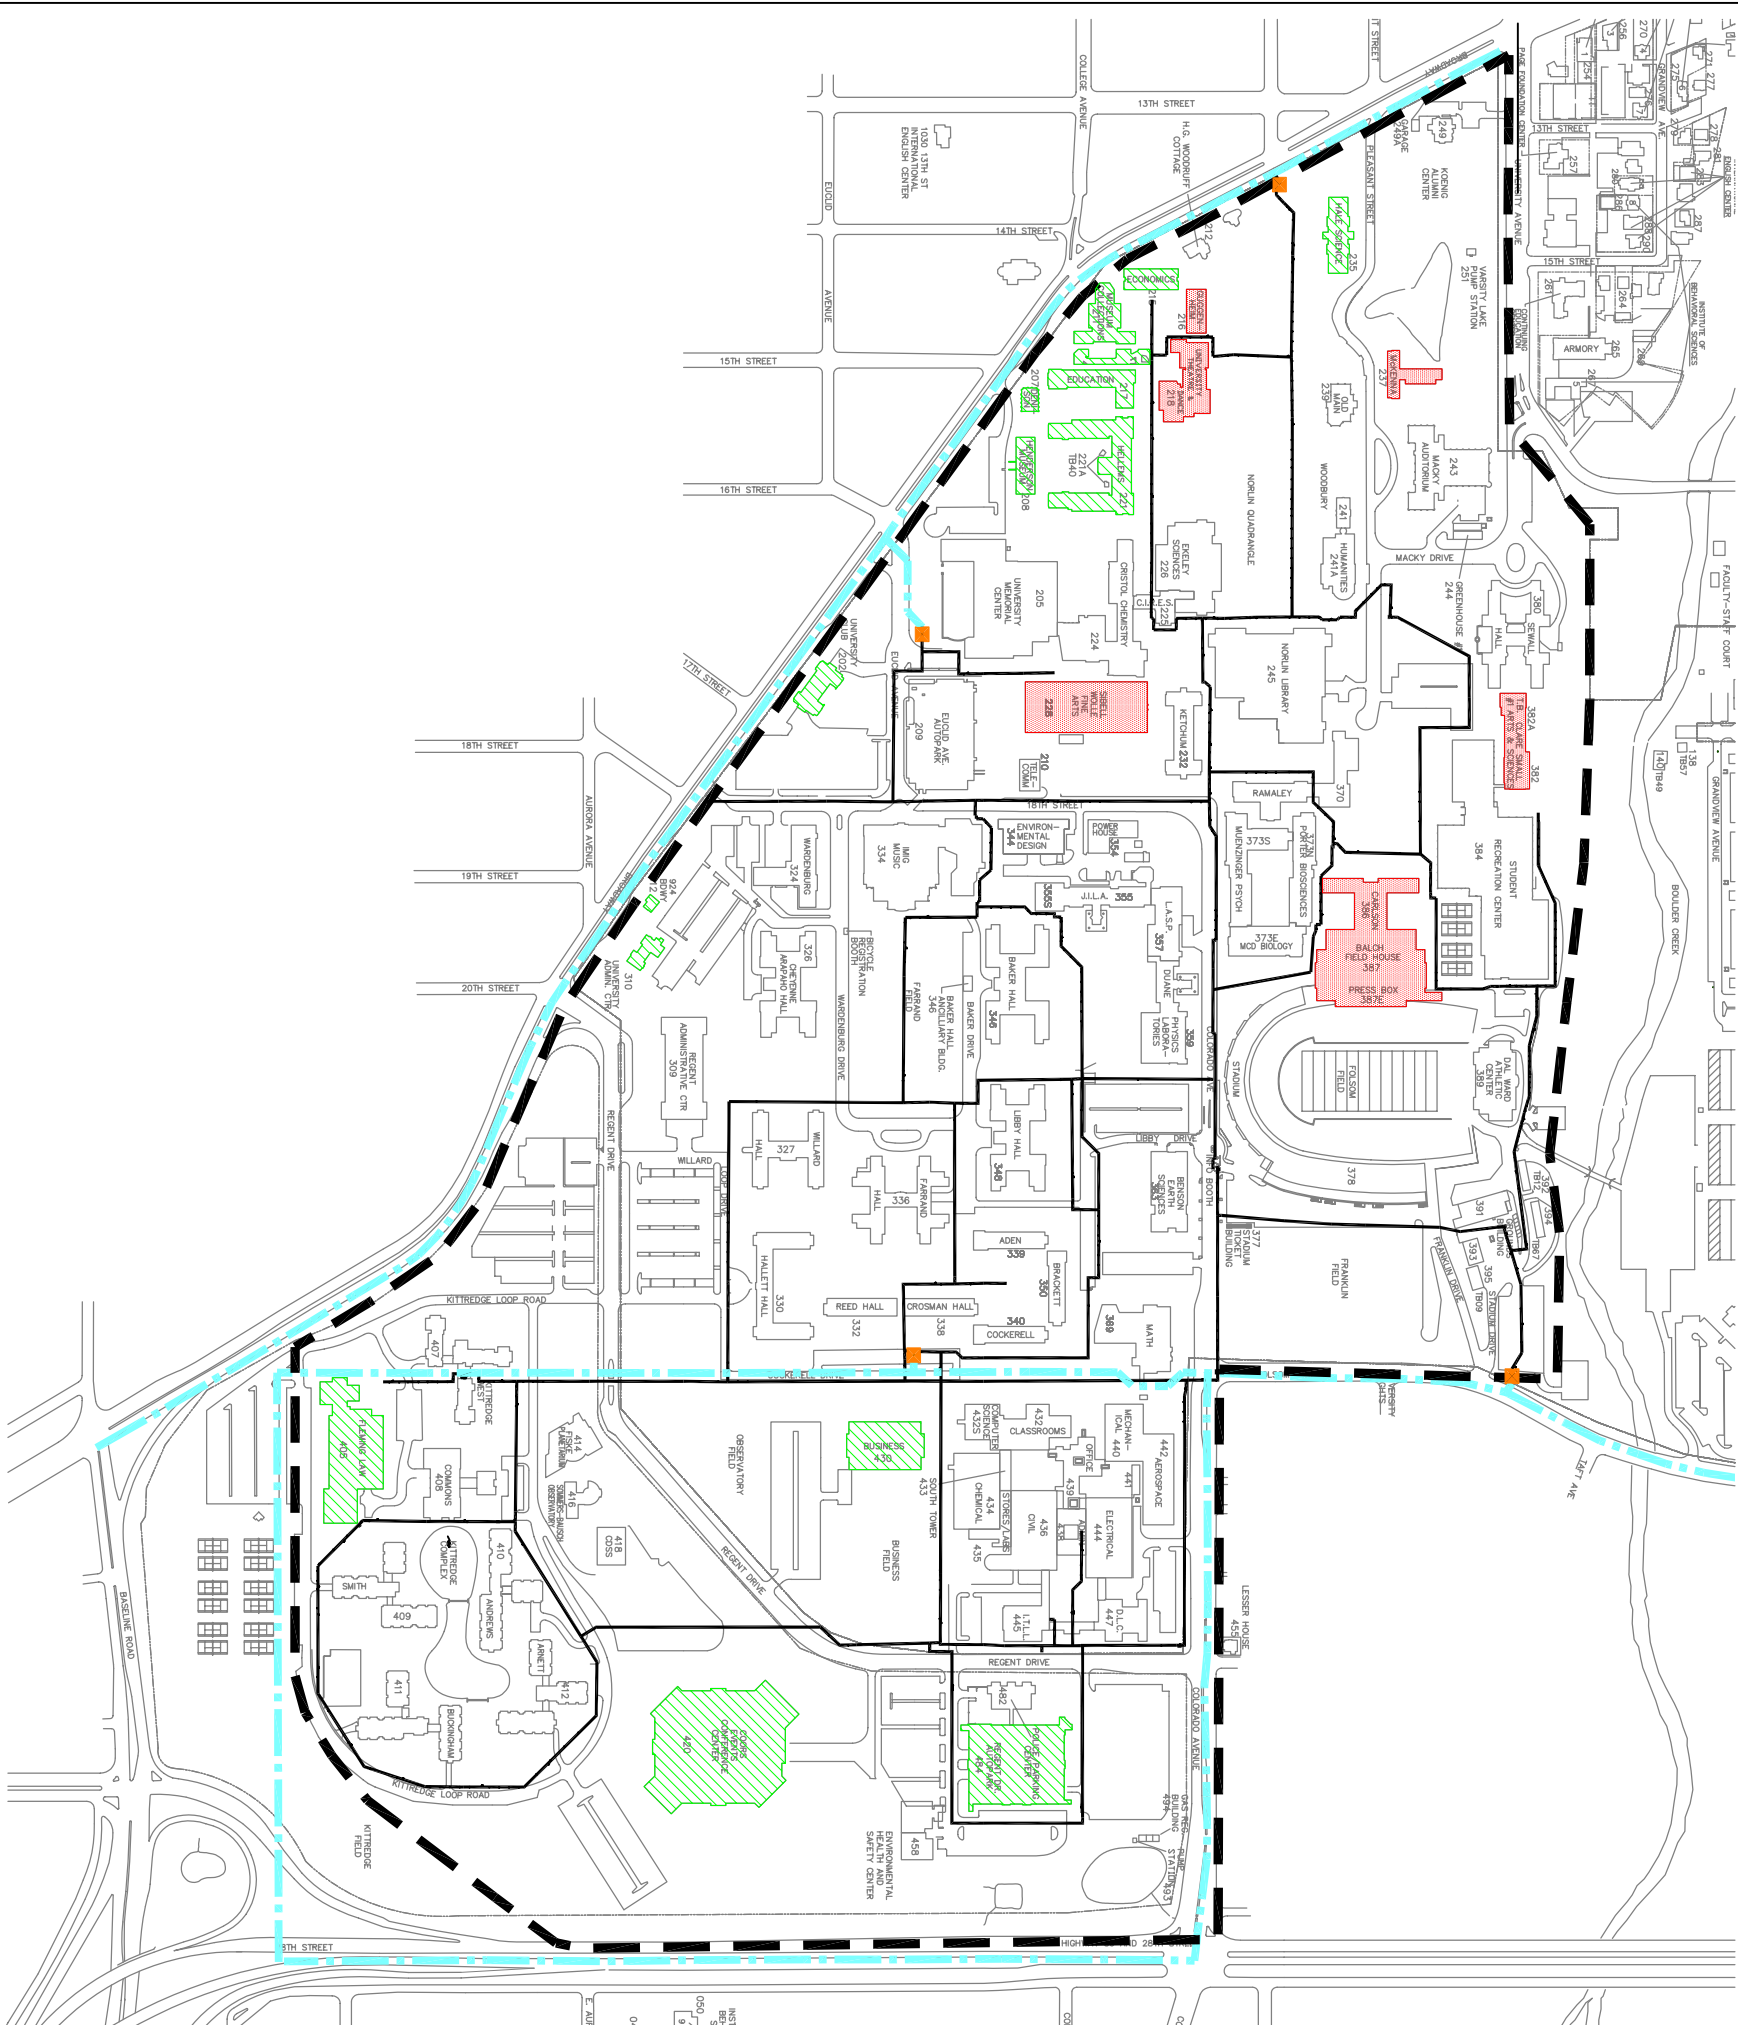
FIGURE-4

The existing potable water system on the Main Campus is of varying age, ranging from over 50 years old to constructed this year. The system is sufficient to meet estimated normal demands, defined as peak demands during a weekday during the school year. The system is in relatively good shape, given the age of pipe, but the older portions are in need of replacement. In addition, the system does not have the ability to provide the desired fire flow demands, as defined by the Campus Fire Marshal, under existing conditions. The reasons for the deficiencies are:

- The City cannot provide more than about 650 gpm above a pressure of 70 psi to the Penn and UMC Meters (meters serving the west side of campus). Note that fire flows of 1,500 to 3,000 gpm, in addition to normal demands, are desired.
- Pipe near the Norlin Quad is old and is thought to be heavily tuberculated, based both on apparent pipe roughness factors (which correlated with available test data) and staff observations when repairing breaks.
- The elevation and hydraulic gradeline on the west side of campus is such that the Reed and Folsom meters do not readily provide water west of about the Norlin library. Thus, the west side of campus is reliant on the Penn and UMC meters.

MAIN CAMPUS - EXISTING CONDITIONS
FIRE FLOW CONDITIONS WITH NO IMPROVEMENTS
