Homework Assignment

Rock Slope Stability

(Problems taken from *Computational Engineering Geology*, by E. Derringham, 1998)

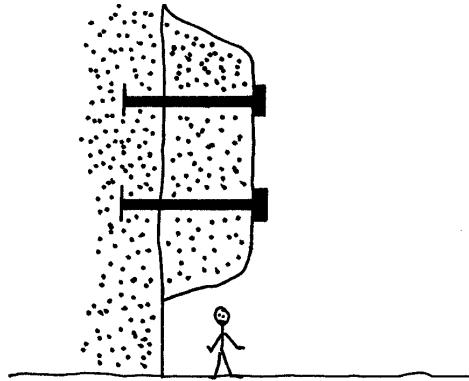
1. The slab shown in the figure below has a mass of 2.84×10^5 kg, will drop if the vertical joint ruptures. The contact area is 38.0 m^2 . Between the slab and the cliff face, the coefficient of friction is 0.3 and the cohesion is equal to 73.3 kPa. To keep the slab from dropping, cables are installed. Each cable has an area of 8.42 cm^2 and is tightened to a tension of 410 MPa. How many cables are needed to get a factor of safety of 1.50?

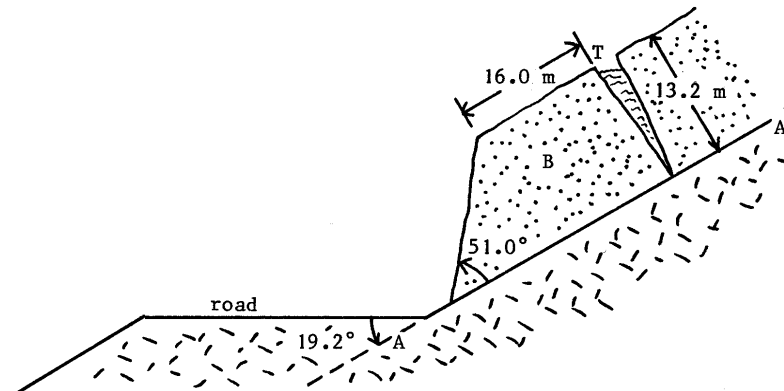
2. The figure below shows the cross section of a road cut into the side of a mountain. The line AA is a weak bedding plane along which sliding is possible. The block B, 18.6 m wide, directly above a stretch of the road is separated from uphill rock by a tension crack T normal to AA. The dip angle of the bedding plane is 19.2° and the coefficient of friction between block B and the bedding plane is 0.39. The density of the block is 2.88 g/cm^3 . Ignore cohesion. (a). Show that the block does not slide. (b) Water seeps into the tension crack and freezes, exerting a driving force on the block. What value of this force will trigger a slide?

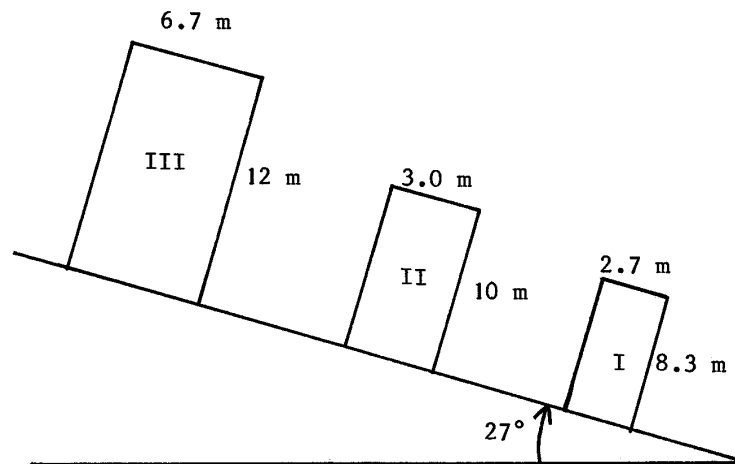
3. A slab of weight 28.0 MN sits on a 23.0° -incline. The angle of friction between the slab and the incline is 15.0° ; cohesion equals zero. (a) How many tightened rock bolts are needed to get a factor of safety of at least 1.5? The bolt specifications are: shear strength 230 MPa; area 5.80 cm^2 ; tightened to tension 86.4 MPa. (b) Due to an oversight, only 20 of the needed bolts actually are tightened; what is the real factor of safety?
4. Which if any, of the rectangular blocks in the figure below will topple? Assume no sliding.
