SNOW DEPTH INFORMATION AND MITIGATION BEFORE AVALANCHES

Manufacturing Status Review

- Team SIMBA shall provide a mobile snow depth measuring system to help Copper Mountain Ski Patrol mitigate the risk of avalanches.

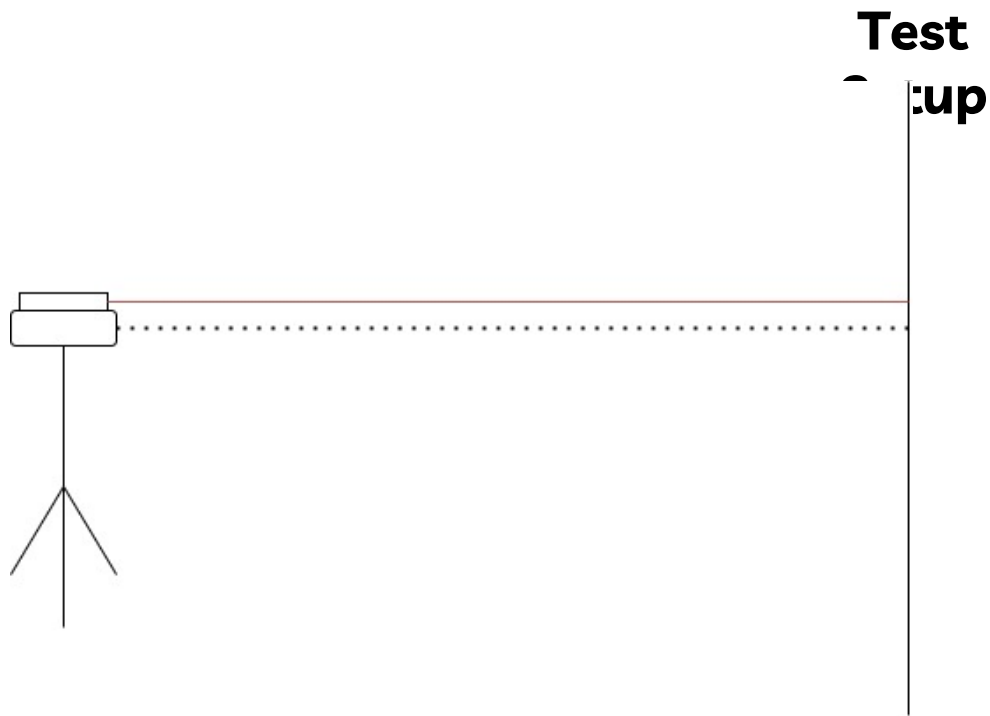
Potentiometers: Accuracy

1. Assemble range finder, stepper motor, and potentiometers within enclosure and place on the tripod
2. Attach laser pointer onto tilting plate with the rangefinder and attach all electronics to the Raspberry Pi or ADC as needed
3. Point system at target 25m away, take range measurement and mark initial location of the laser pointer with marker
4. Step motors in 2° increments and repeat step 3 until you cover a 30° range.
5. Measure distance from initial point to each additional point using tape measure.
6. Calculate pointing angle using the law of cosine and each distance measurements
7. Compare to Potentiometer output and potentiometer accuracy model

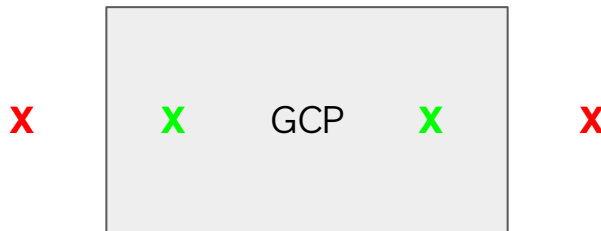
Whole System: Calibration

- Place GCP at known distance away
- Initiate software to find GCP

- Software is expected to find GCP with a searching grid of 1 degree by 1 degree

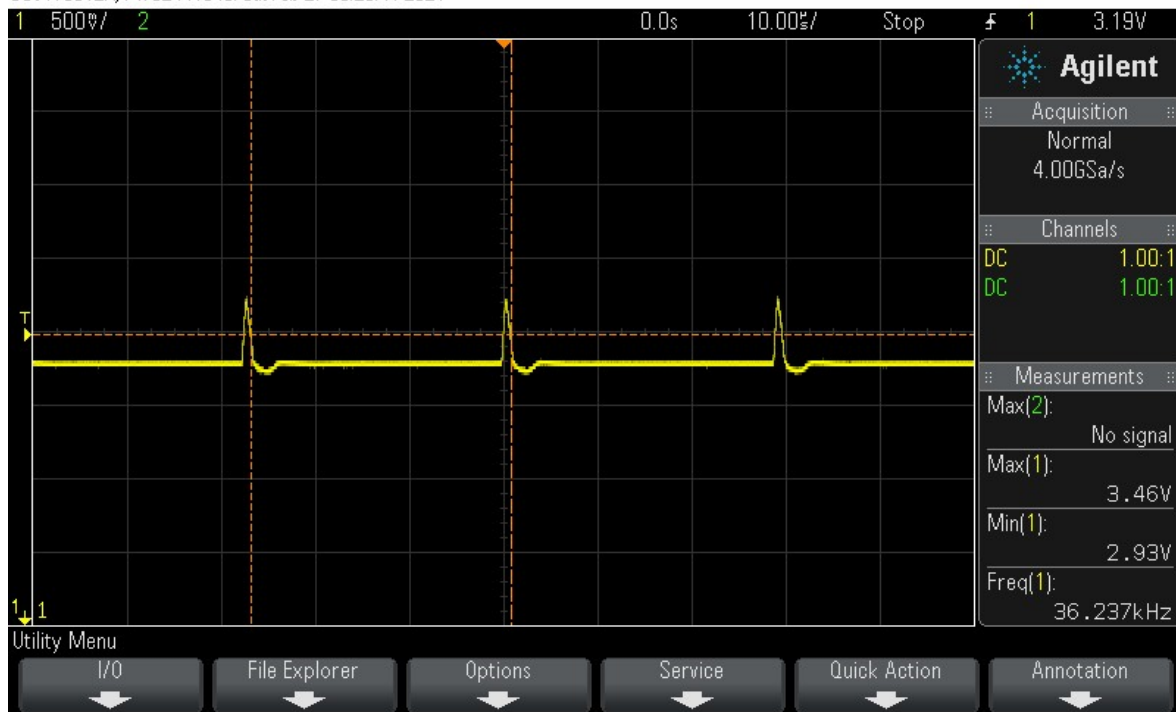
3V Ripple

DSO-X 3012A, MY52441046: Sat Feb 27 03:23:41 2021

- Expected -> 5V, 3V steady supply, 2.5V voltage fluctuation
- Results ->
 - 5V: 12.9kHz 5.81V spikes lasting >1 microsecond
 - 3V: 36.2kHz 3.46V spikes lasting >1 microsecond
 - 2.5V: 368Hz 3.28V spikes lasting ~1 microsecond
