Service Life Assessment of Internal Replacement Pipe: External Load Testing of I-Main™

Final Report 1.0

REPAIR Testing & Analysis Team

December 2024

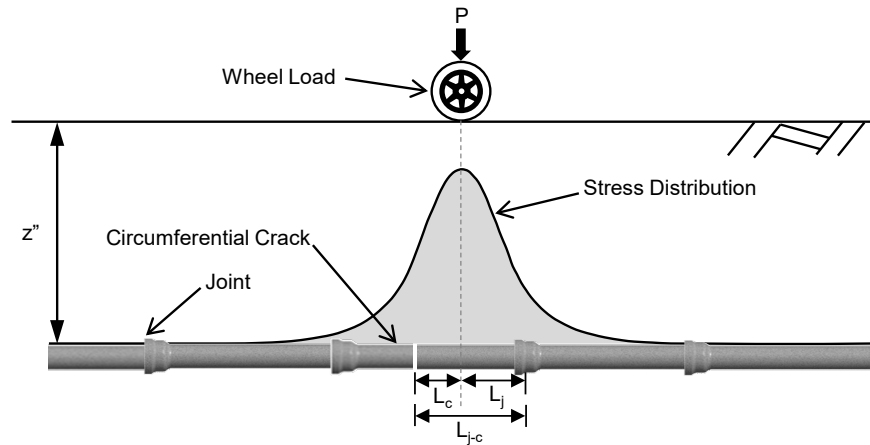
Figure 1. Schematic of traffic loading scenario

As described in detail by Klingaman et al., (2022), traffic loading was derived from an HS-20 design truck and was conservatively increased to 30 kips (130 kN). The resulting traffic load was assumed to be applied at the ground surface according to the Boussinesq stress distribution for a point load on a semi-infinite elastic medium. The stress calculated at a depth of 30 in. (762 mm) was multiplied by the vertically projected area of the pipe (diameter times element size) and discreetly applied to each pipeline node in the FE model (Figure 1). Resulting pipe deformations (e.g., relative rotations) were recorded so that they could be applied in the lab.

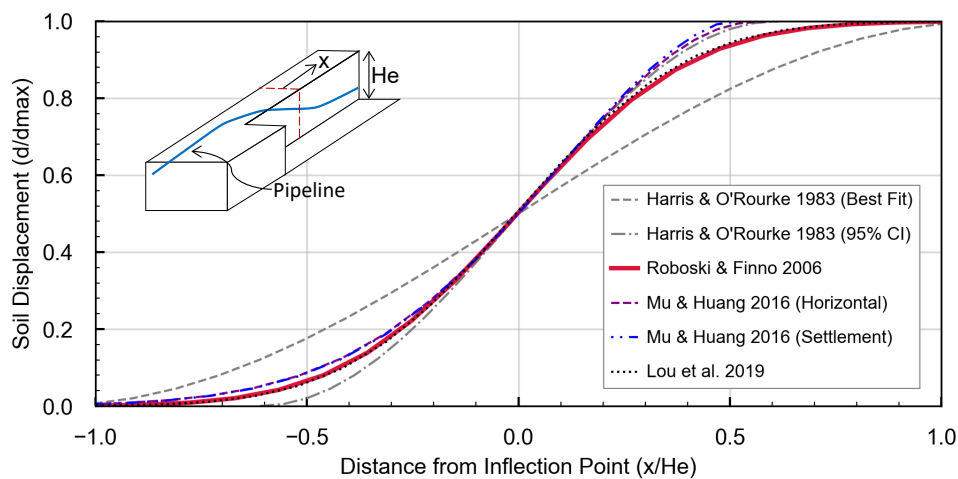
Figure 2. Soil displacement profiles parallel (adjacent) to an excavation from previous studies

As described by Klingaman et al. (2024), soil displacement profiles were developed using a functional form proposed by Roboski & Finno (2006), which requires 3 inputs: excavation depth, H_e , maximum soil displacement, d_{max} , and the length over which d_{max} is developed, L . The adjacent excavation (AE) depth was assumed to be 20 ft. (6 m), various values of d_{max} were considered, ranging from 2.5-10 in. (63.5-254 mm), and L was assumed to be 50 ft. (15.2 m) (Figure 2). The soil displacements were applied to each soil node in the FE model and resulting rotations were recorded so that they could be applied in the lab. During this study, the smaller and larger parallel (adjacent) excavation events, typically referred to as PE1 and PE2 for each specimen, were associated with d_{max} of 2.5 in. (63.5 mm) and 5 in. (127 mm), respectively.

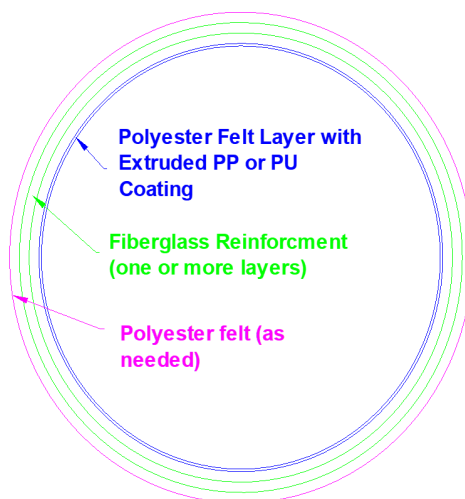
Figure 4. Cross-sectional drawing of the lining system in the installed state.

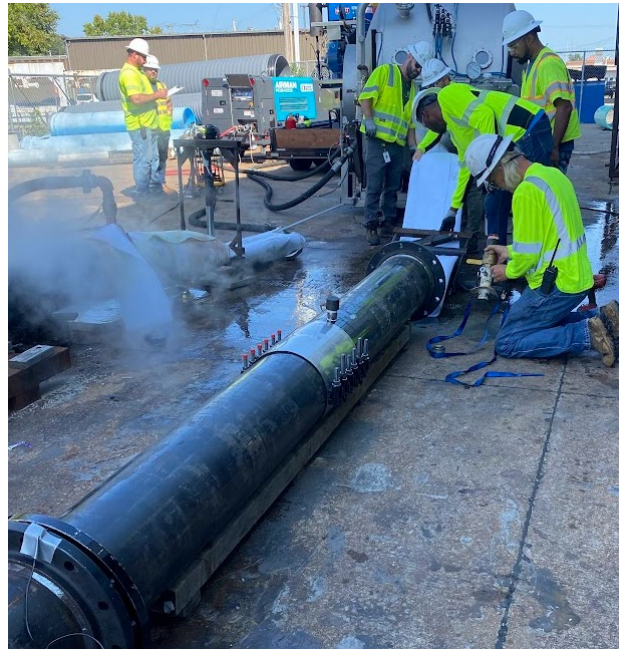
Figure 5. Installation setup of Insituform test specimen

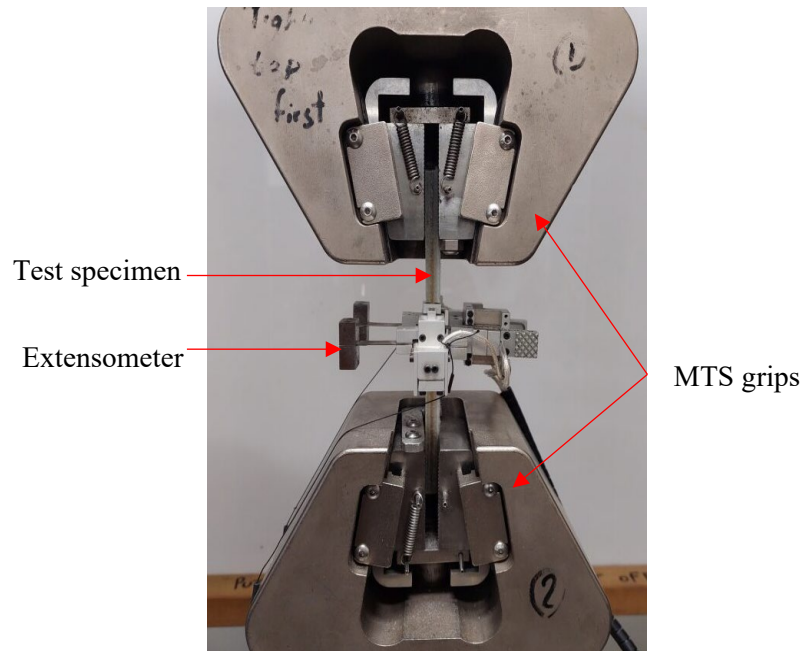
Figure 5. Test set-up for tensile test

The tensile testing of Insituform materials was carried out in accordance with ASTM D638 (ASTM, 2014) (another appropriate test method option for composites is ASTM D3039/D3039M (ASTM, 2017a)]. The tensile test setup is depicted in Figure 5. Loading is applied in the hoop direction of the installed liner. The specimens were subjected to a tensile load at a rate of 1.3 mm/min using a 100 kN MTS machine. An extensometer was affixed to the middle of the specimen until an extension of at least 0.15 mm was reached. From this test, the maximum load, modulus of elasticity, ultimate tensile strength and failure strain were determined.

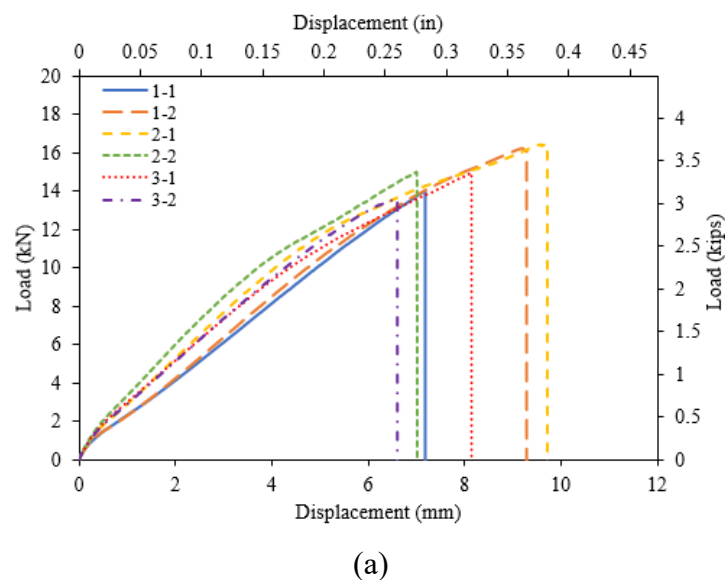
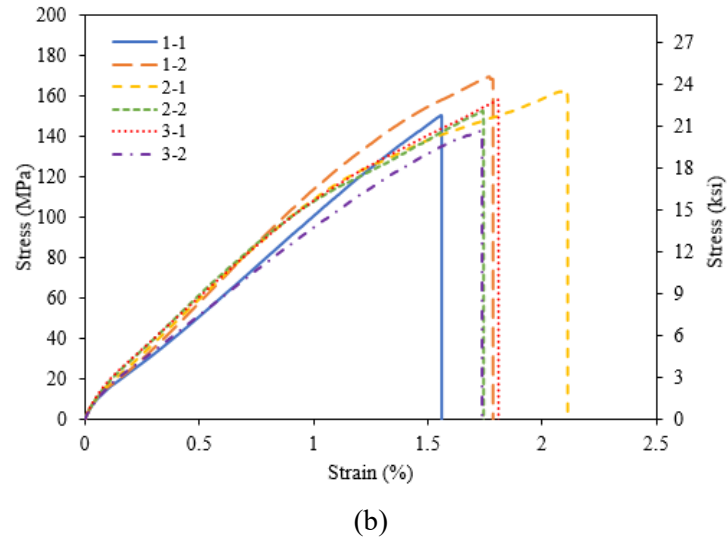
Figure 6. Tensile test results including (a) load vs. deflection and (b) stress vs. strain behavior (circumferential)

Figure 6a and b show the tensile load vs. displacement and stress vs. strain behavior of Insituform tensile coupons, respectively, in the circumferential direction. Table 1 provides a summary of the results, including ultimate tensile strength, maximum load, modulus of elasticity, and fiber strain. The modulus of elasticity is determined by taking the average of the initial stiffnesses of all tested coupons.

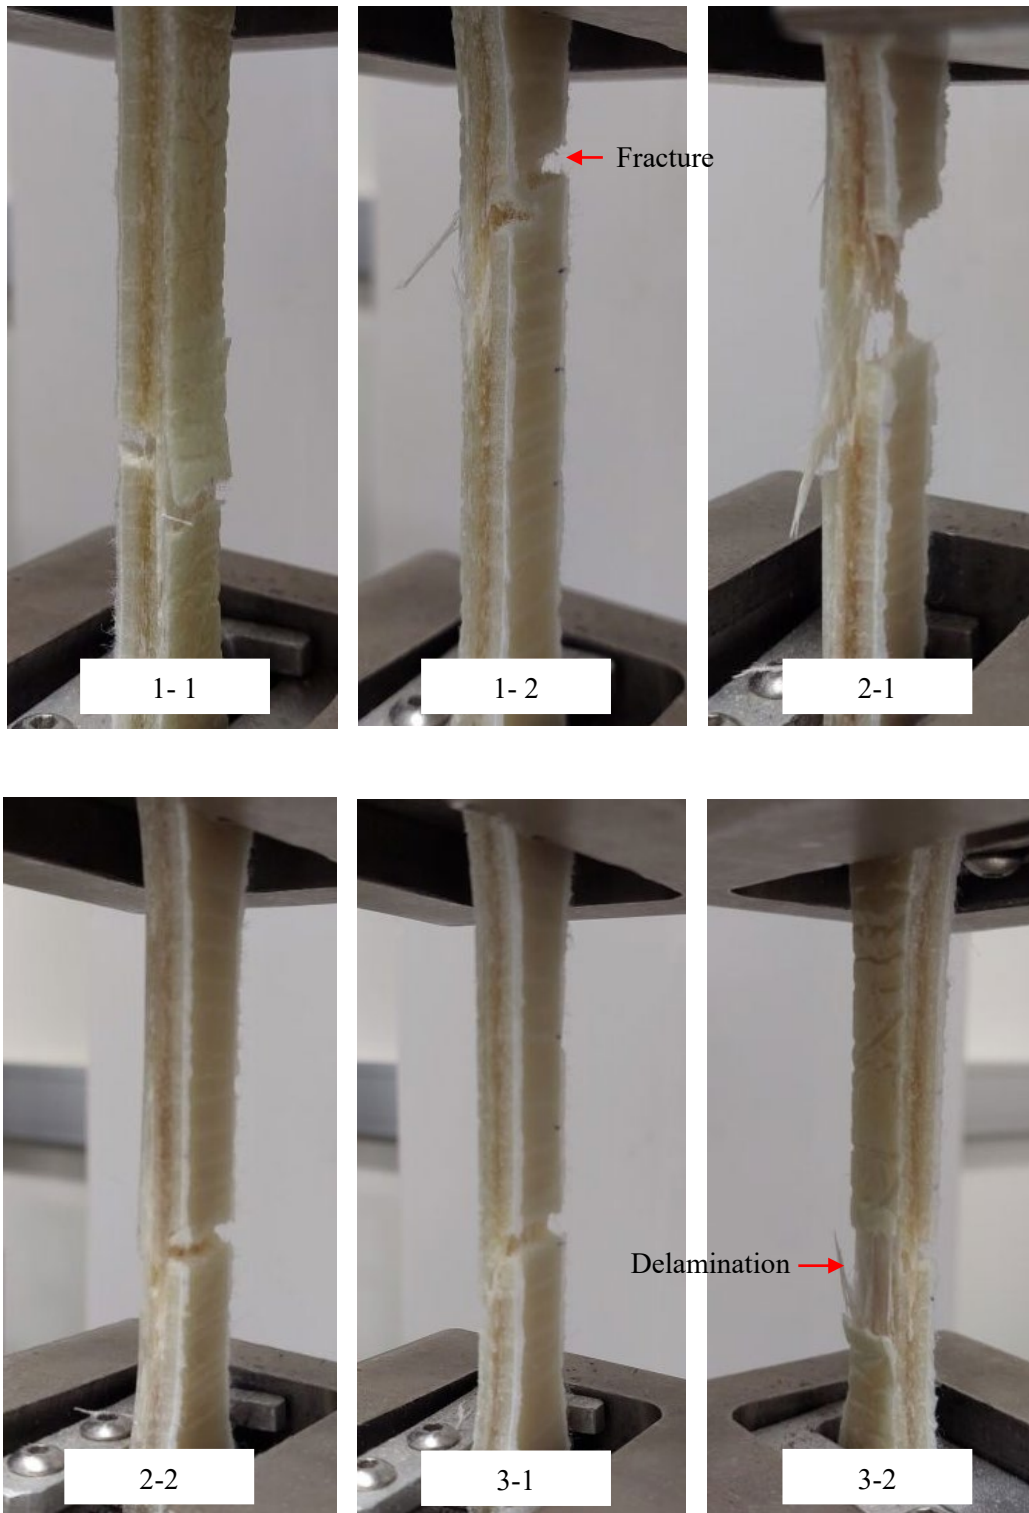
Figure 7. Failure of tensile coupons

Insituform tensile dog bone coupons exhibited initial elastic behavior followed by an immediate failure due to fiber fracture. Figure 7 and Figure 8 show the failure of the Insituform tensile dog bone coupons. Figure 7 shows photos of each specimen in the loading apparatus at the end of testing. Fracture of the resin and fibers as well as delamination of resin from the fibers is presented. Figure 8 provides a collective view of the failed specimens.

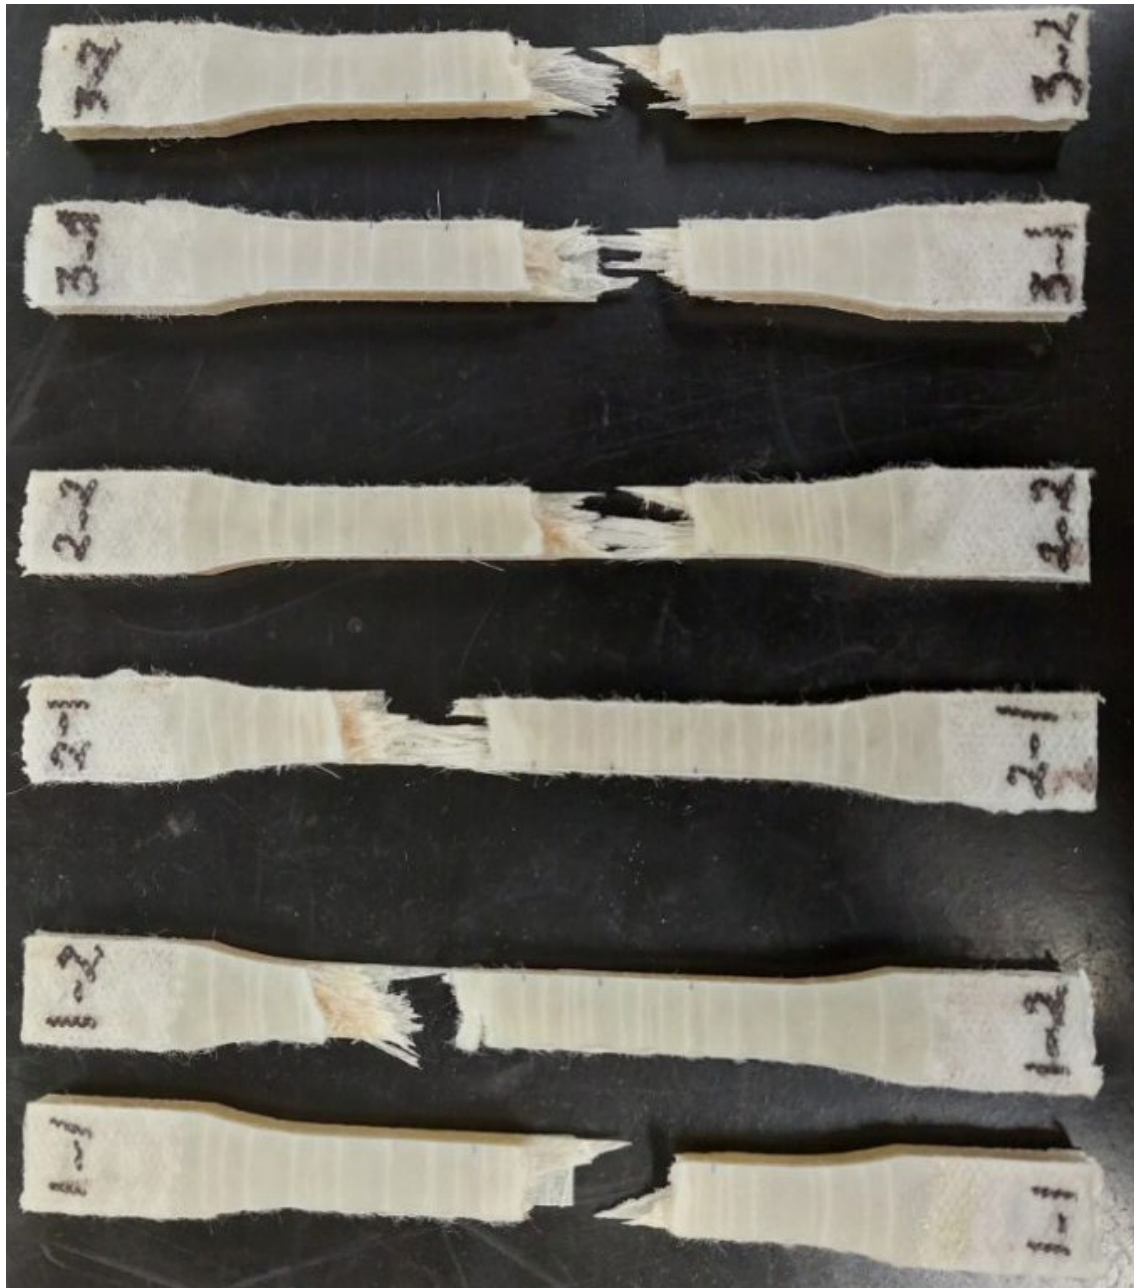
Figure 8. Tested tensile coupons

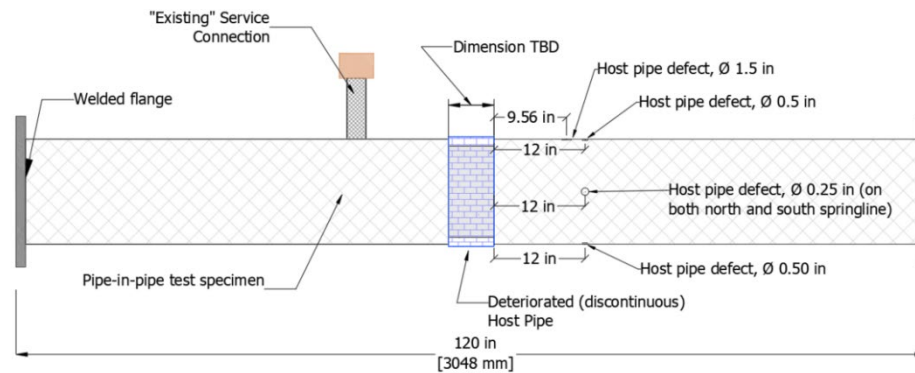
Figure 9. Dimensioned drawings of specimens including locations of defects and service connection

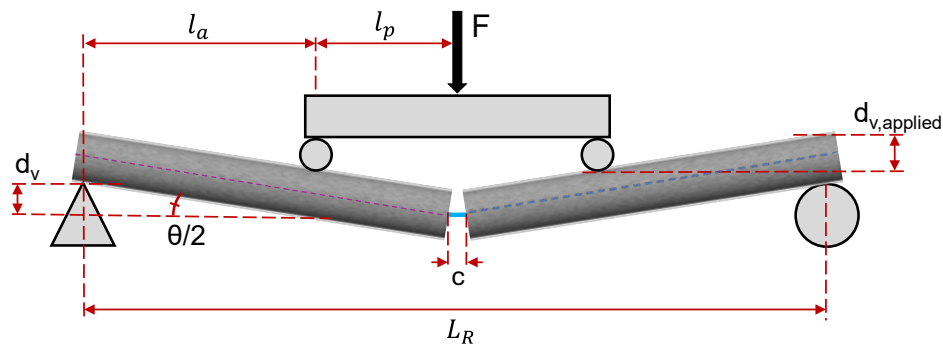
Figure 10. Schematic of 4-pt bending test and rotation angle, θ_t (adapted from Klingaman et al. 2022).

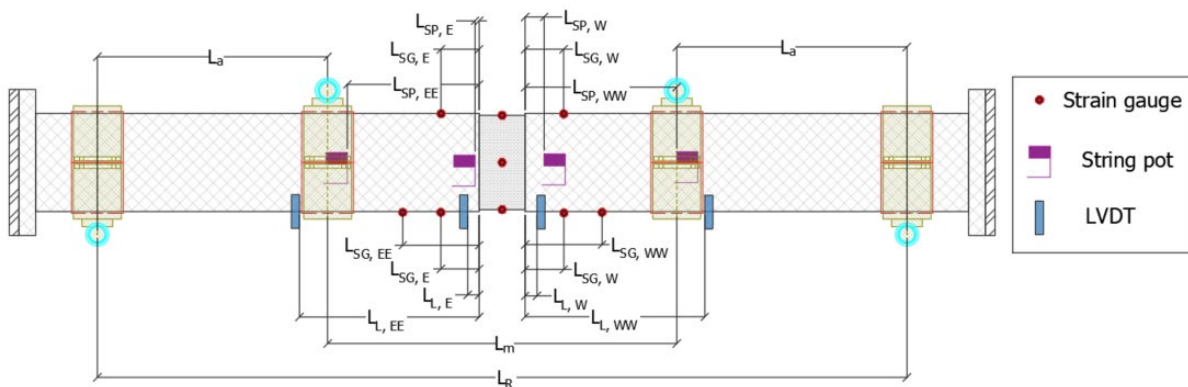
Figure 11. Test instrumentation schematic and dimension

The instrumentation used for ISES01 during lateral testing is outlined in Table 3. The instrumentation consisted of strain gauges on the crown and invert over the middle 40 in. (1000 mm) (maximum moment) span in the vicinity of the crack. Linear variable differential transducers (LVDTs) and string potentiometers (SPs) were vertically arranged to measure pipe deflection at various locations on the beam. LVDTs were mounted on stands on the ground and the rods were connected to the pipes with brackets or screw sockets. SPs were mounted on the pipe, stands on the grounds, and beams extending from the strong wall (frame support). Additionally, the north facing side of the pipe over and in the vicinity of the gap was painted white and speckled black for digital image correlation (Figure 12) (see Appendix A for further discussion of DIC). Figure 11 provides a schematic of specimen measurements and instrumentation locations and Table 4 gives the values corresponding to the figure used for this specimen.

Table 6 gives the values corresponding to the dimensions previously shown in Figure 11. The geometry of the specimen was set up in a 4-point bending configuration, with distances between supports and load points being 30 in. – 40 in. – 30 in. (762 mm – 1016 mm - 762 mm), centered about the crack opening.

Table 8 provides the values corresponding to the dimensions shown in Figure 11. The geometry of the specimen was set up in a 4-point bending configuration, with distances between supports and load points being 30 in. – 40 in. – 30 in. (762 mm – 1016 mm - 762 mm), centered about the crack opening.

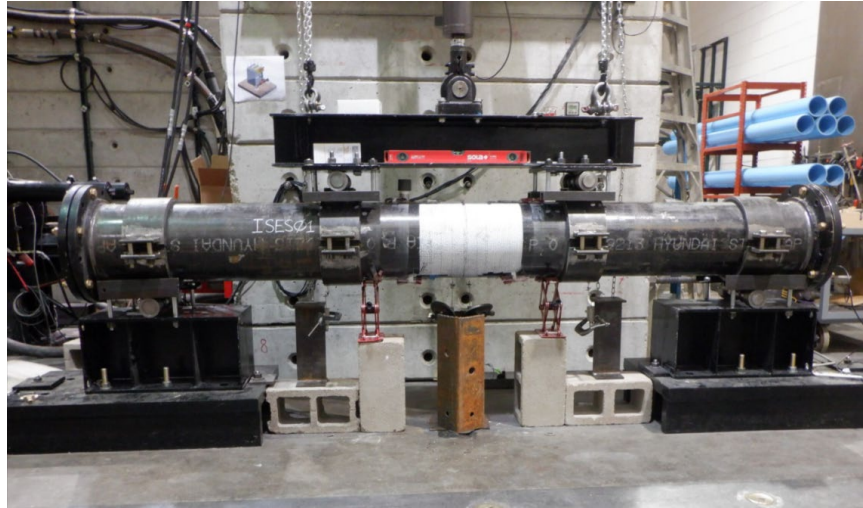
Figure 12. Image of ISES01 bending setup

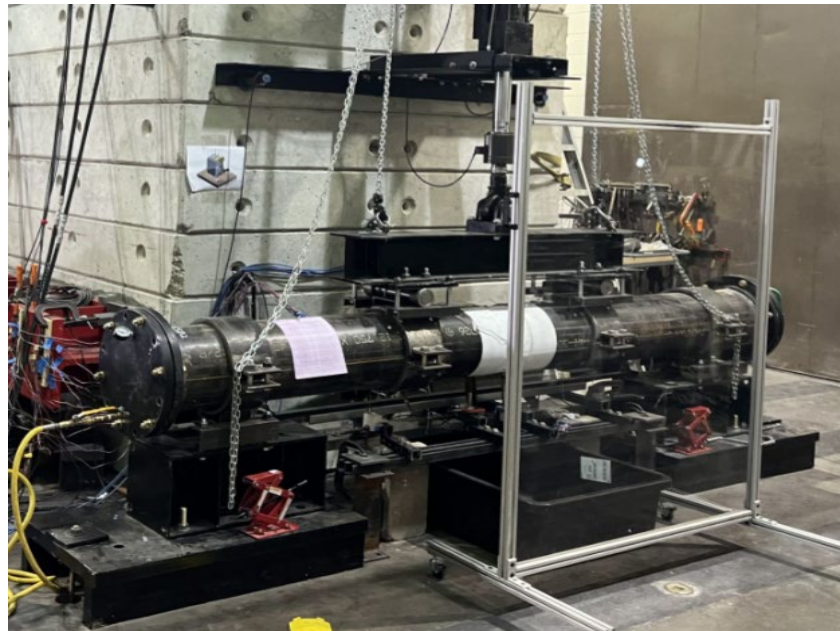
Figure 13. Photo of ISES02 bending setup

The specimen for ISES02 is composed of a steel host pipe with nominal initial gap opening of 6.0 in. (150 mm) and rehabilitated with I-MAIN CIPP installed with a pre-liner. The instrumentation used for ISES02 during lateral testing is outlined in Table 5. The instrumentation consisted of strain gauges on the crown and invert over the middle 40 in. (1000 mm) (maximum moment) span in the vicinity of the crack. LVDTs and SP were vertically arranged to measure pipe deflection at various locations on the beam. LVDTs were mounted on stands on the ground and the rods were connected to the pipes with brackets or screw sockets. SPs were mounted on the pipe, stands on the grounds, and beams extending from the strong wall (frame support). Additionally, the north facing side of the pipe over and in the vicinity of the gap was painted white and speckled black for digital image correlation (Figure 13).

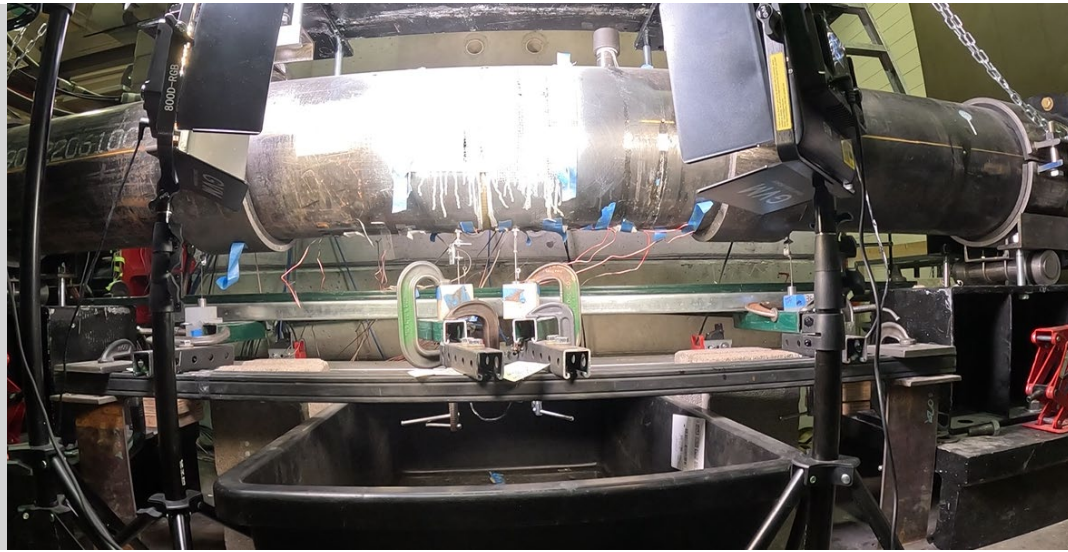
Figure 14. Photo of ISES03 bending setup

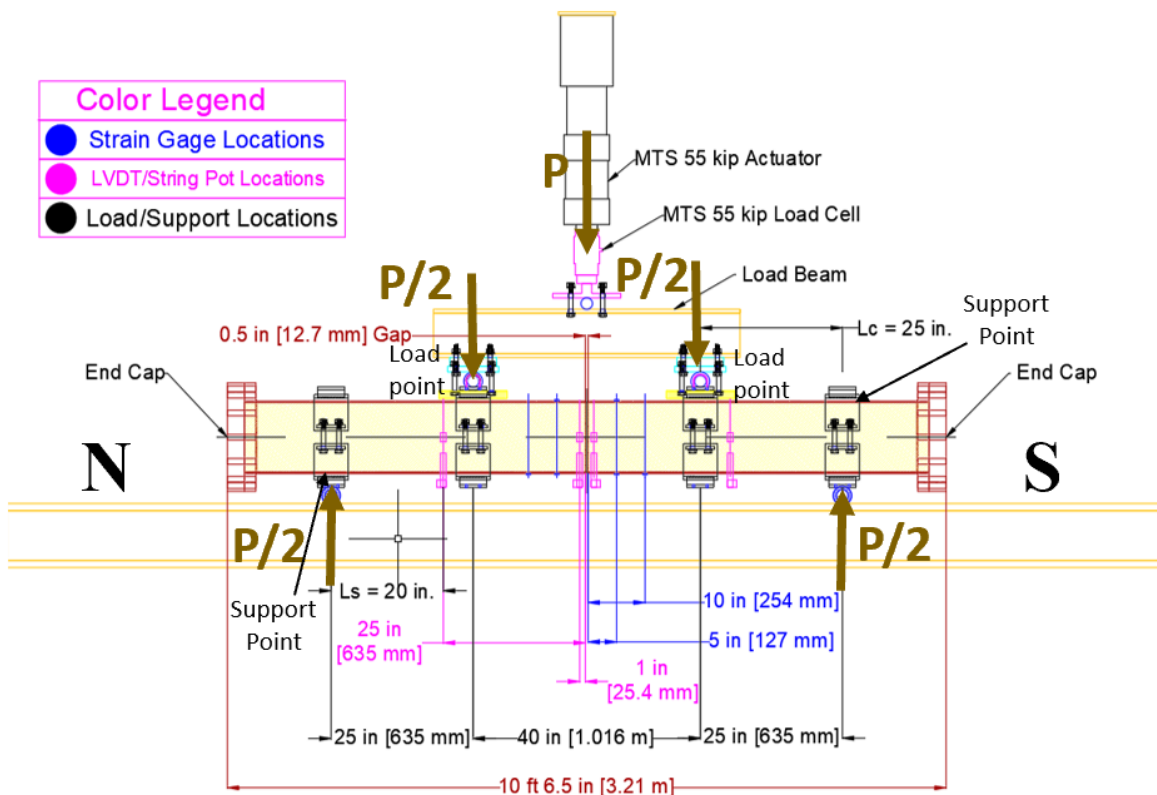
Figure 15. Schematic of four-point bending test for specimen ISES04

for which d_{v1} and d_{v2} are the relative vertical displacements (in.) between the support points and the nearest linear voltage differential transformer (LVDT)/string potentiometer (SP) locations on either side of the gap. The distance 20 in. refers to the separation between the support point and the nearest LVDT/SP location. As shown in Figure 15, load was applied to load and support points through saddles fitted to the pipe. North and south directions for the Cornell specimen are shown by N and S, respectively, in Figure 15 as well as in other test schematics and photographs.

Figure 16 presents a photograph of the test set-up depicted in Figure 15. The test pipeline, MTS actuator, load cell, load beam, load contacts and supports can be seen in the figure. The gap was centered in the load frame. Four-point bending was applied, for which the reaction locations were positioned 25 in. (635 mm) north and south of the loading locations, which were in turn were separated by 40 in. (1016 mm). This arrangement is referred to as a 25 in. – 40 in. – 25 in. configuration.

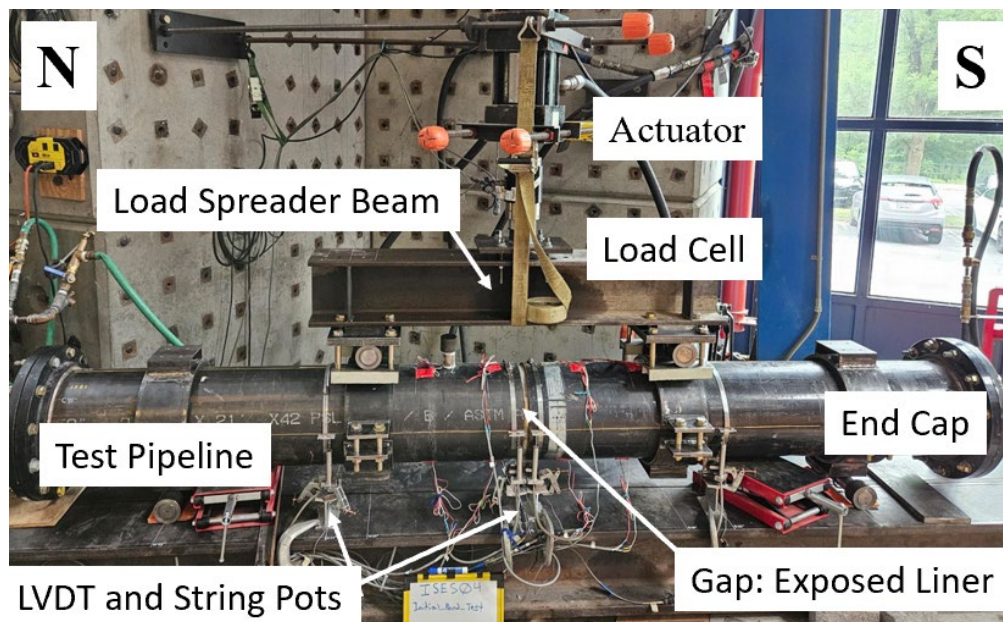
Figure 16. Photograph of ISES04 in bending test frame

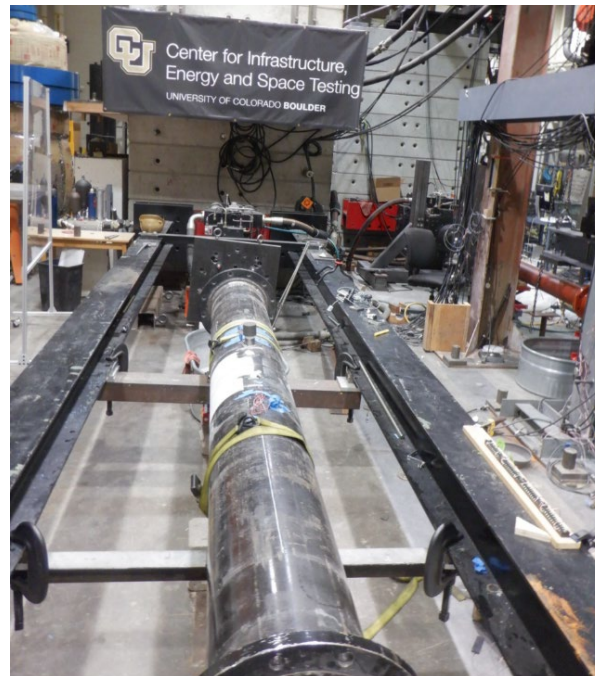
Figure 17. Image of ISES01 axial test setup

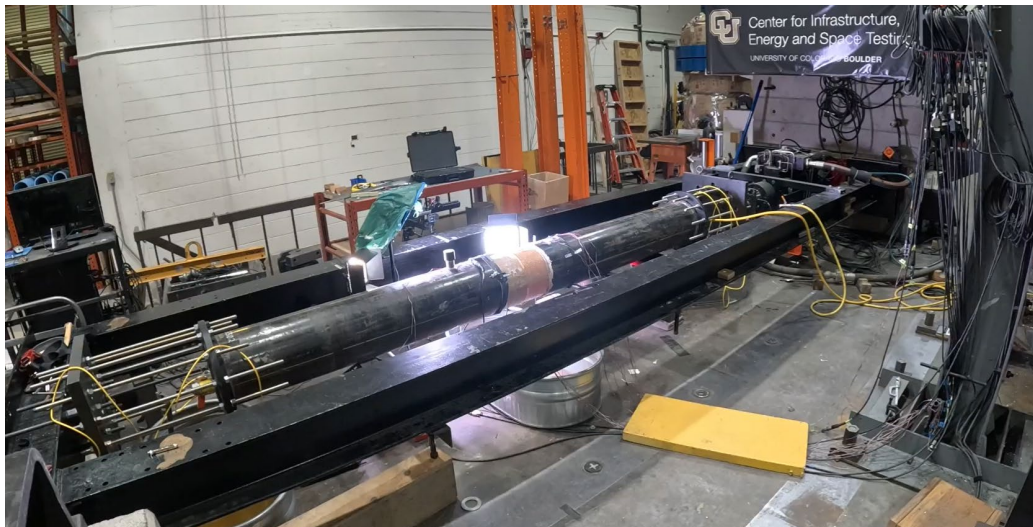
Figure 18. Photo of ISES02 axial test setup

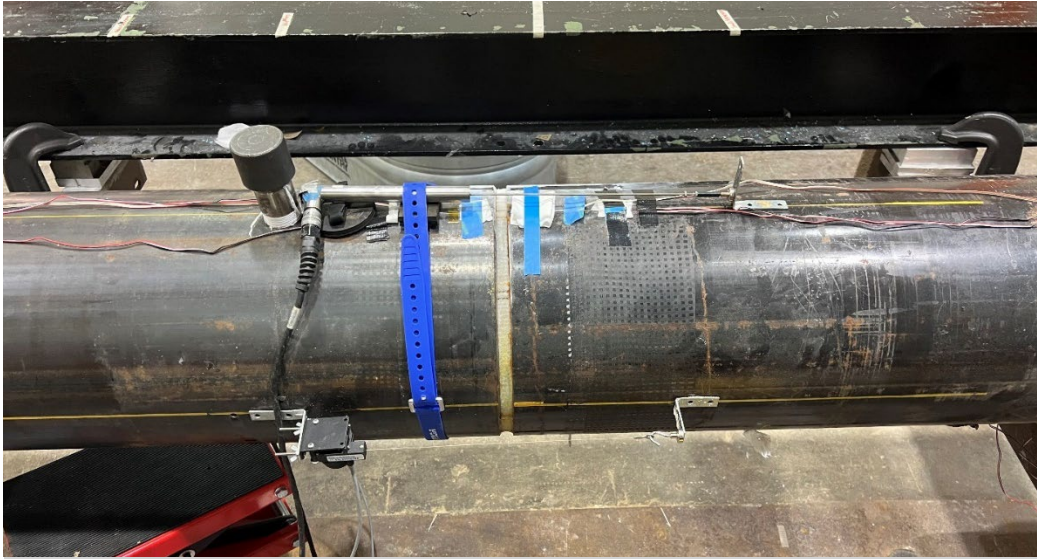
Figure 19. Photo of ISES03 axial test setup

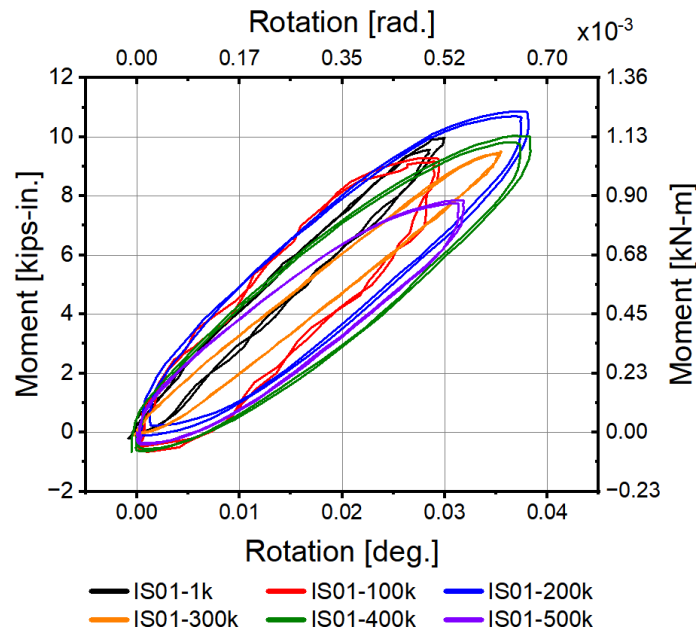
Figure 20. ISES01 moment vs. rotation for selected traffic cycles

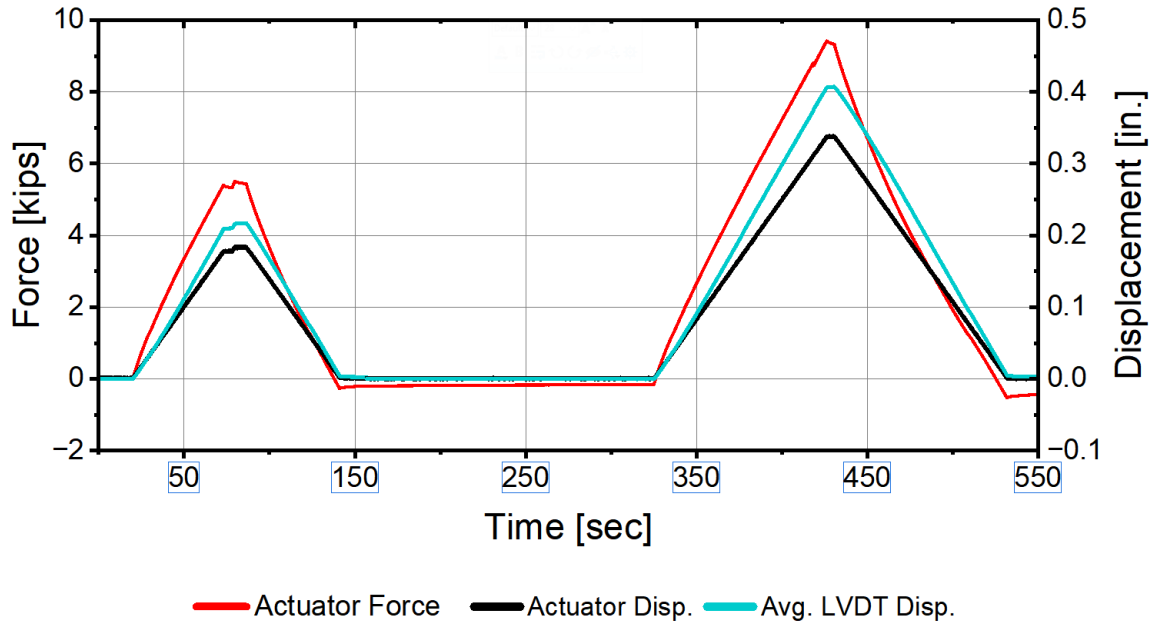
Figure 21. ISES01 actuator displacement, actuator force, average LVDT displacement vs. time for adjacent excavation events

test reached a maximum rotation of 1.1° at an applied moment of 120 kip-in. (13.6 kN-m). The apparent stiffness for both AE events was approximately 125 kip-in./deg. (14.1 kN-m/deg.), which is 50% lower than the stiffness measured during the previous traffic cycle (250 kip-in./deg.).

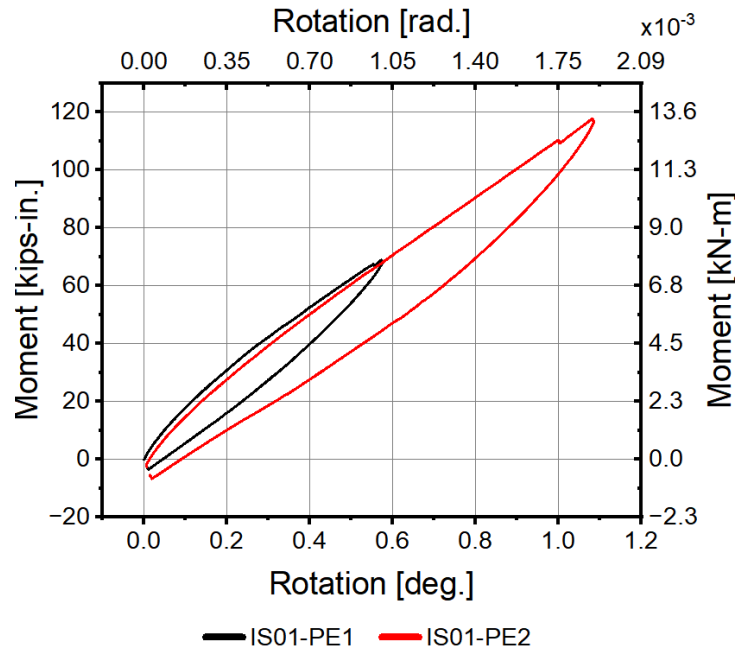
Figure 22. ISES01 moment vs. rotation for adjacent excavation events

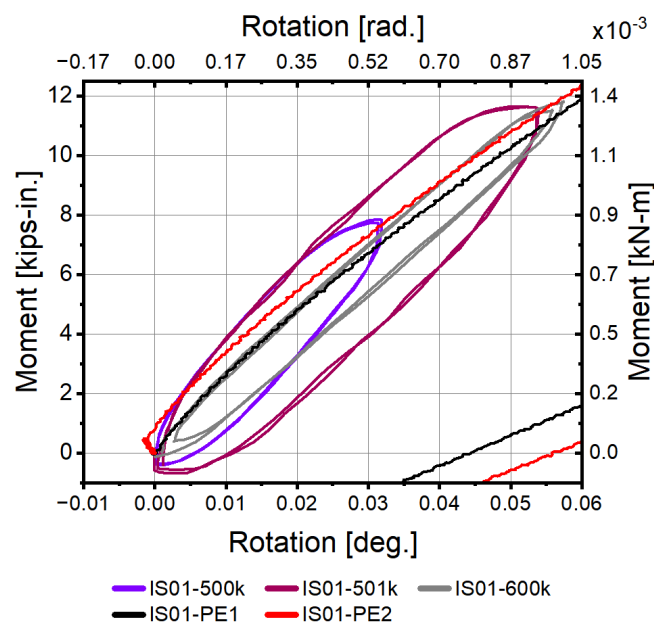
Figure 23. ISES01 moment vs. rotation for traffic cycles pre- and post-AE tests

To complete transverse testing for this specimen, an additional 100,000 traffic cycles were applied following the larger AE deformations. Figure 23 shows the moment-rotation response of selected cycles. After the AE tests, the traffic cycles were updated to achieve a target rotation of about 0.055° , 83% greater than the target rotation of 0.03° observed during the cycles prior. The applied moment required to reach this target rotation was approximately 11.5 kip-in. (1.2 kN-m), 44% greater than the 8.0 kip-in (0.9 kN-m) applied moment for the cycles prior. Despite these increases, the apparent stiffness for the cycles following the AE events was about 235 kip-in./deg. (26.6 kN-m/deg.), representing a 6% decrease relative to earlier traffic cycles.

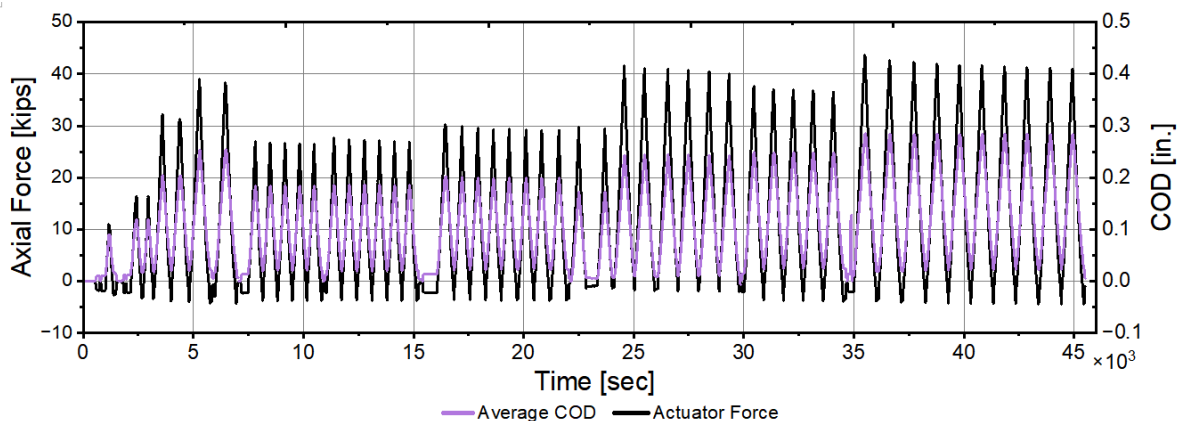
Figure 24. ISES01 actuator force and average LVDT measurements vs. time for thermal expansion cycles

A preliminary cycle with a relatively small target displacement was conducted to measure the specimen's initial stiffness. During this cycle, the actuator applied a displacement that generated approximately 11 kips (49 kN) of tensile force, resulting in a measured COD of 0.09 in. (2.3 mm). From these measurements, an initial stiffness of around 200 kip/in. (35 kN/mm) was calculated. This stiffness was then used to calculate the target COD for the subsequent cycles. As the testing progressed, the target COD increased because the apparent stiffness from each set of cycles was used to adjust the target displacement for the following set. In the early cycles, the average stiffness of the specimen was about 200 kip/in. (35 kN/mm), while during the later cycles, the average stiffness dropped to around 175 kip/in. (30.6 kN/mm), indicating a reduction of about 13%.

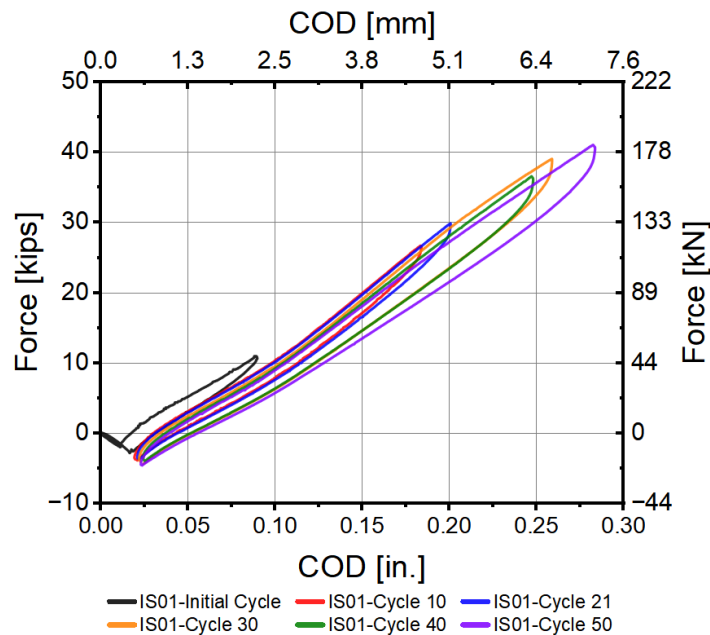
Figure 25. ISES01 actuator load vs. crack opening displacement (COD) for thermal expansion cycles

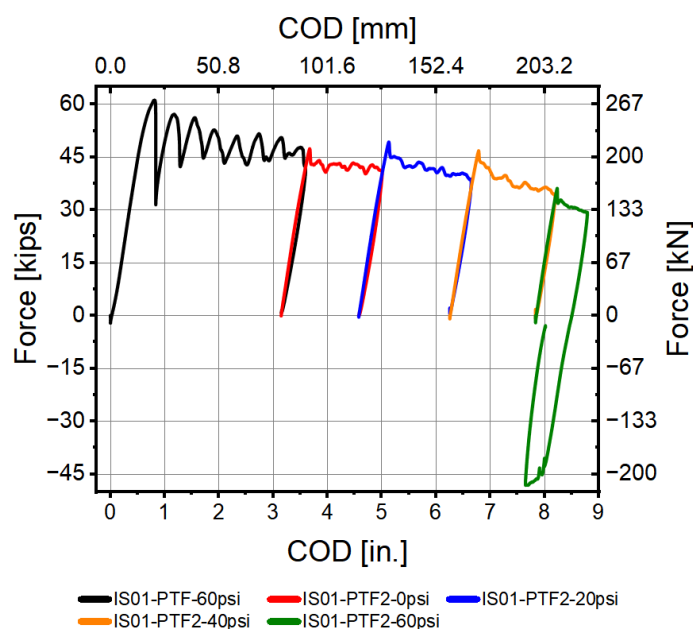
Figure 26. IS01 axial force vs. crack opening displacement

Once thermal expansion cycles were completed, the specimen was axially loaded to its ultimate capacity. Figure 26 shows the axial force relative to the COD over the duration of this test while Figure 27 provides a sequence of images during the first test sequence. The specimen reached a peak ultimate force capacity of about 61 kips (272 kN) at a COD of about 0.9 in. (23 mm) (Figure 27b). Following this peak, a sudden drop in force occurred, reducing the applied axial tension to around 31 kips (138 kN) and corresponding to some moderate leakage at the gap. As axial displacement continued to be applied, the force built up again until another sudden drop occurred at a local maximum of 58 kips (28 kN) with a COD of about 1.25 in. (31.8 mm). However, this drop in force was less severe, bringing the applied tension to 43 kips (191 kN) before increasing again. This rise and drop in axial force persisted throughout the test, with each successive local maximum and corresponding drop being smaller than the previous one. The first load drop was associated with full detachment of the IRP from the host pipe. Because pressurization plugs were used at either end of the specimen, leakage at the center of the specimen was minimal at detachment, however, it is assumed the specimen would have leaked more if regular end caps had been used. The accumulated force and subsequent drops after the first event are associated with frictional resistance that develops between the IRP and host pipe interface. As the IRP is pulled out of the host pipe, the contact area between the two is reduced, corresponding to a gradual reduction in applied load.

Following the initial ultimate capacity sequence (shown in black), several additional sequences were performed at varying internal water pressure. Further details about the influence of pressure on the specimen's axial force capacity are discussed in subsequent sections of this report. Overall, the trend showed a gradual decline in force capacity as COD increased. The final maximum tensile force recorded was approximately 30 kips (134 kN) at a COD nearing 10 in. (250 mm). Additionally, one compressive cycle was applied towards the end of the test to compare frictional resistance in the other direction. The axial compressive force reached about 40 kips (178 kN) after 0.5 in. of applied COD before beginning to plateau. The maximum COD change for this compressive test was around 1.0 in. (25 mm), with the highest recorded compressive force being approximately 48 kips (214 kN).

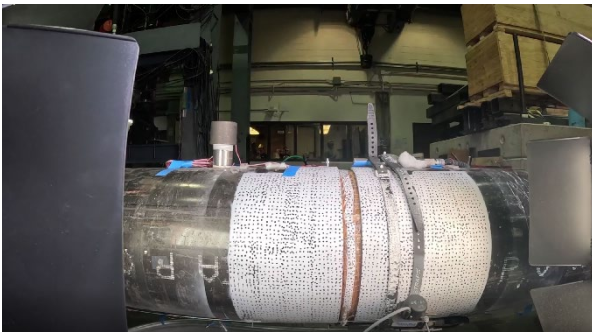
(a)

(b)

(c)

(d)

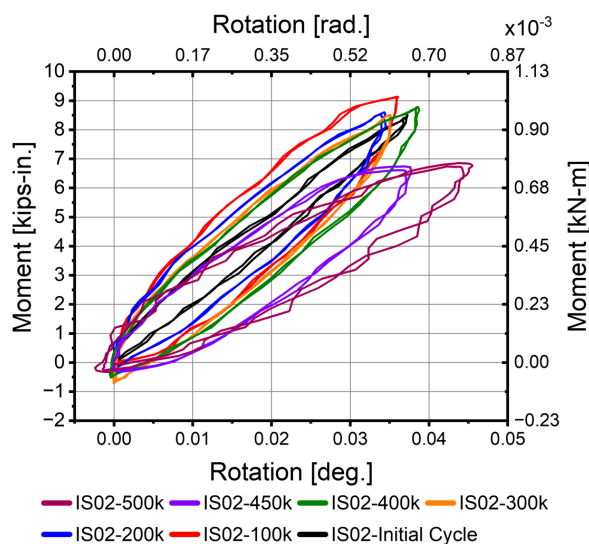
Figure 28. ISES02 moment vs. rotation for selected traffic cycles

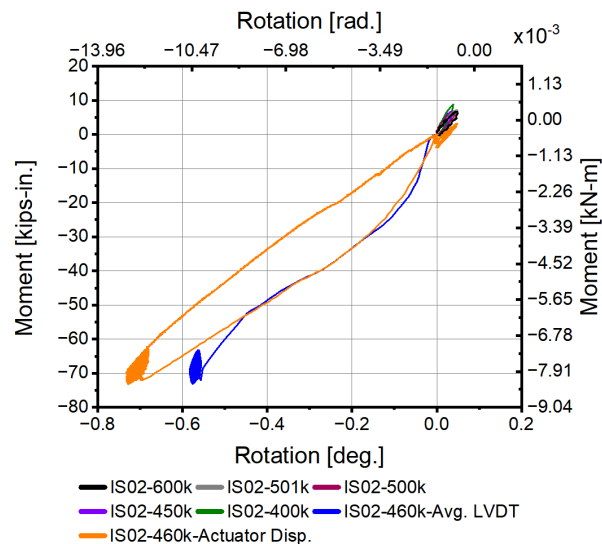
Figure 29. ISES02 moment vs. rotation for accidental large displacement

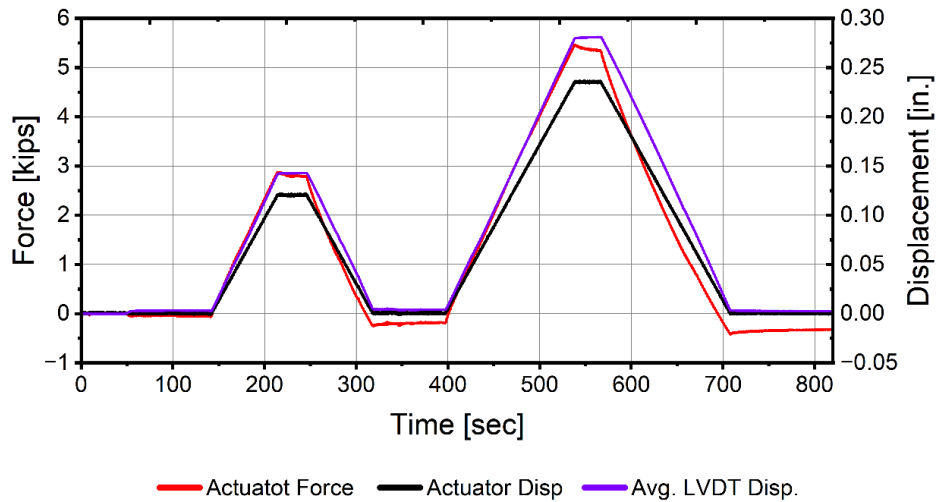
Figure 30. ISES02 actuator displacement, actuator force, average LVDT displacement vs. time for adjacent excavation events

maximum rotation of 0.4° was achieved at an applied moment of 35 kip-in. (4.0 kN-m), while the second test reached a maximum rotation of 0.8° at an applied moment of 69 kip-in. (7.8 kN-m). The apparent stiffness for both AE events was approximately 87 kip-in./deg. (9.8 kN-m/deg).

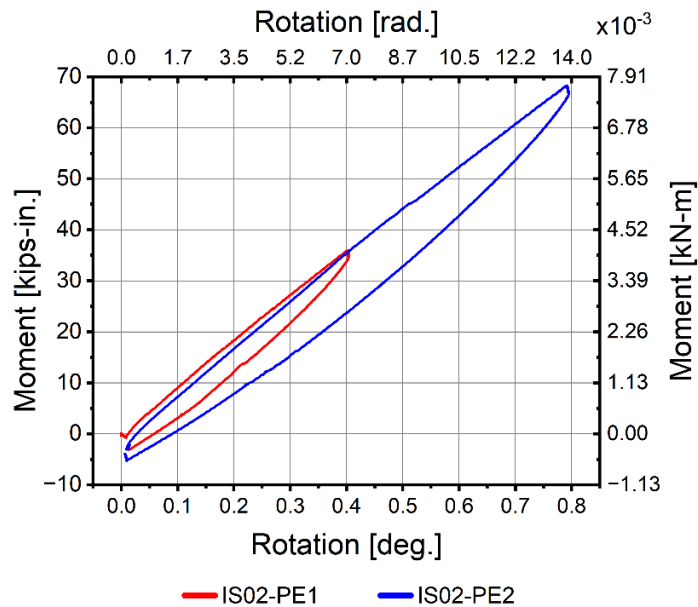
Figure 31. ISES02 moment vs. rotation for adjacent excavation events

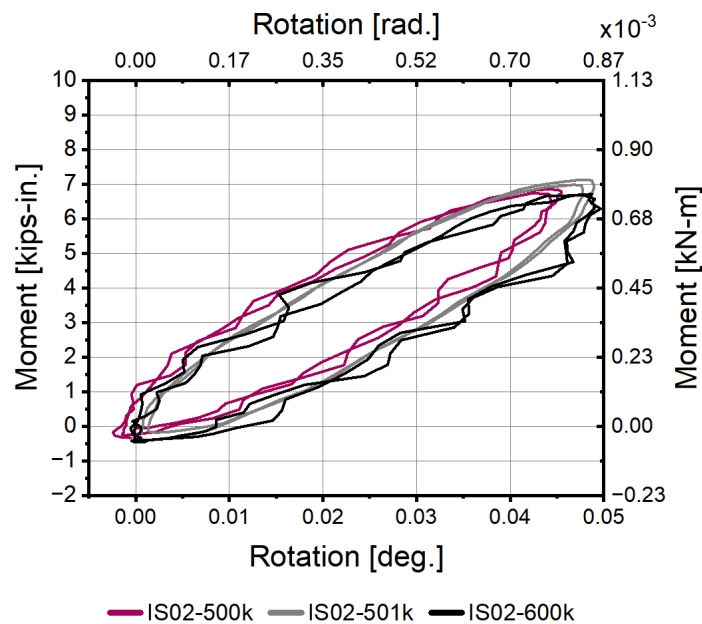
Figure 32. ISES02 moment vs. rotation for traffic cycles pre- and post-AE tests

To complete transverse testing for this specimen, an additional 100,000 traffic cycles were applied following the larger AE deformations. Figure 32 shows the moment-rotation response of selected cycles. After the AE tests, the traffic cycles were updated to achieve a target rotation of about 0.05° , 40% greater than the target rotation of 0.036° observed during the cycles prior. The applied moment required to reach this target rotation was approximately 7 kip-in. (0.8 kN-m), which was similar to the applied moment for the cycles prior. Despite these increases, the apparent stiffness for the cycles following the AE events was about 140 kip-in./deg. (15.8 kN-m/deg.), representing a 38% decrease relative to traffic cycles prior to the lifting incident, and a 7% decrease relative to traffic cycles after the lifting incident and before the AE events.

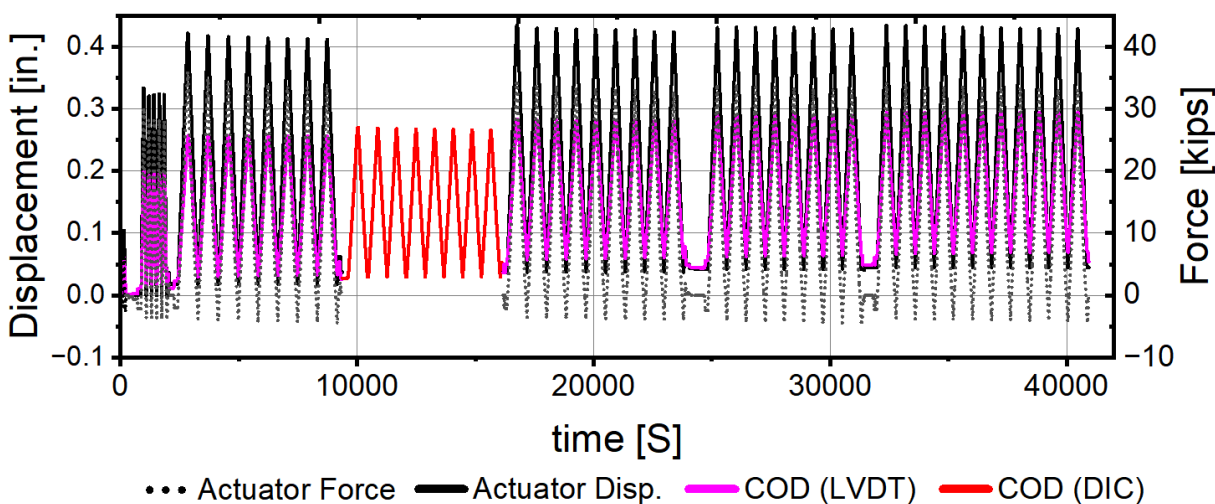
Figure 33. ISES02 actuator displacement, actuator force, and average LVDT measurements vs. time for thermal expansion cycles

A preliminary cycle with a relatively small target displacement was conducted to measure the specimen's initial stiffness. During this cycle, the actuator applied a displacement that generated approximately 6 kips (27 kN) of tensile force, resulting in a measured COD of 0.06 in. (1.5 mm). From these measurements, an initial stiffness of around 170 kip/in. (30.0 kN/mm) was calculated. This stiffness was then used to calculate the target COD for the subsequent cycles. The average stiffness for all cycles performed was approximately 160 kip-in. (18.1 kN-m).

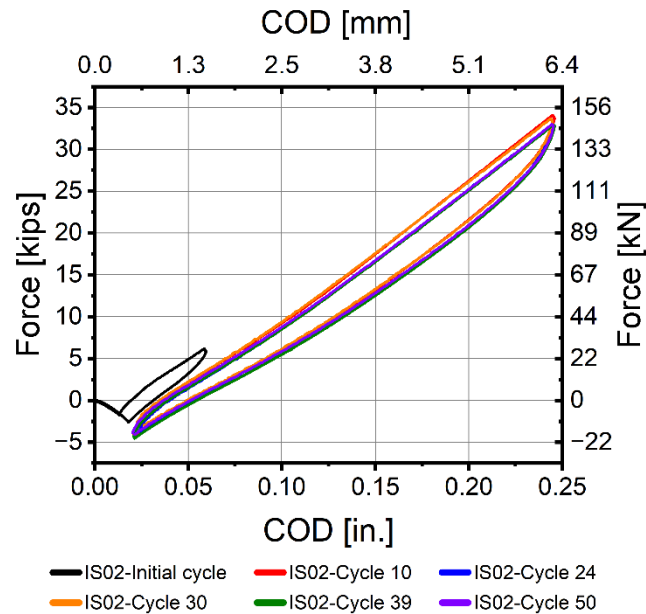
Figure 34. IS02 actuator load vs. crack opening displacement (COD) for thermal expansion cycles
