Service Life Assessment of Internal Replacement Pipe: External Load Testing of I-Main™

Final Report 1.0

REPAIR Testing & Analysis Team

December 2024

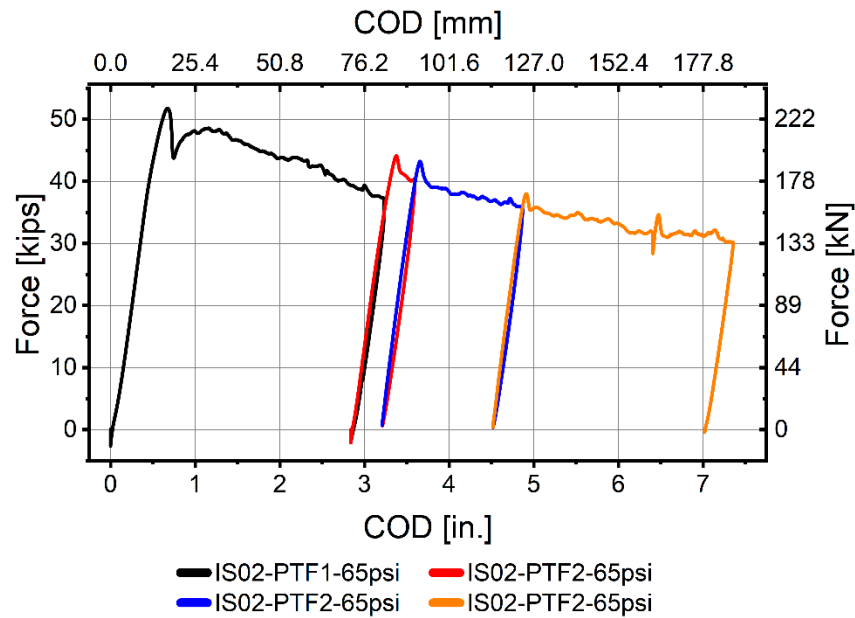
Figure 35. ISES02 axial force vs. crack opening displacement

Once thermal expansion cycles were completed, the specimen was axially loaded to its ultimate capacity. Figure 35 shows the axial force relative to the COD over the duration of this test. The specimen reached a peak ultimate force capacity of about 51 kips (227 kN) at a COD of about 0.65 in. Following this peak, a sudden drop in force occurred, reducing the applied axial tension to around 45 kips (200 kN). As axial displacement continued to be applied, the force built up again, reaching a softer local maximum of about 49 kips (218 kN) before gradually reducing in force as the COD increased. The first load drop was associated with full detachment of the IRP from the host pipe. Because pressurization plugs were used at either end of the specimen, leakage at the center of the specimen did not correspond with detachment, however, it is assumed the specimen would have leaked to some extent at this point. The accumulated force and subsequent drops after the first event are associated with frictional resistance that develops between the IRP and host pipe interface. As the IRP is pulled out of the host pipe, the contact area between the two is reduced, corresponding to a gradual reduction in applied load.

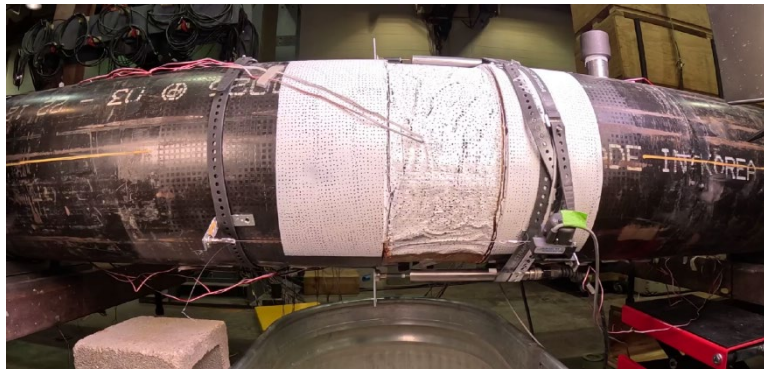
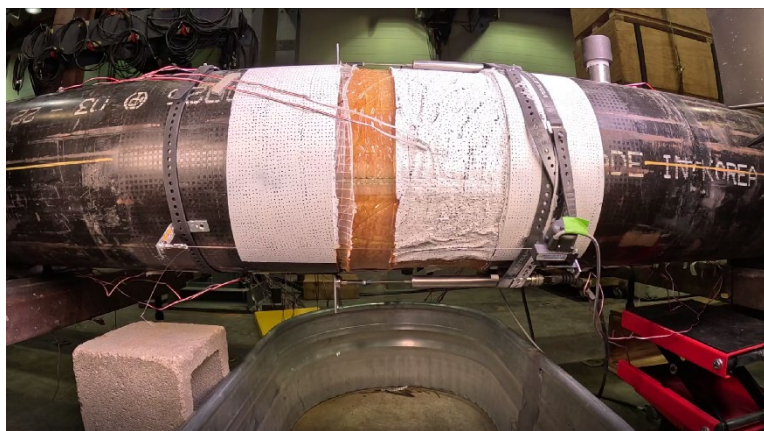
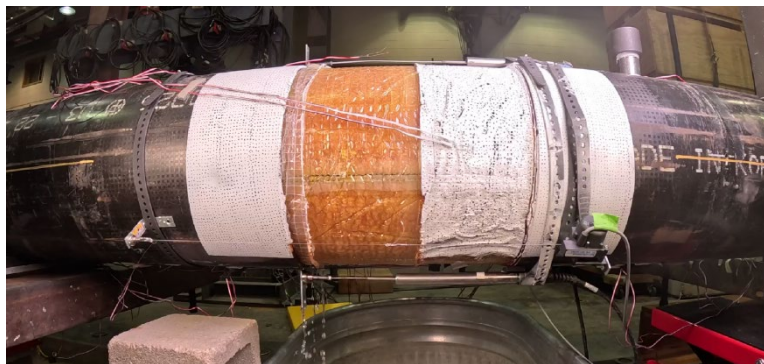
(a) Pretest

(b) First Leak

(c) End of first test sequence

Following the initial ultimate capacity sequence (shown in black), several additional sequences were performed at varying displacement rates. Further details about the influence of displacement rates on the specimen's axial force capacity are discussed in subsequent sections of this report. Overall, the trend showed a gradual decline in force capacity as COD increased. The final maximum tensile force recorded was approximately 30 kips at a COD of 7.25 in. (184 mm). Figure 36 shows the specimen (a) before loading, (b) during loading, and (c) after rupture occurred.

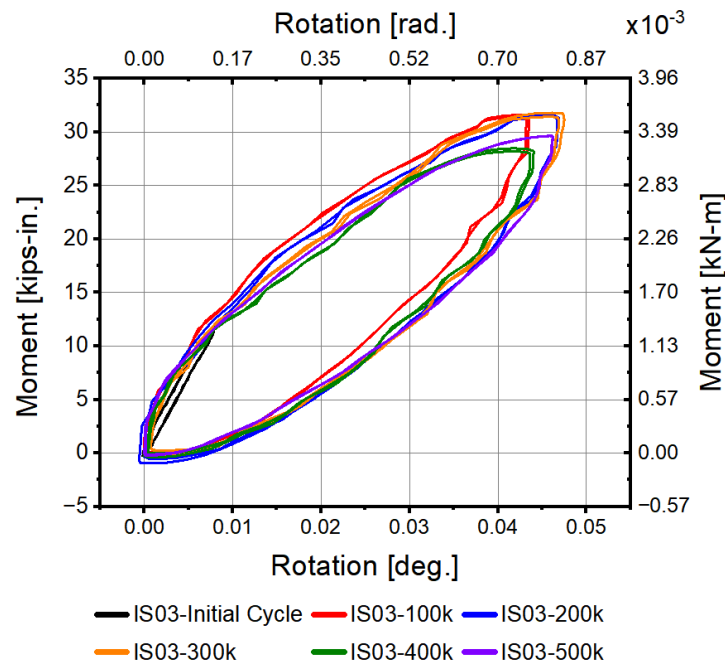
Figure 37. ISES03 moment vs. rotation for selected traffic cycles

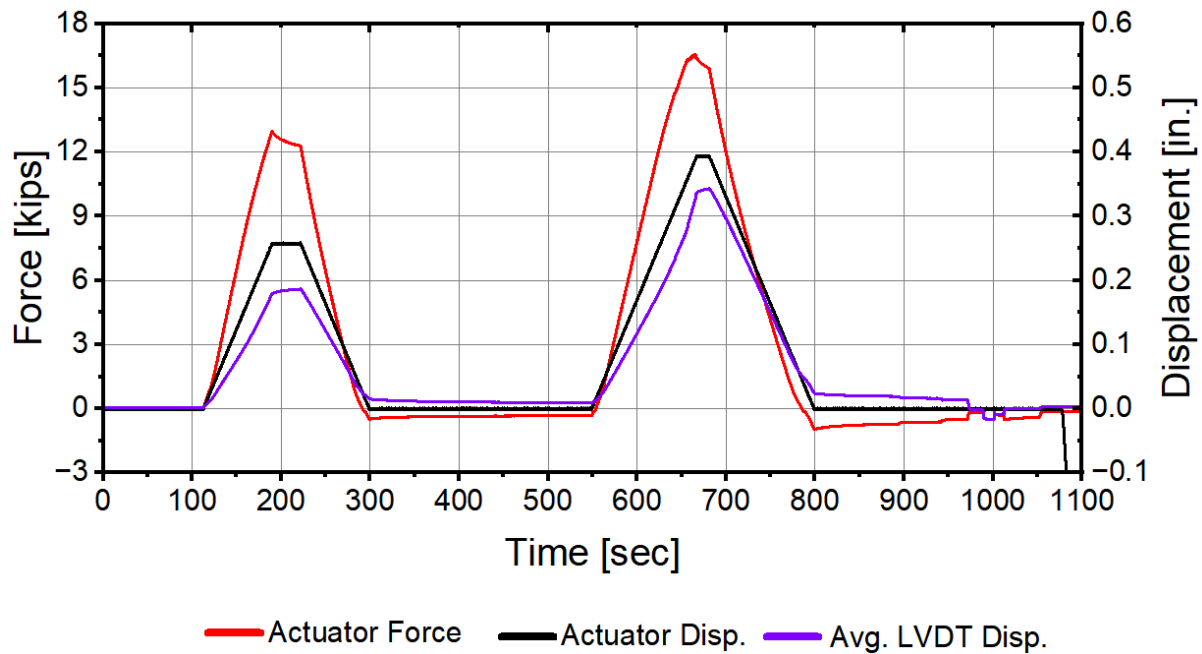
Figure 38. ISES03 actuator displacement, actuator force, average LVDT displacement vs. time for adjacent excavation events

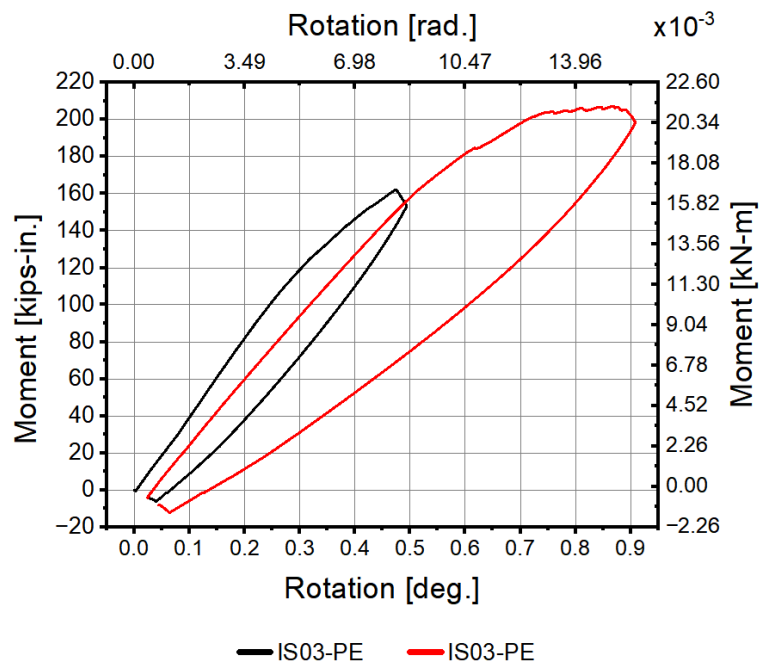
Figure 39. ISES03 moment vs. rotation for adjacent excavation events

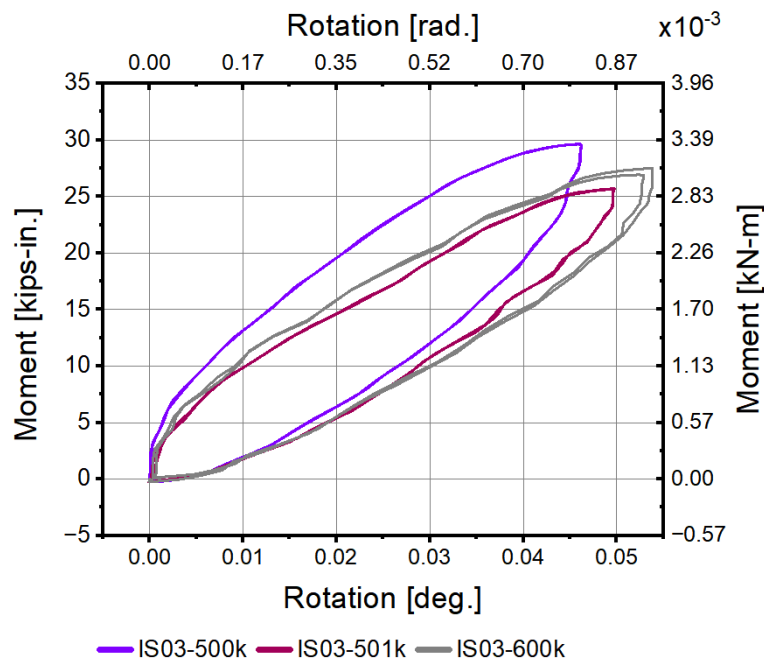
Figure 40. IS03 moment vs. rotation for traffic cycles pre- and post-AE tests

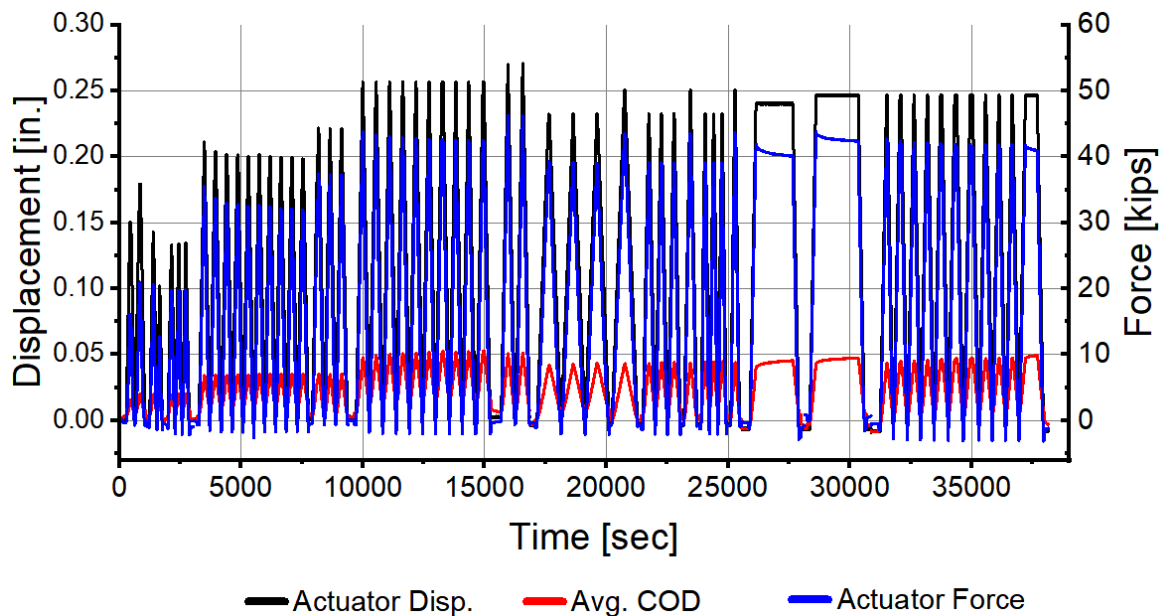
Figure 41. ISES03 actuator displacement, actuator force, and average LVDT measurements vs. time for thermal expansion cycles

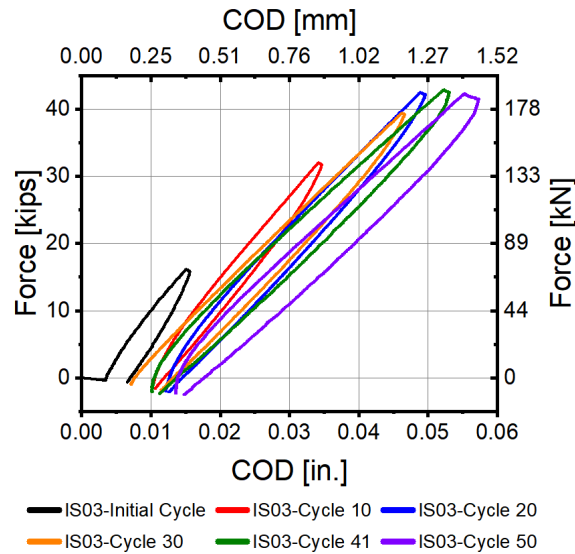
Figure 42. IS03 actuator load vs. crack opening displacement (COD) for thermal expansion cycles

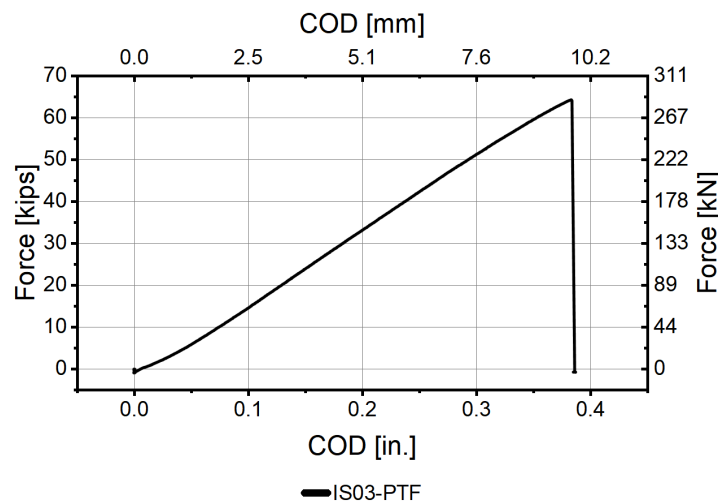
Figure 43. IS03 axial force vs. crack opening displacement

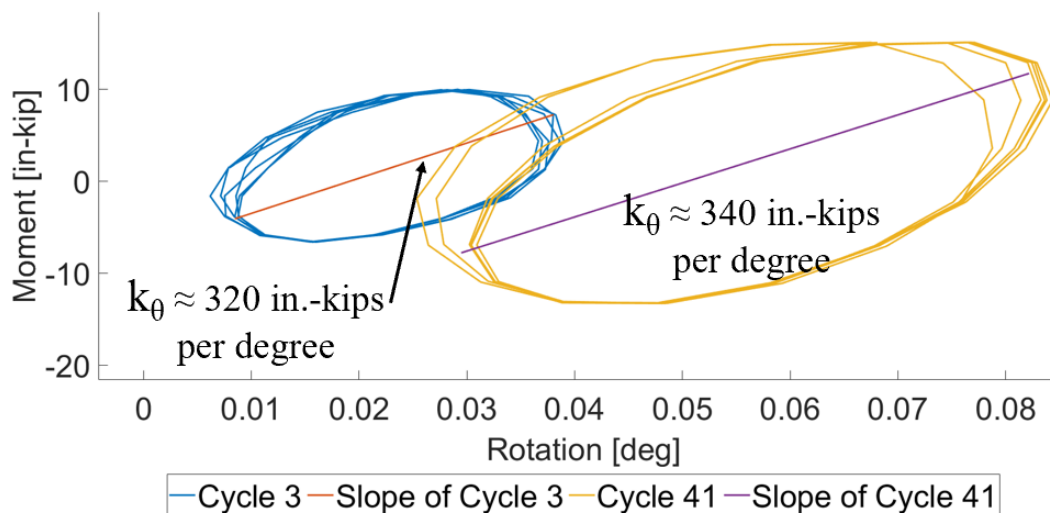
Figure 45. Typical moment vs rotation and rotational stiffness, k_θ

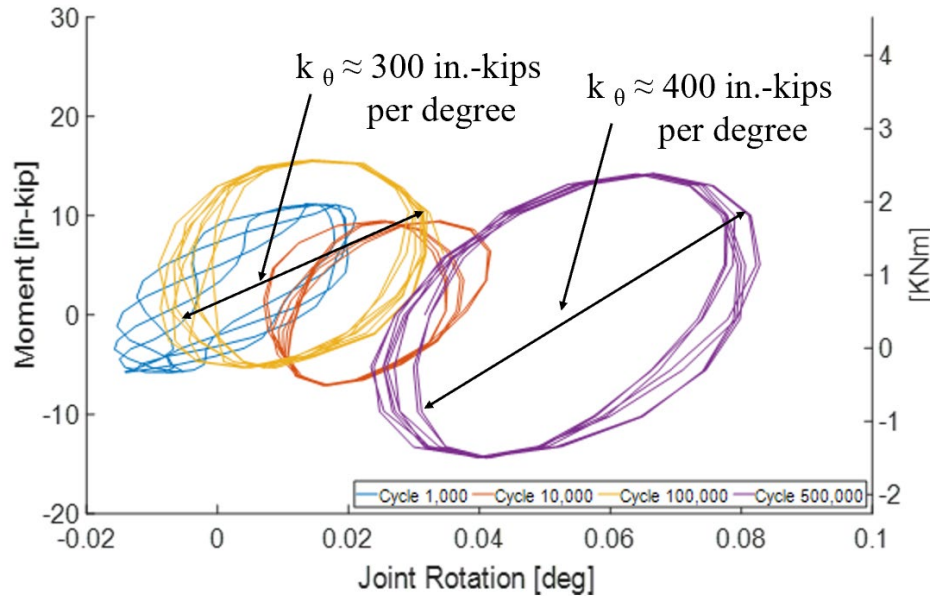
Figure 46. Moment vs. rotation for various cycles of traffic load

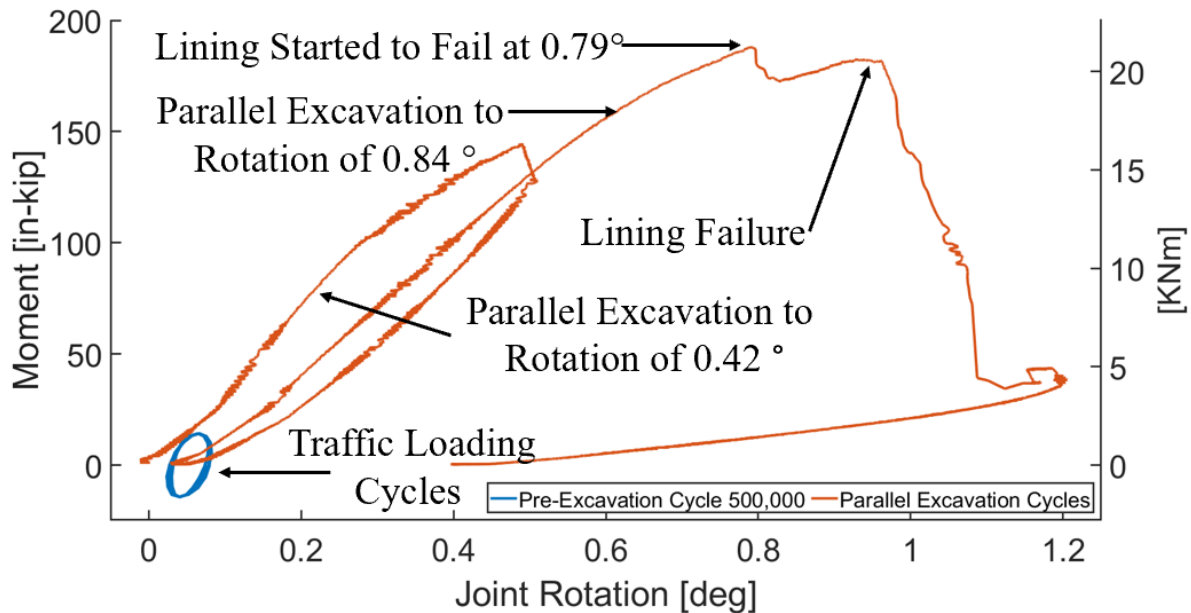
Figure 47. Moment vs. rotation of traffic cycles (~500,000) and two cycles of adjacent excavation

steep drop in moment after about 0.92° , which was accompanied by a pressure drop to approximately 55 psi (380 kPa).

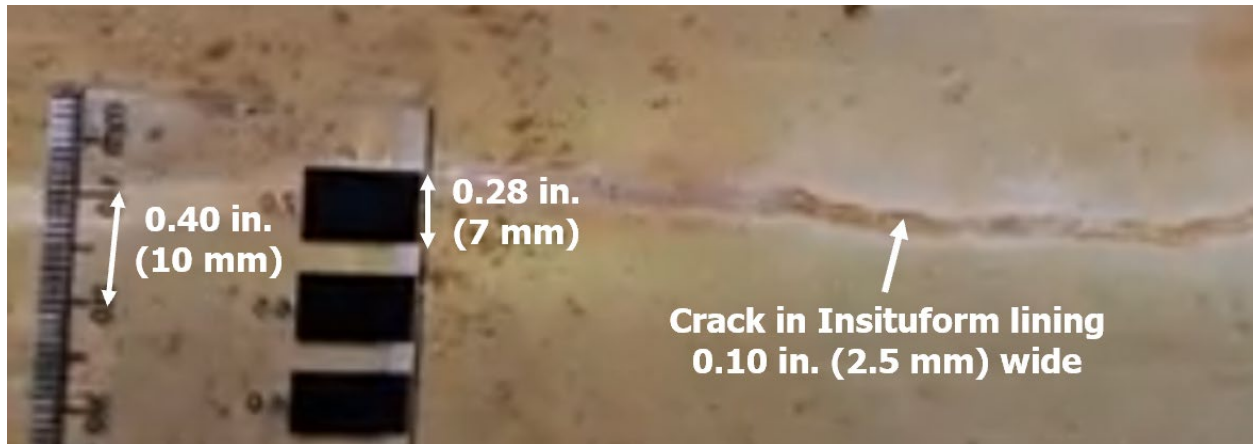
Figure 48. Photo of crack in I-Main lining at invert of pipeline specimen

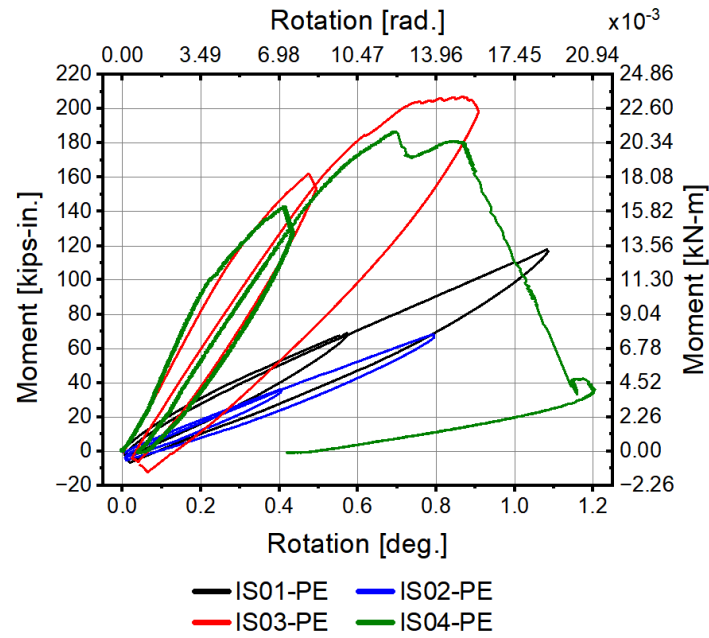
Figure 49. Moment vs. rotation for adjacent excavation events for each specimen

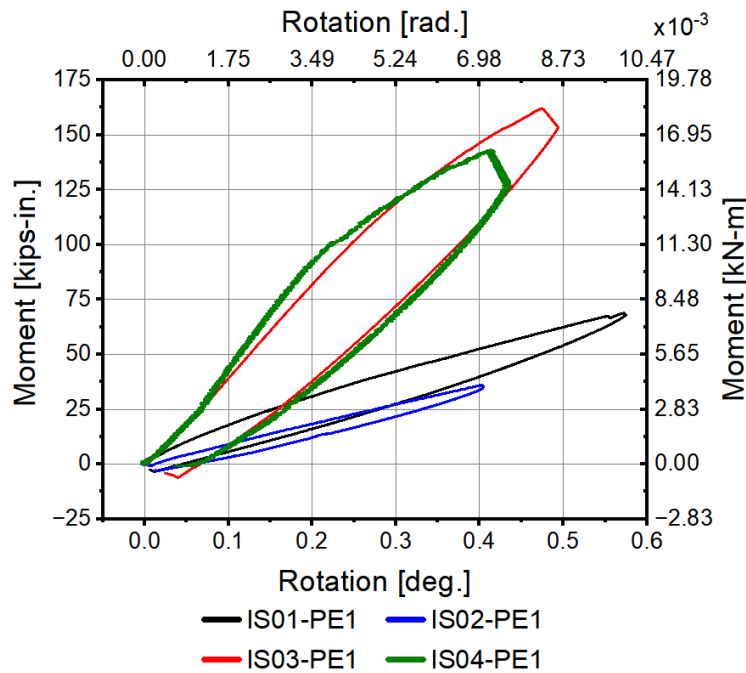
Figure 50. Moment vs. rotation for small adjacent excavation events for each specimen

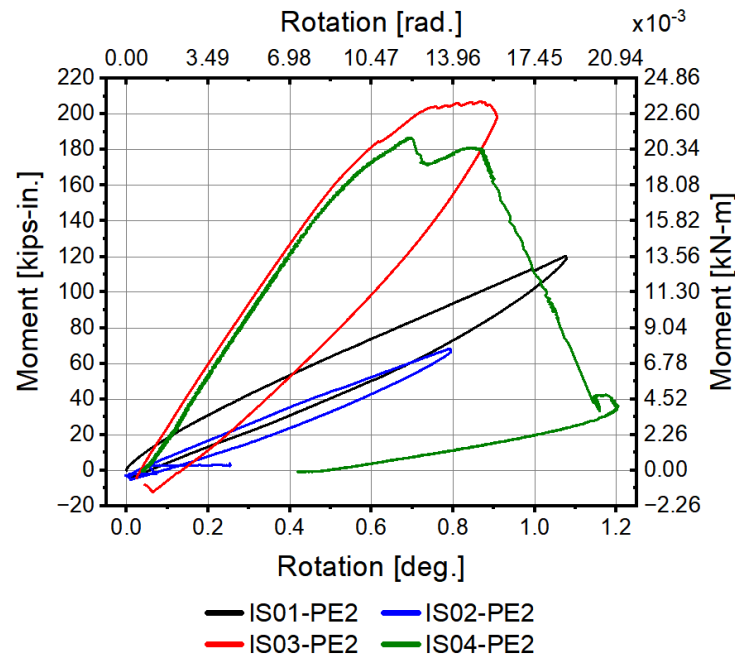
Figure 51. Moment vs. rotation for large adjacent excavation events for each specimen

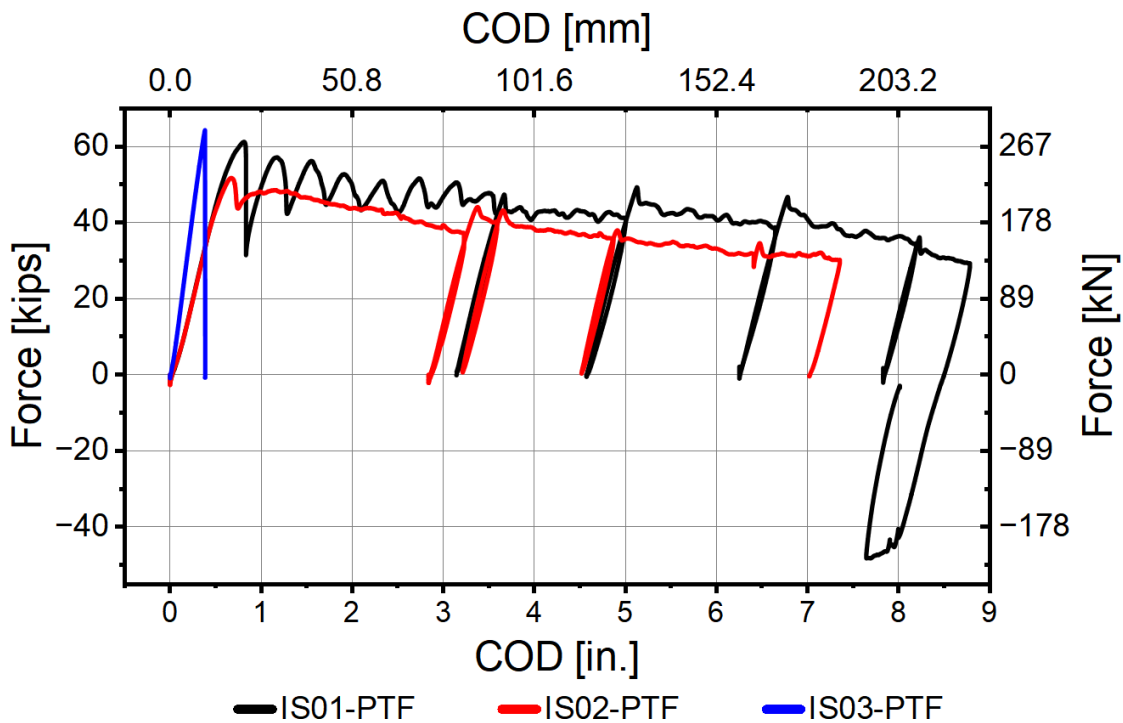
Figure 52. Axial force vs. COD for ultimate capacity tests for all specimens

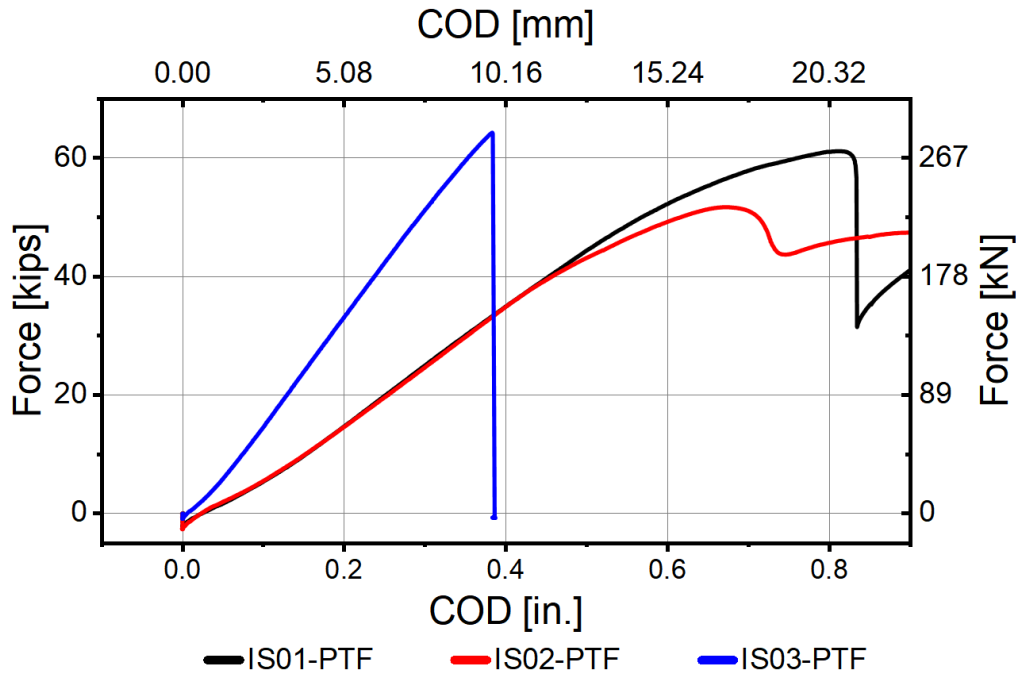
Figure 53. Axial force vs. COD at initial loading for ultimate capacity tests for all specimens

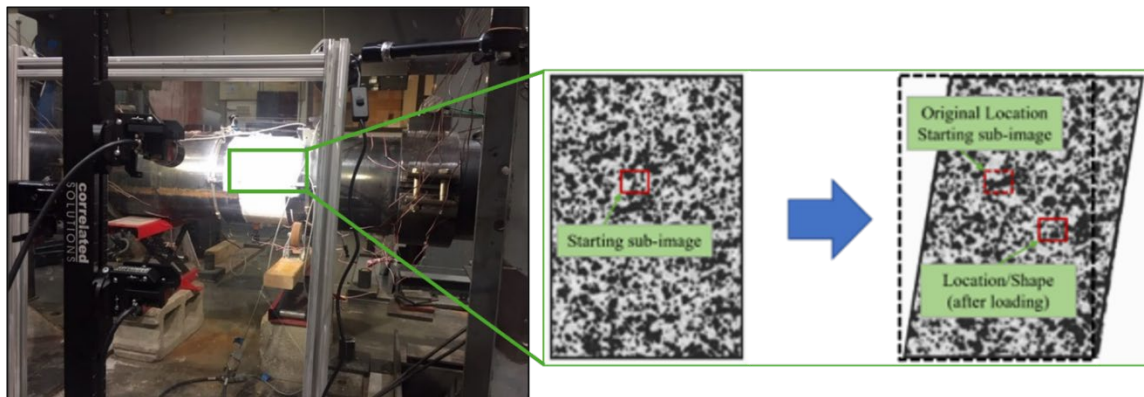
Figure 54. DIC setup for in-frame specimen associated with measurement mechanisms

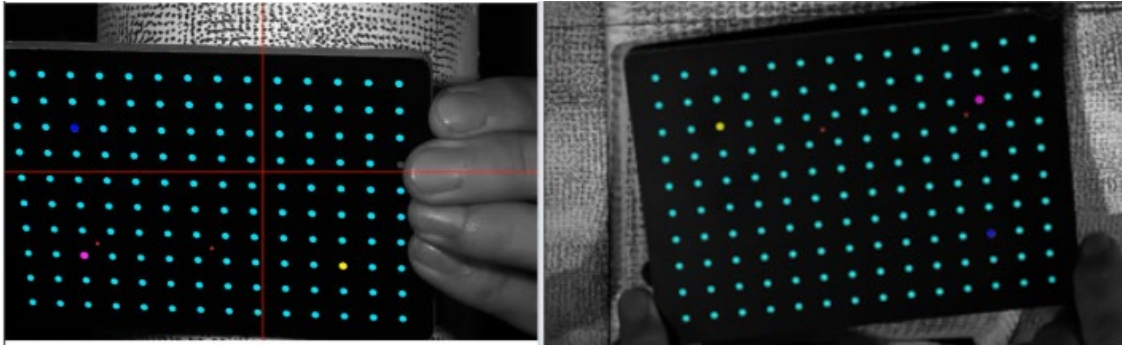
Figure 55. Calibration process before testing steps

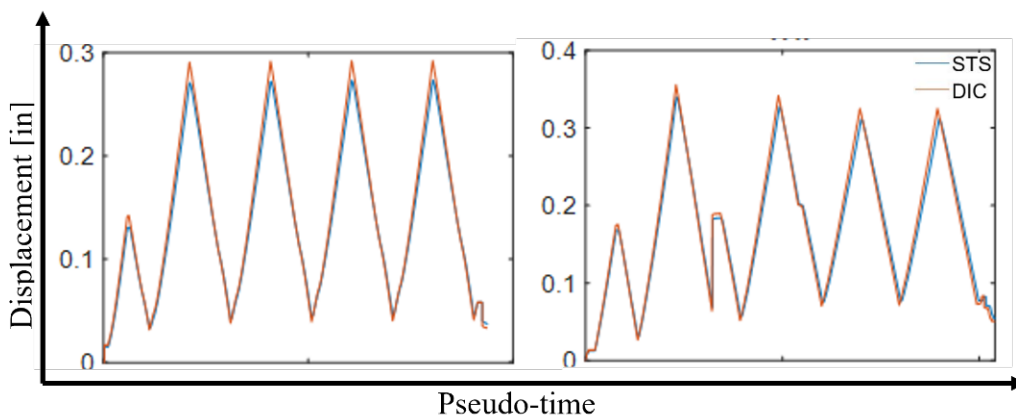
Figure 56. Comparisons between DIC and conventional measurements with R^2 equal to 99%

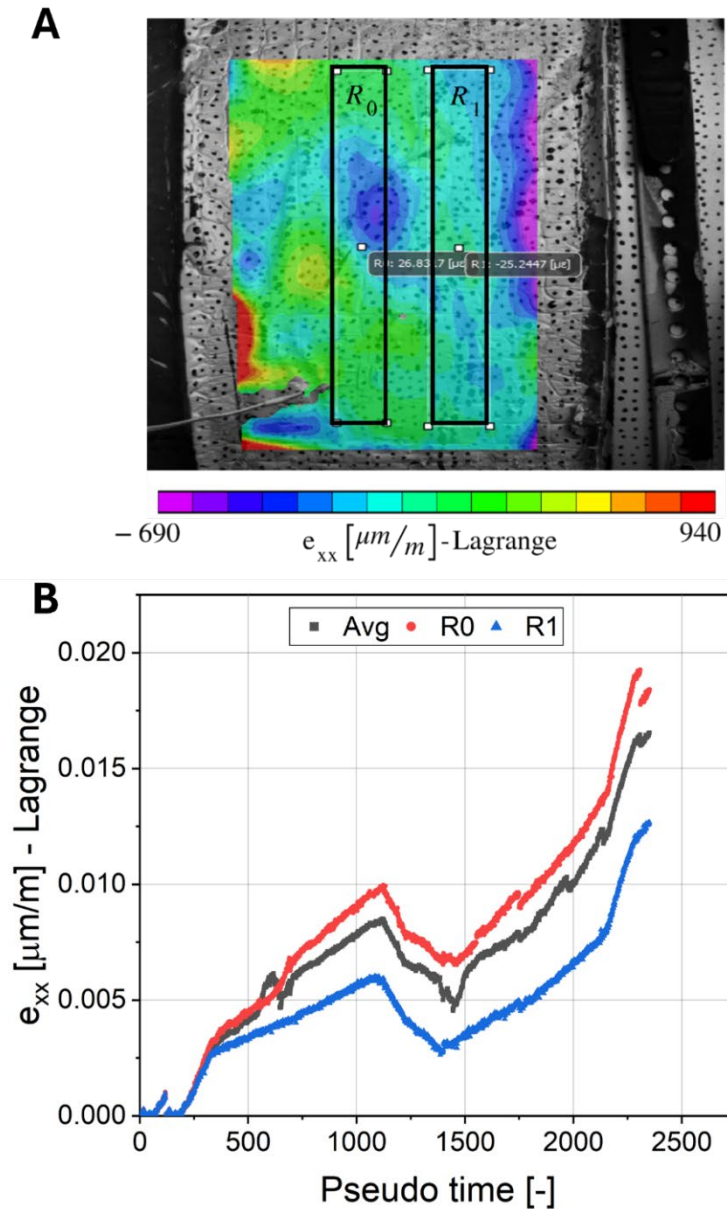
Figure 57. DIC measurements from the pull-to-failure test on ISES02: (A) Color contour of axial deformation (e_{xx}) in the crack area; (B) Comparison of plot curves for the average of the ROI, R0, and R1.

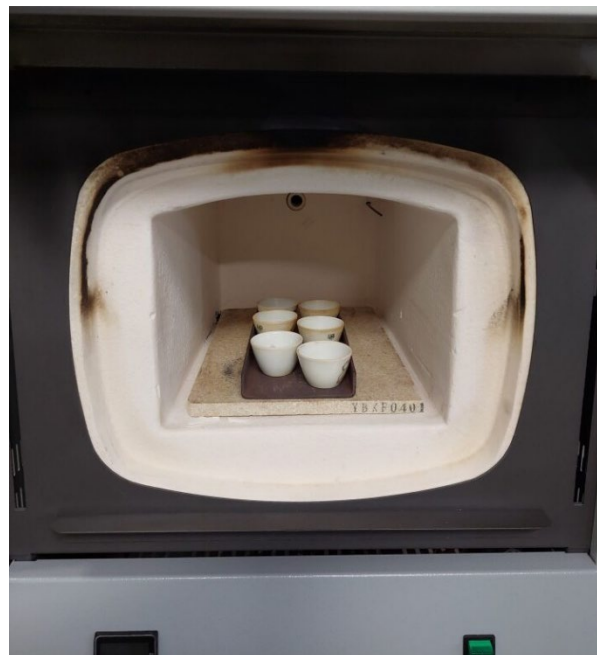
Figure 58. Samples in an electric furnace

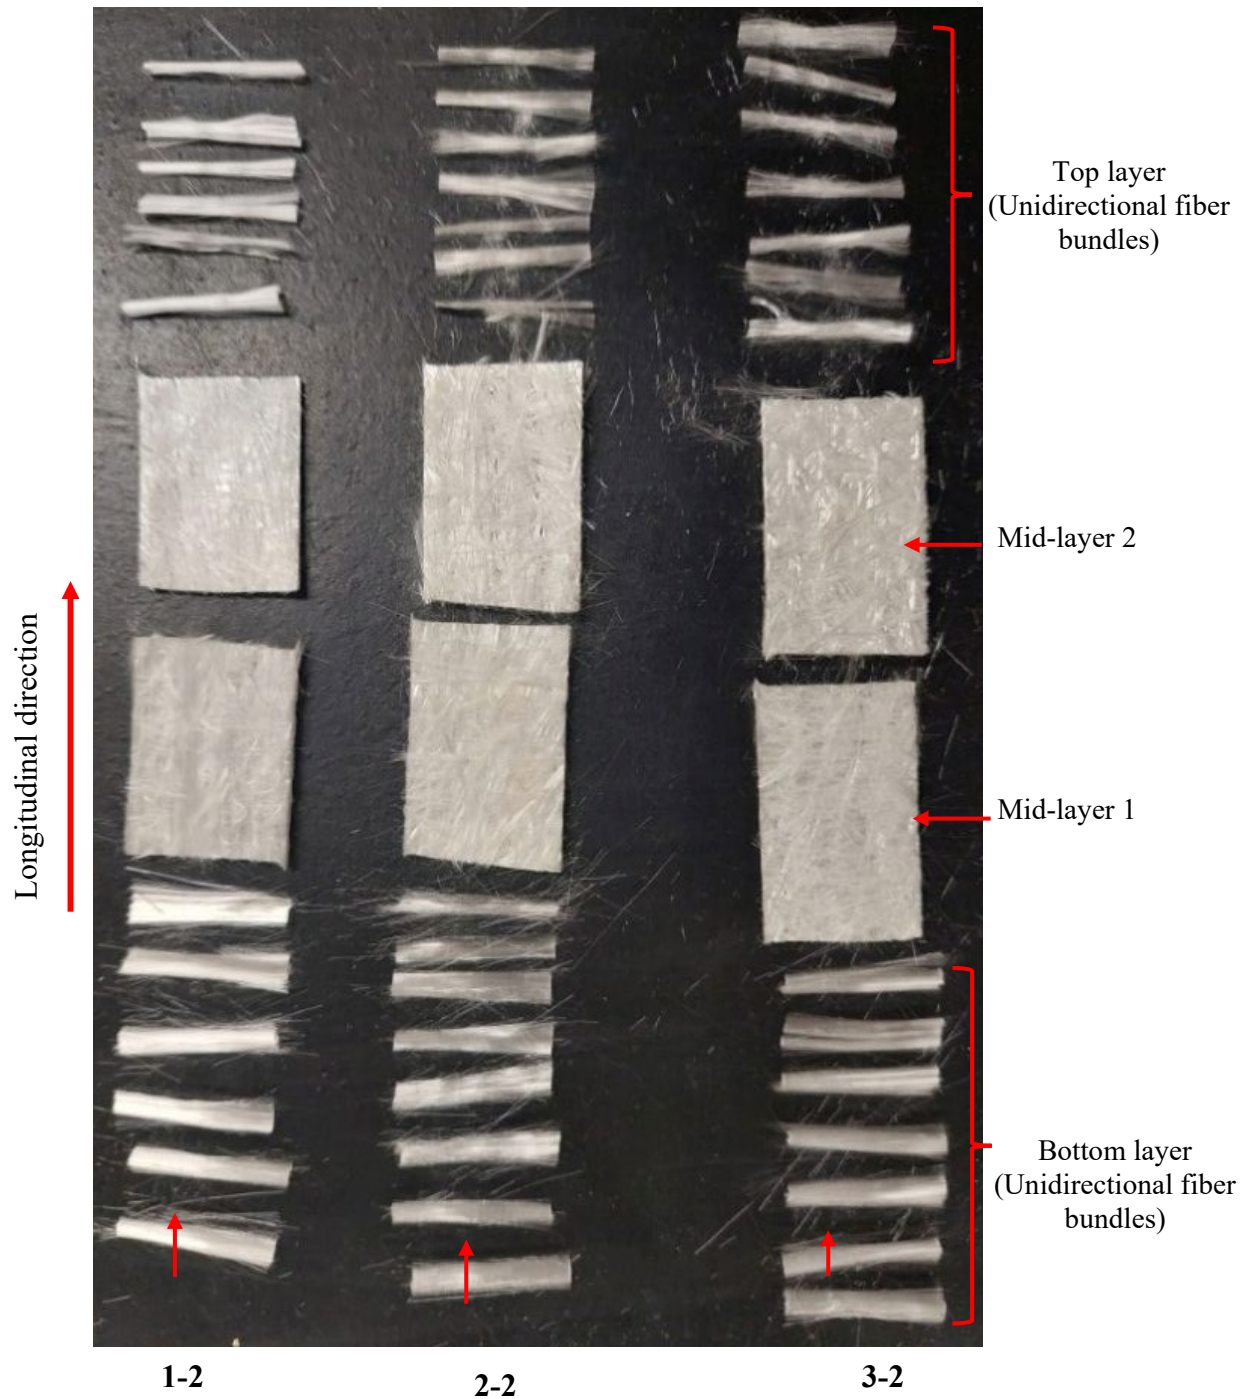
Figure 60. Ply orientation of the Insituform material

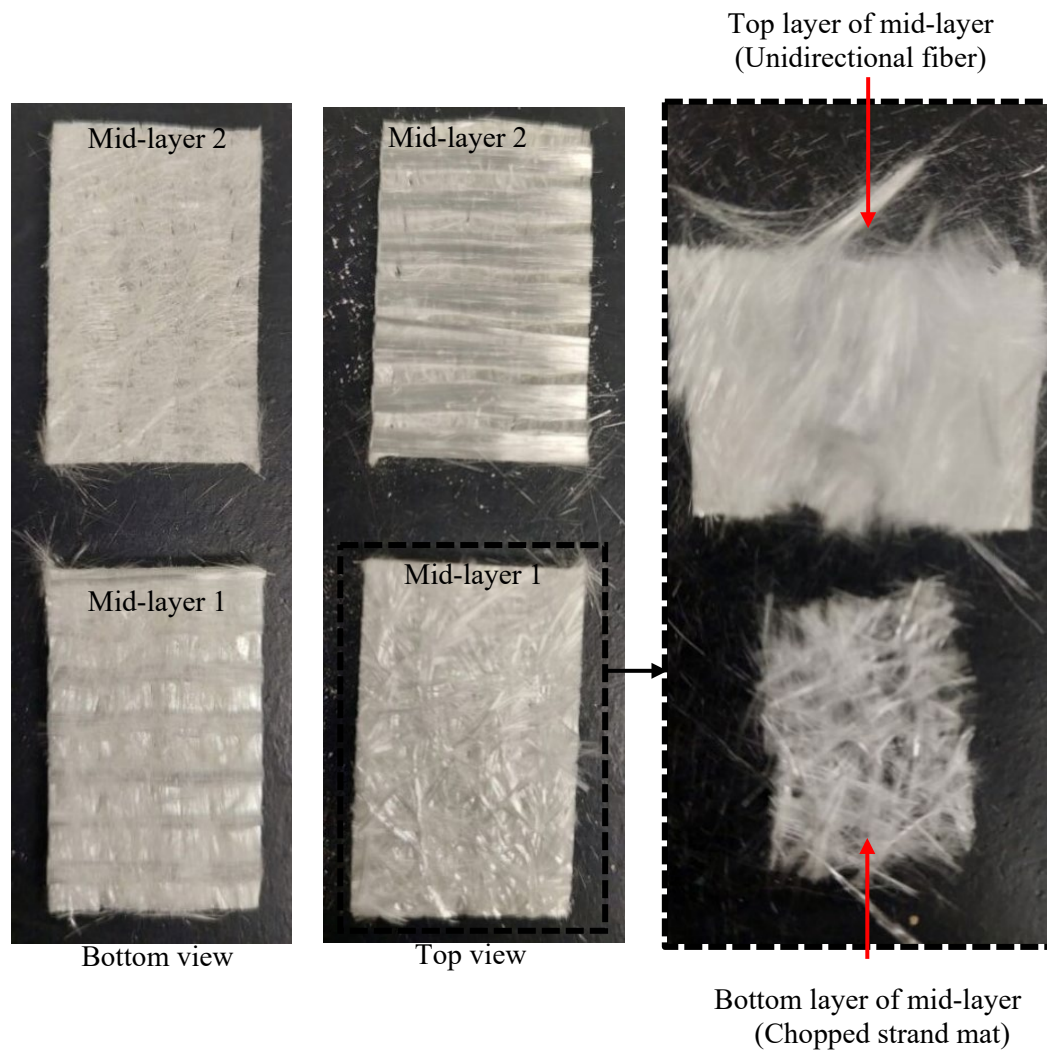
Figure 61. Mid-layers of Insituform material
