Service Life Assessment of Internal Replacement Pipe: External Load Testing of AQUA-PIPE™

Final Report

**DOE/ARPA-E REPAIR
COREAQUA**

November 2024

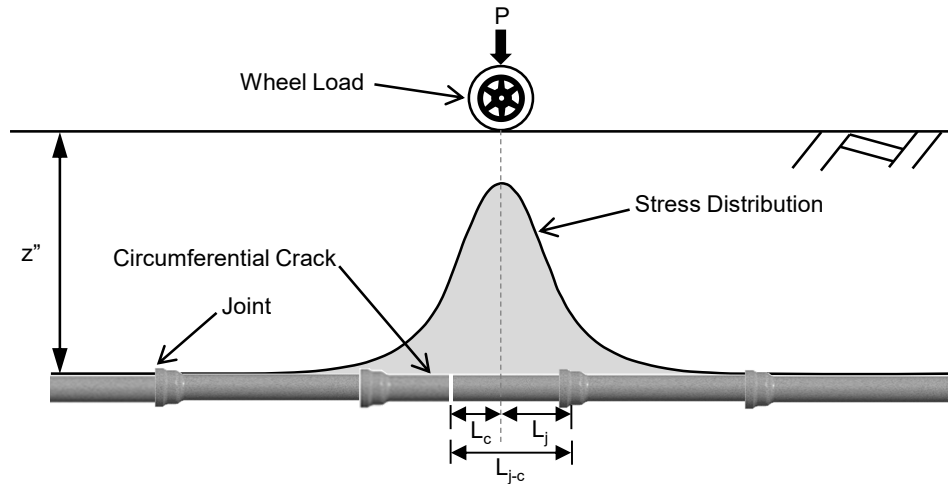
Figure 1. Schematic of traffic loading scenario

As described in detail by Klingaman et al., (2022), traffic loading was derived from an HS-20 design truck and was conservatively increased to 30 kips (130 kN). The resulting traffic load was assumed to be applied at the ground surface according to the Boussinesq stress distribution for a point load on a semi-infinite elastic medium. The stress calculated at a depth of 30 in. (762 mm) was multiplied by the vertically projected area of the pipe (diameter times element size) and discretely applied to each pipeline node in the FE model (Figure 1). Resulting pipe deformations (e.g., relative rotations) were recorded so that they could be applied in the lab.

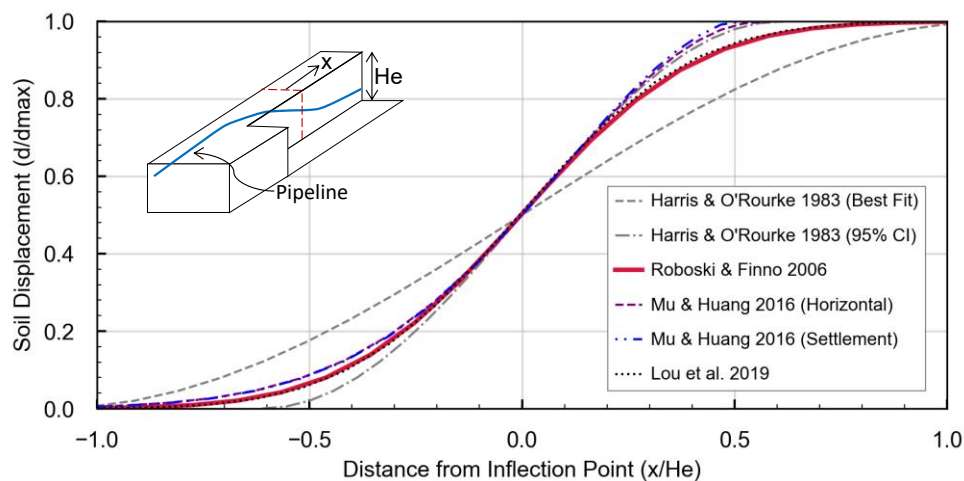
Figure 2. Soil displacement profiles parallel (adjacent) to an excavation from previous studies

As described by Klingaman et al. (2024), soil displacement profiles were developed using a functional form proposed by Roboski & Finno (2006), which requires 3 inputs: excavation depth, H_e , maximum soil displacement, d_{max} , and the length over which d_{max} is developed, L . The adjacent excavation (AE) depth was assumed to be 20 ft. (6 m), various values of d_{max} were considered, ranging from 2.5-10 in. (63.5-254 mm), and L was assumed to be 50 ft. (15.2 m) (Figure 2). The soil displacements were applied to each soil node in the FE model and resulting rotations were recorded so that they could be applied in the lab. During this study, the smaller and larger parallel (adjacent) excavation events, typically referred to as PE1 and PE2 for each specimen, were associated with d_{max} of 2.5 in. (63.5 mm) and 5 in. (127 mm), respectively.

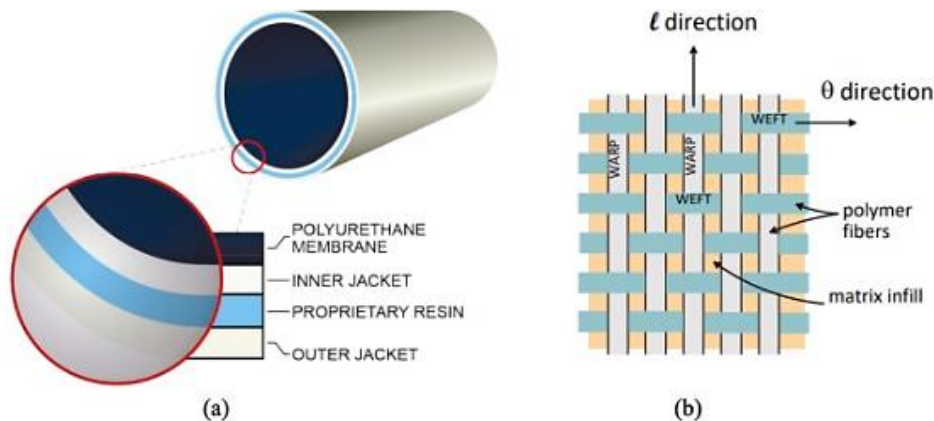
Figure 4. Illustration of AQUA-PIPE™ liner and its components.²

AQUA-PIPE™ is cured-in-place pipe system. The structural components are woven polyester (PET) and glass fibers in an epoxy matrix (Figure 4). AQUA-PIPE™ also consists of an inner jacket, which is in contact with the fluid inside the pipe, as well as an outer jacket. A similar product, AQUA-PIPE™, has been investigated by others (e.g., Fu et al., 2020; O'Rourke et al., 2021). O'Rourke et al. (2021) also tested AQUA-PIPE™ and performed experiments with host pipe reinforced by this IRP.

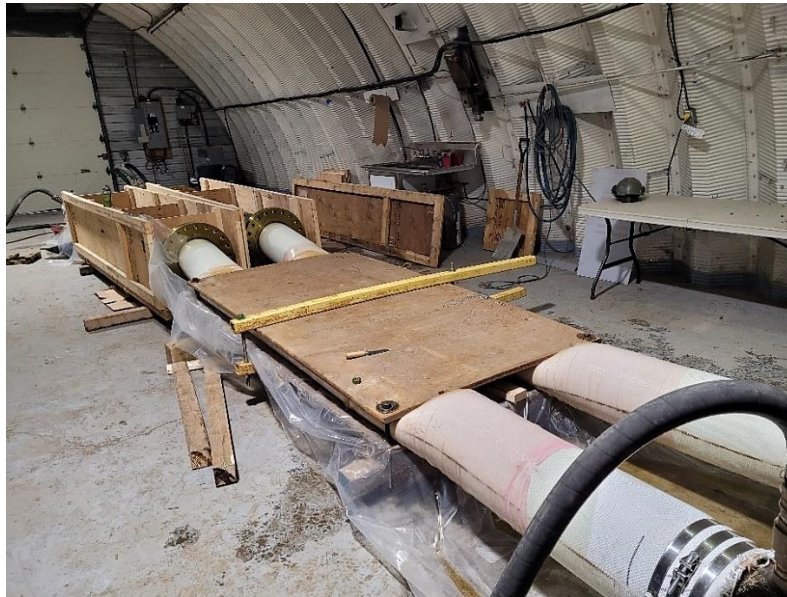
Figure 5. Preparation of AQUA-PIPE™ specimens, including full-scale specimens (rear) and plates for material testing (center, covered by plywood)

Tensile coupons and full-scale test specimens were prepared by COREAQUA (formerly Sanexen Environmental Services) at their facilities (Figure 5). Host pipes were shipped in specially designed crates to the manufacturer, and the specimens were prepared following typical installation procedures and then shipped back to the respective testing laboratories.

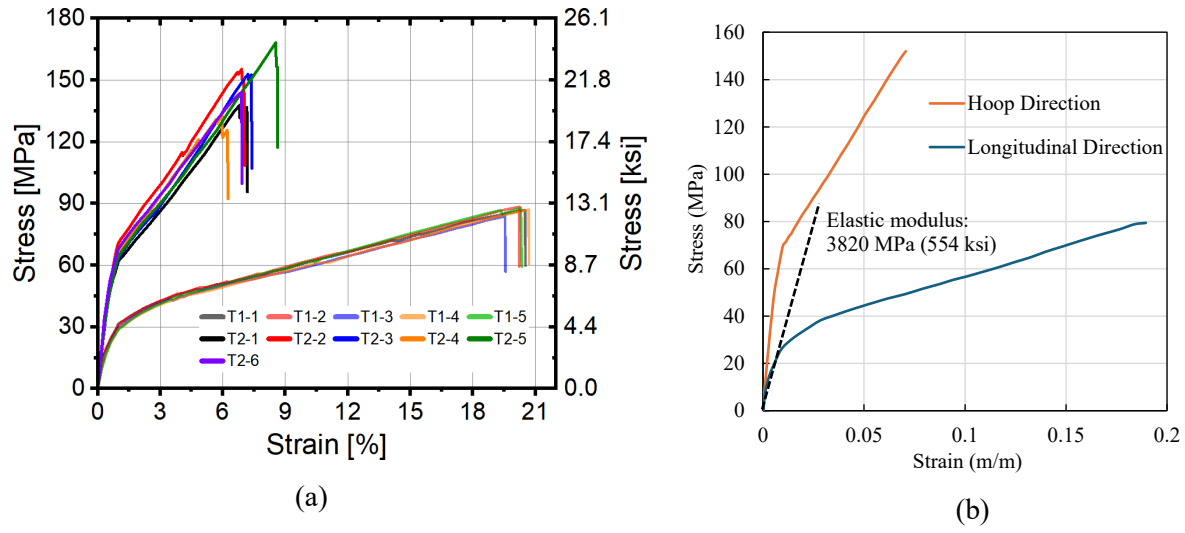
Figure 6. Stress-strain behavior of AQUA-PIPE™ in the longitudinal and hoop directions: (a) tensile coupon test data and (b) representative curve fit to test data

The stress-strain behavior of AQUA-PIPE™ in both the weft (circumferential/hoop) and warp (longitudinal) directions are shown in Figure 6. The data in Figure 6(a) was reported by the *Centre de Développement des Composites du Québec* [CDQC] (Bussi res, 2021) and Figure 6(b) shows the representative average response based on the coupon specimens. The initial elastic modulus in the axial direction, 554 ksi (3820 MPa), is used in the following sections.

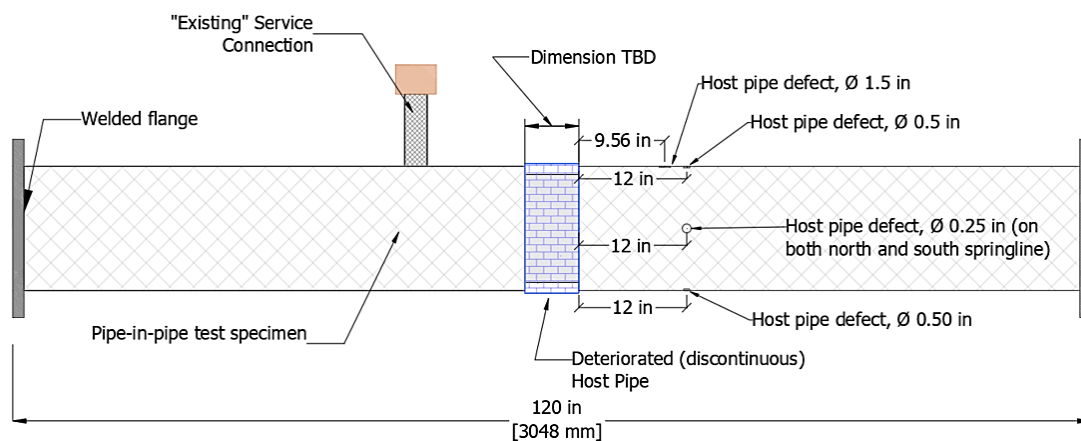
Figure 7. Drawings of specimens including locations of defects and service connection

Each steel specimen consisted of two 60 in. (1524 mm) long steel host pipe segments, one of which was intact and the other which featured several holes with diameters ranging from 0.25 in. (6.35 mm) to 1.5 in. (38.1 mm). Figure 7 shows drawings of these specimen dimensions.

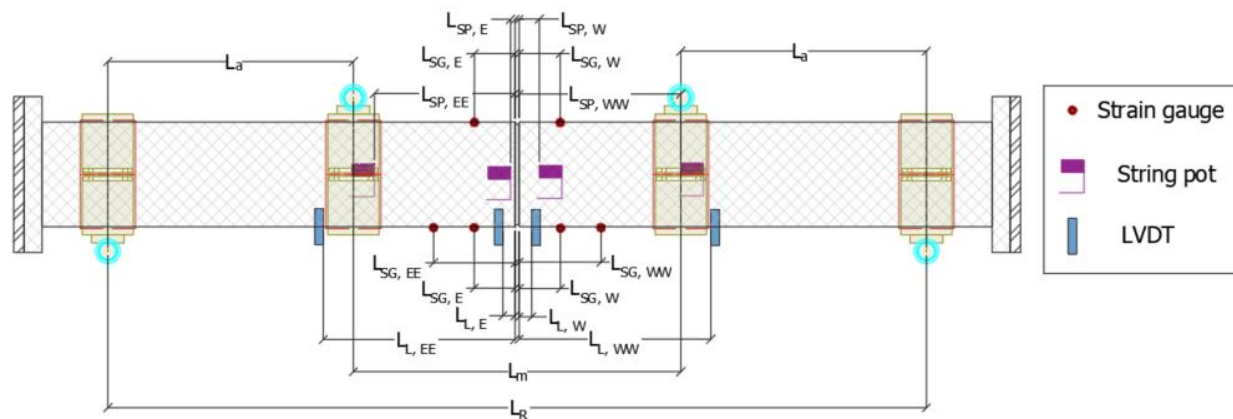
Figure 9. Dimensioned test instrumentation schematic

A schematic of test arrangement featuring the measurement devices is shown in Figure 9. The spacing of the sensors and clamps in Figure 9 are listed in detail in Table 3, for S01, and similar tables in the following sections.

Sensor / Measurement	Symbol	Distance
Strain Gauge (EE)	$L_{SG, EE}$	10 in
Strain Gauge (E)	$L_{SG, E}$	5 in
Strain Gauge (W)	$L_{SG, W}$	5 in
Strain Gauge (WW)	$L_{SG, WW}$	10 in
String Pot (EE)	$L_{SP, EE}$	19.75 in
String Pot (E)	$L_{SP, E}$	0.5 in
String Pot (W)	$L_{SP, W}$	2.5 in
String Pot (WW)	$L_{SP, WW}$	19.75 in
LVDT (EE)	$L_{L, EE}$	23 in
LVDT (E)	$L_{L, E}$	1.5 in
LVDT (W)	$L_{L, W}$	1.5 in
LVDT (WW)	$L_{L, WW}$	23 in
Distance between reaction and applied force	L_a	30 in
Distance between reactions	L_R	100 in
Distance between applied forces	L_m	40 in

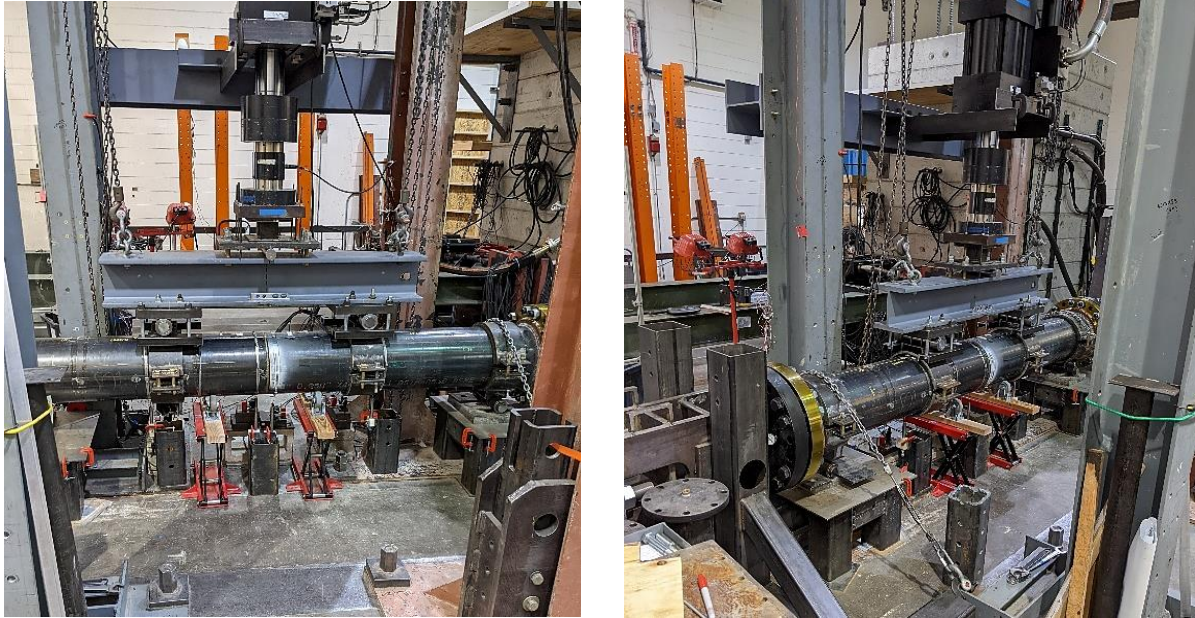
Figure 10. Images of S01 bending setup

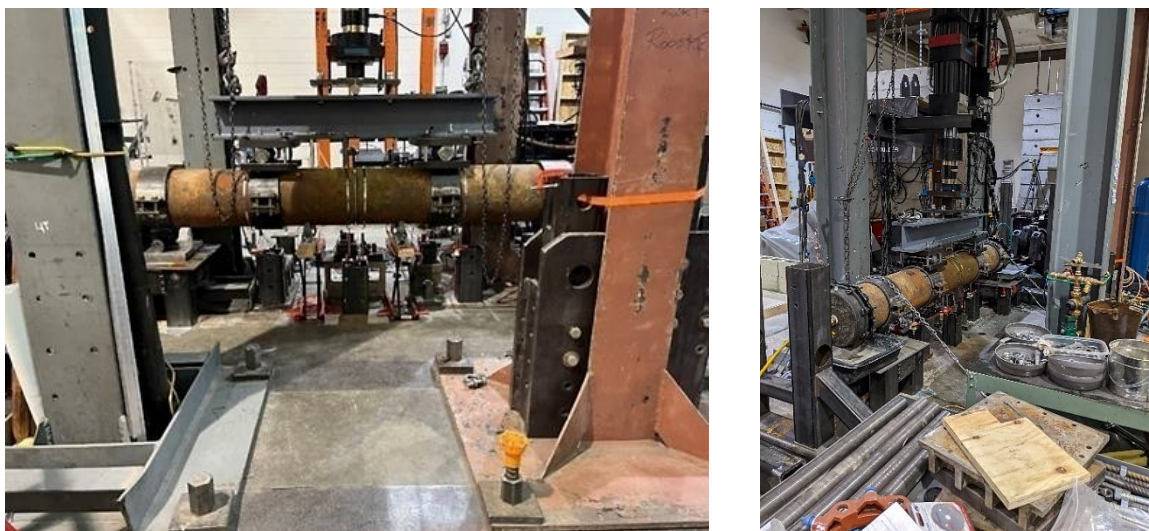
Figure 11. Images of C01 bending setup

The average gap width of C01 was initially measured at 0.6 in. (15.24 mm). For analysis purposes, this nominal value was used. The instrumentation of C01 for bending is given by Table 4. It is very similar to that for S01. The bending test configuration for C01 was 25 in. – 40 in. – 25 in. (635 mm – 1016 mm – 635 mm). It is noted that gap is centered in the test setup. Photographs of specimen and test setup are shown in Figure 11.

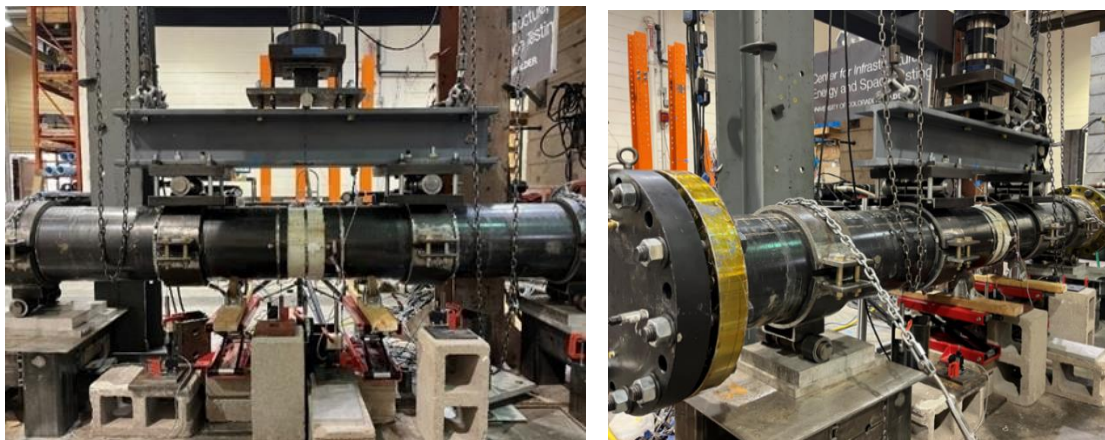
Figure 12. S02 bending setup

The average gap opening width of S02 was initially measured at 6.11 in. (155.2 mm). For analysis purposes, this nominal value was used. The instrumentation of S02 for bending is given by Table 5. It is very similar to that for S01 and C01 but features some instrumentation on the exposed AQUA-PIPE™ repair pipe. The bending test configuration for S02 was 26.5 in. – 40 in. – 26.5 in. (673 mm – 1016 mm – 673 mm). It is noted that gap is centered. Photographs of the specimen and test setup are shown in Figure 12.

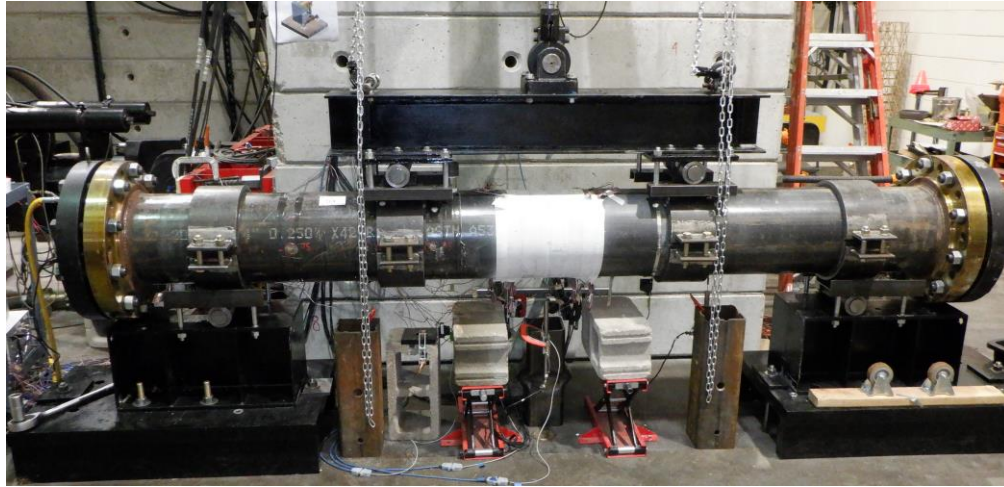
Figure 13. S03 bending setup

the pipe over and in the vicinity of the gap was painted white and speckled black for digital image correlation (see Figure 13).

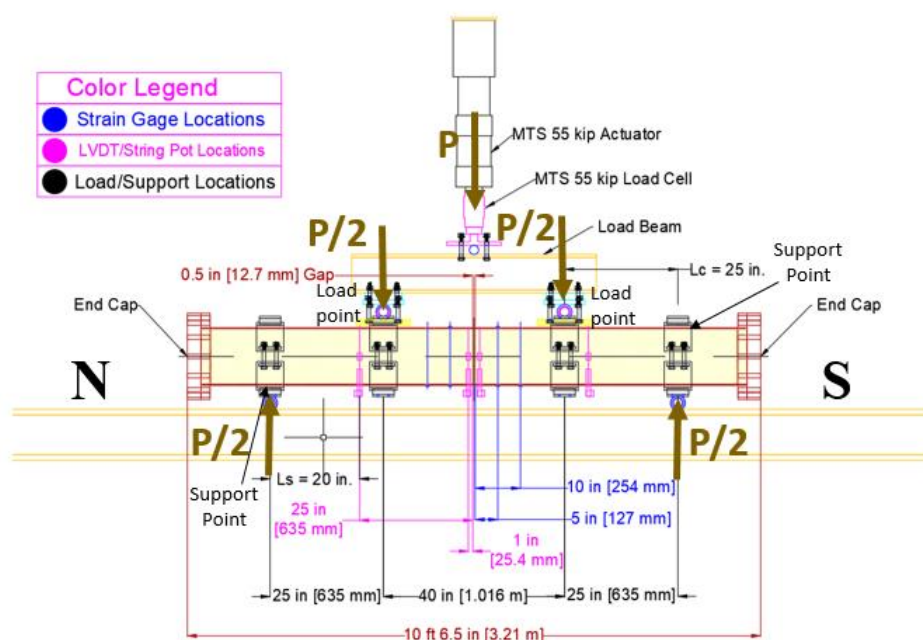
Figure 14. Schematic of four-point bending test for specimen SNES04

As shown in Figure 14 load was applied to load and support points through saddles fitted to the pipe. The saddles allowed the pipeline to return to its initial position, thus simulating deflection in the field wherein the pipeline in soil returns to its original position after rolling traffic loads move across the pipe. To duplicate this condition some tensile force is mobilized through the saddles to counterbalance the dead weight of the pipeline. North and South are shown by N and S, respectively, in Figure 14 as well as in other test schematics and photographs.

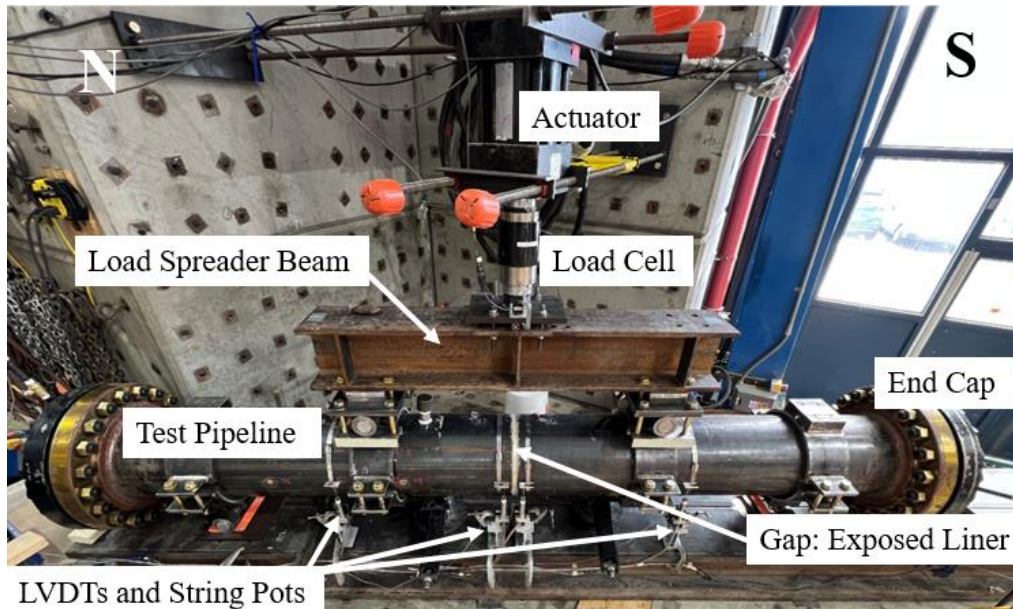
Figure 15. Photograph of four-point bending test

(635 mm) north and south of the loading locations, which were in turn separated by 40 in. (1016 mm). This arrangement is referred to as a 25 in. – 40 in. – 25 in. configuration.

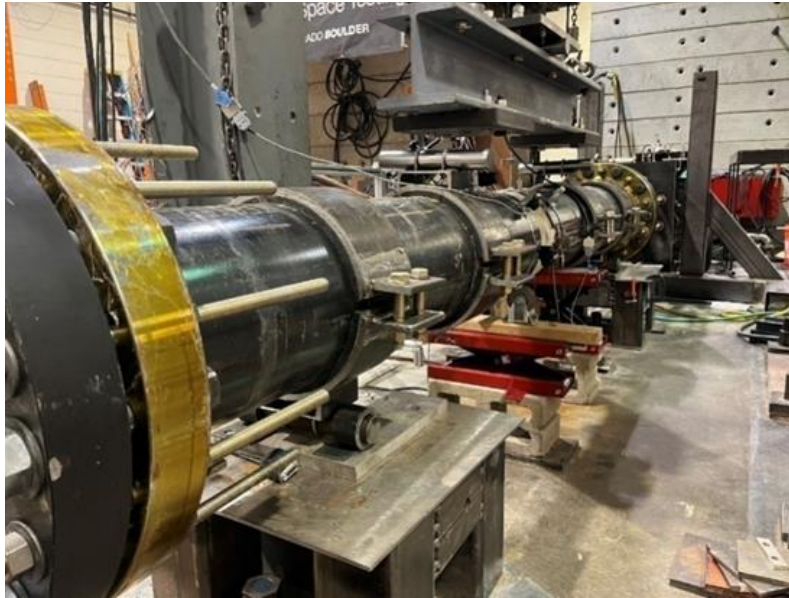
Figure 18. S02 axial test setup

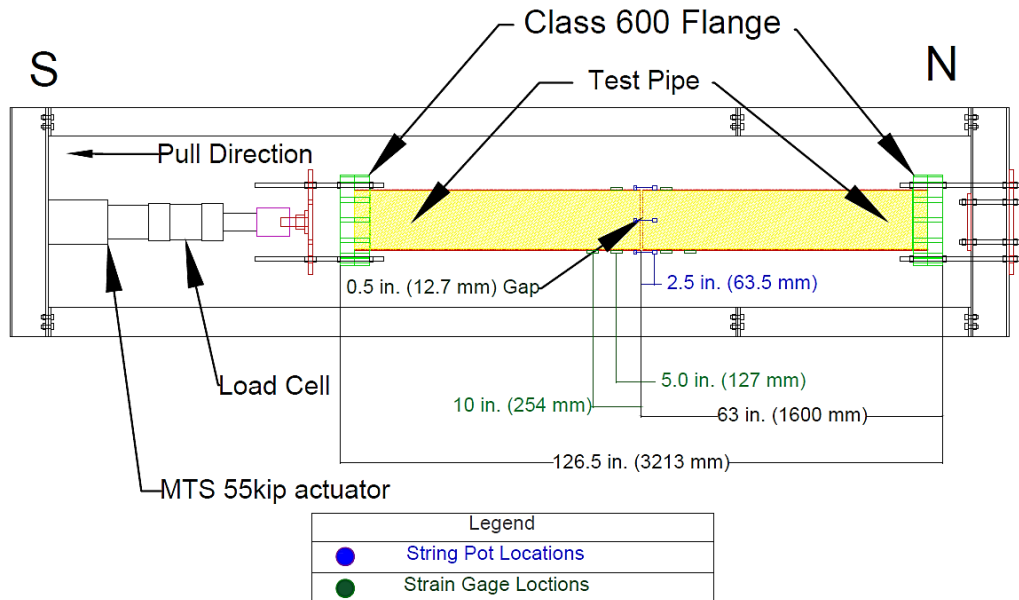
Figure 20. Schematic of axial test setup for specimen SNES04

Figure 21 presents a photograph of the test setup depicted in Figure 20. The test pipeline, MTS actuator, load cell, center gap, flange/end cap, and threaded rods can be seen in the figure. The center gap has been expanded due to axial pull in this figure so that the orange/brown lining is visible on the south (left) side and central part of the opening. The initial gap with white epoxy can be seen on the north (right) side of the opening.

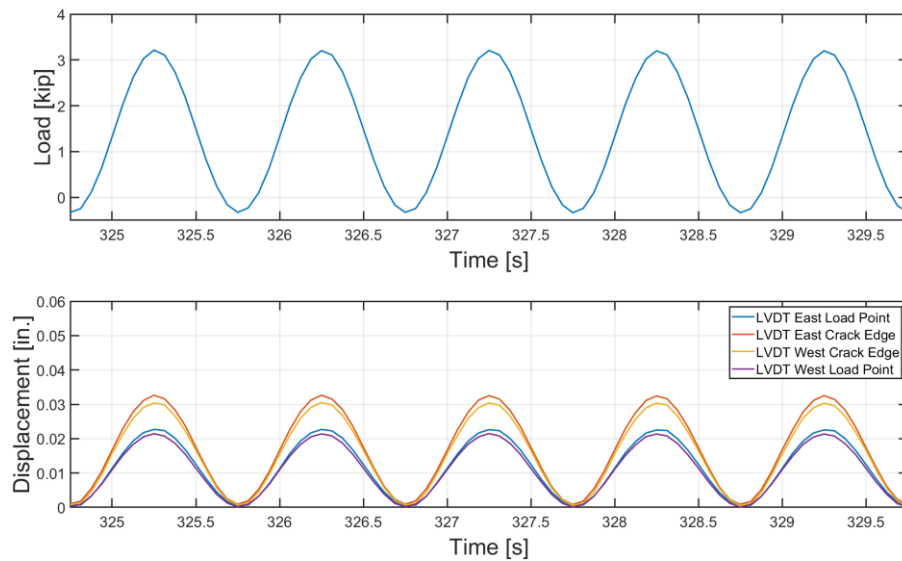
Figure 22. Load and LVDT displacements vs. time from the first set of traffic cycles for S01

Figure 22 shows load-time data and LVDT displacement-time data from the first set of traffic cycles of S01. These cycles are a representative sample of traffic loading cycles performed on S01. Traffic loading of S01 entailed a mechanical load up to roughly 3.3 kips (14.7 kN). A small lifting load was required to support the pipe and return the frame's actuator to its initial position (typically about 300 lbs (1.3 kN)).

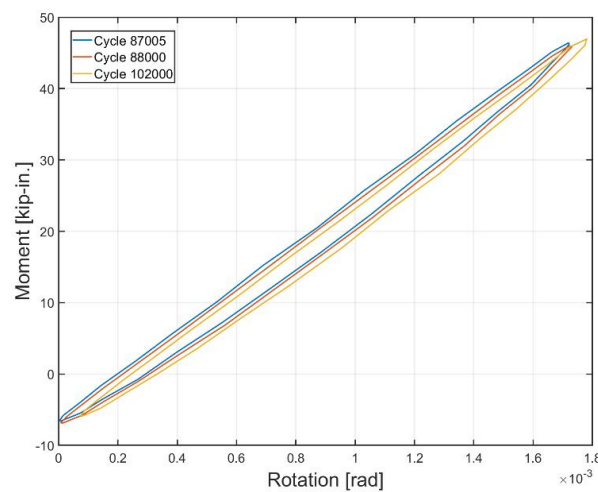
Figure 23. Measured moment vs. global rotation curves from a single block of traffic loading for S01

Figure 23 shows applied moment vs. global rotation curves at different cycle counts from a single set of traffic cycles conducted at a rate of 2 Hz. The cycle count shown in the legend represents the overall number of cycles applied and corresponds to cycles 5, 1000, and 15000 within the set. The figure shows consistent applied moment while a marginal shift in the maximum and minimum rotation values occurred over cycling.

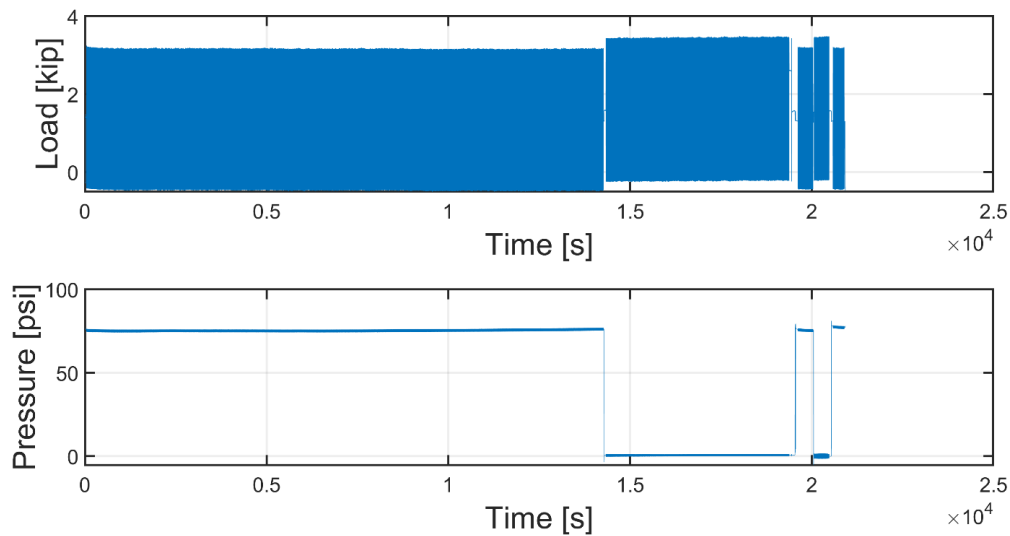
Figure 24. Load and pressure vs. time for S01 traffic loading cycles with variable internal pressure

Figure 24 presents load vs. time and pressure vs. time data for a block of traffic cycles in which the pressure was released. Without pressure, a positive shift in the load is observed; the actuator applies more compressive load to reach the same displacement level and less tensile load to return to the initial position.

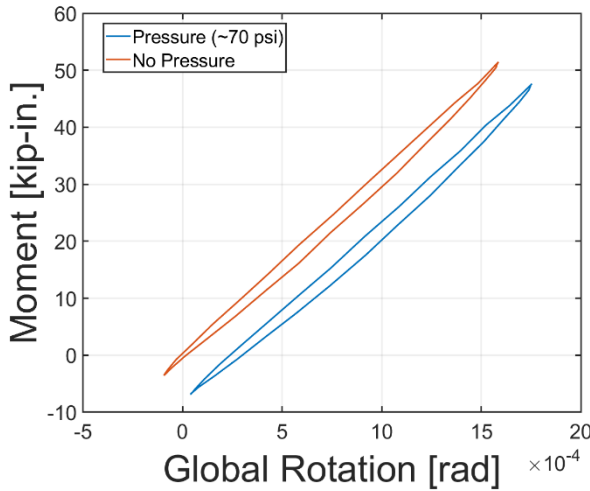
Figure 25. Moment vs. rotation with and without pressure for S01

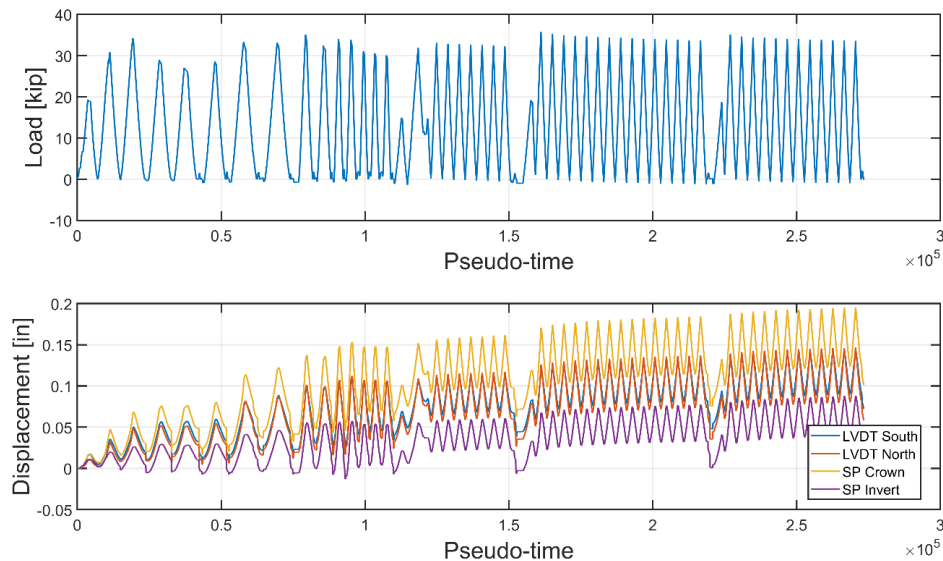
Figure 32. Load and CODs in axial cycling for S01

Figure 32 shows the axial load and displacement measures about the gap opening plotted against a pseudo-time index for most axial cycles of S01. The difference in displacements measured at various positions around the gap opening is attributed to the deformed shape of the specimen imposed by the previous lateral deformation cycles. Note here that the displacement measures are all zeroed from the initial test zero for the purpose of effective visualization only. For purposes of analysis, the displacement data is zeroed at the beginning of each set of cycles.

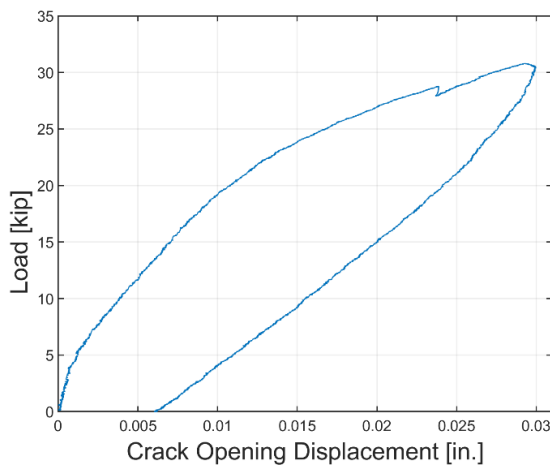
Figure 33. Early axial cycle, load vs. COD for S01

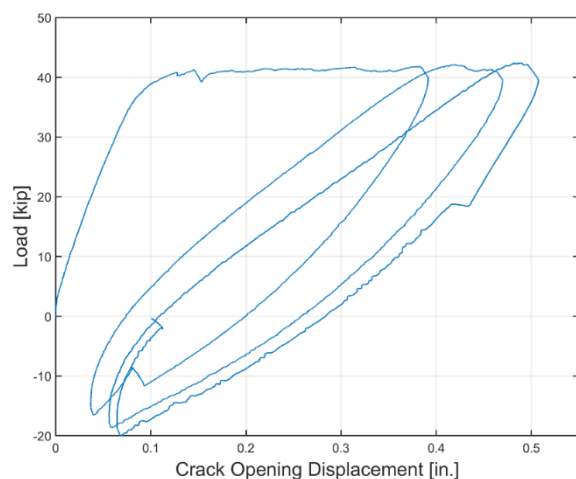
Figure 38. Axial displacement cycles to 0.4 in. featuring compressive loading for S01

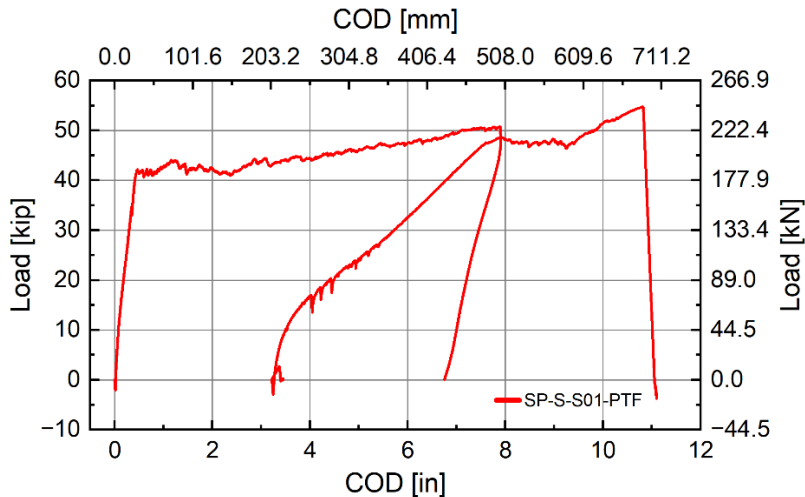
Figure 39. Large axial pulls of S01, load vs. COD

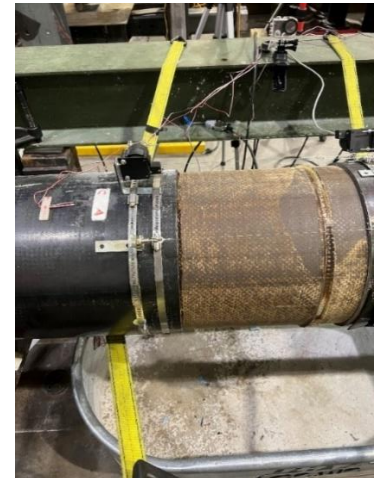
Figure 40. Gap opening in the failed specimen S01

Leakage occurred at the west side of the gap, between the steel and liner. This failure indicates water is backtracking between the detached region from inside the pipe. The gap opening from an overhead view is shown in Figure 40 while Figure 41 provides images of the specimen before, after the first pull, and at the end of the test.

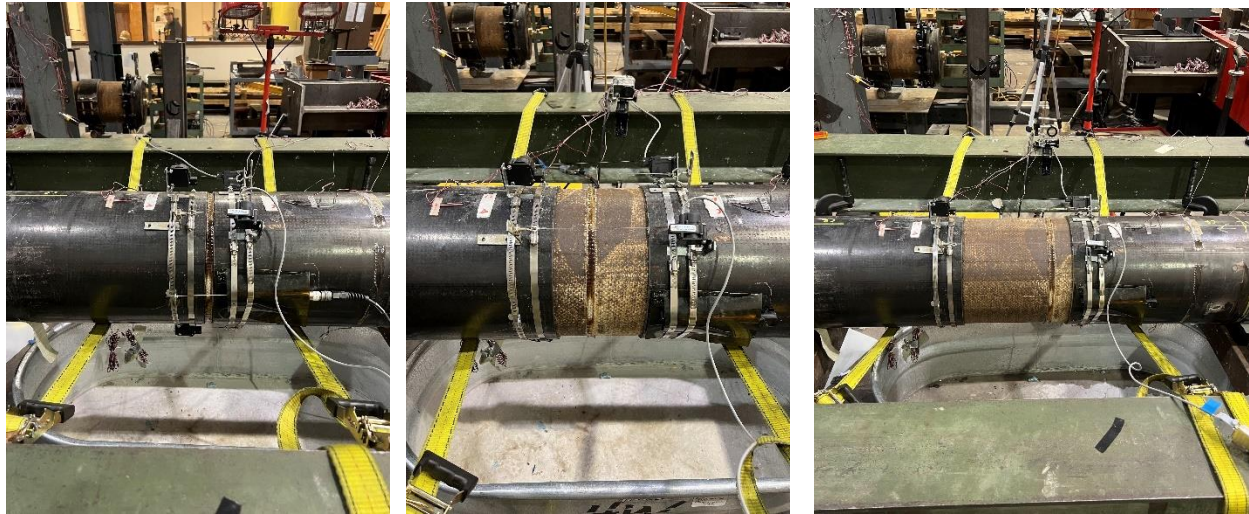
Figure 41. S01 (a) before pull to failure, (b) after first pull applied, and (c) after final detachment

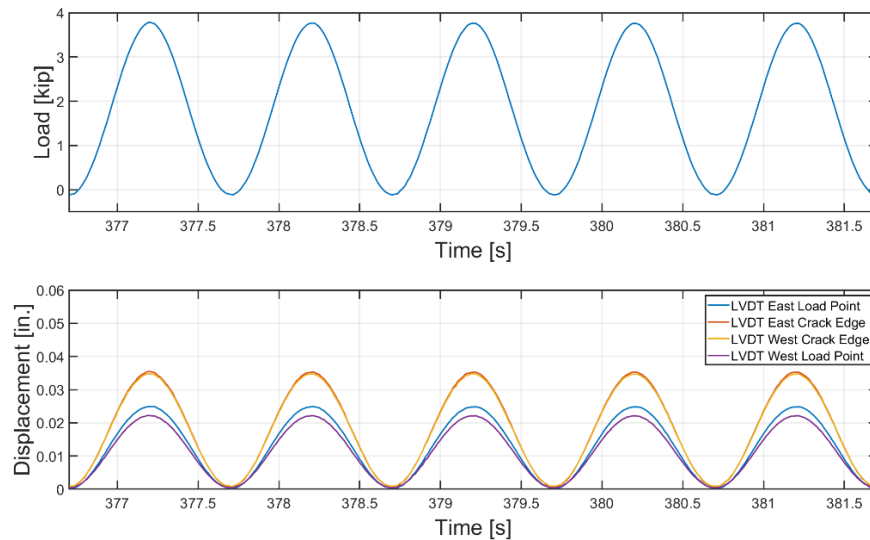
Figure 42. C01 traffic cycles, showing load vs. time and LVDT displacements vs. time from the third set of traffic cycles of C01

Load-time and LVDT displacement-time data are shown for early traffic cycles in Figure 42. The load levels are similar to traffic loading in C01. Nearly 600,000 traffic cycles were applied to C01 in the course of its evaluation.

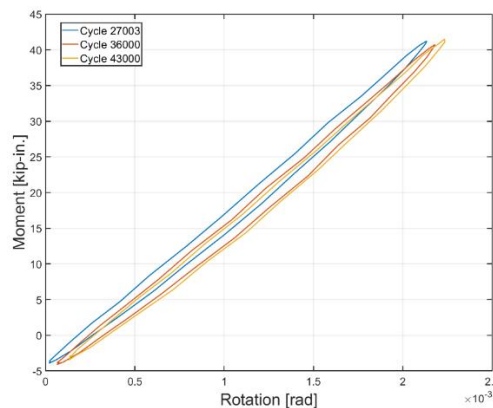
Figure 43. Measured moment global rotation curves from a single block of traffic loading for C01 (within block cycle counts are 3, 9000, 16000)

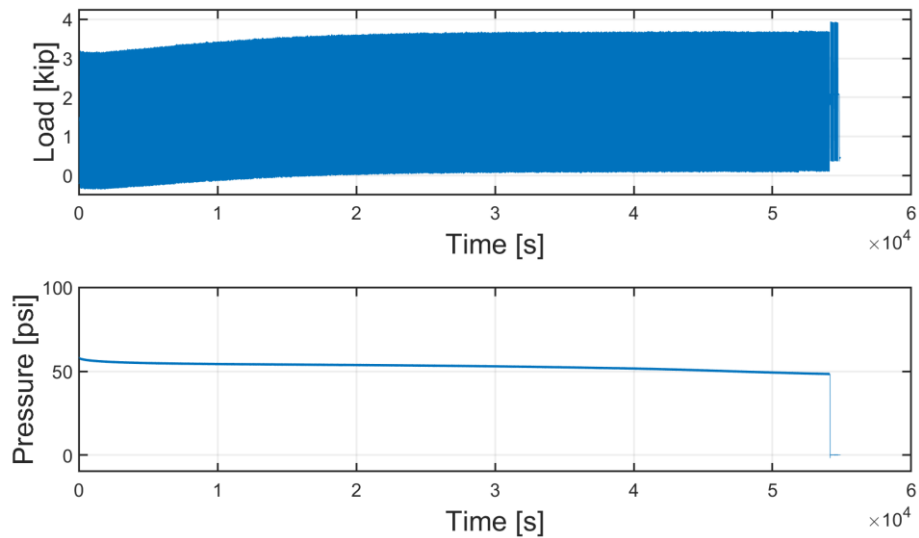
Figure 44. Load and pressure vs. time for C01

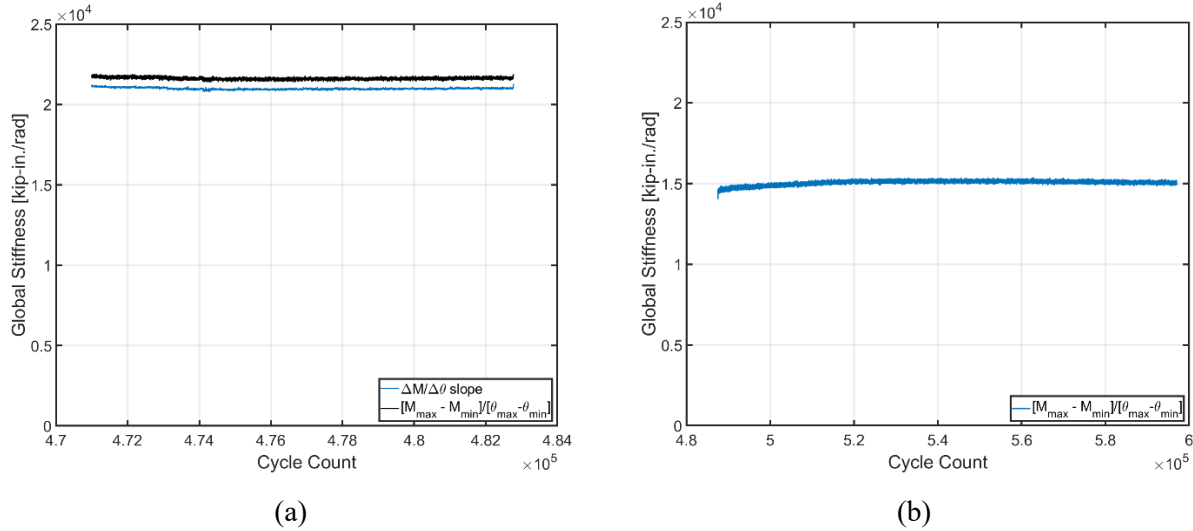
Figure 49. Stiffness vs. cycle count for C01, (a) before the parallel excavation event, (b) after the parallel excavation event

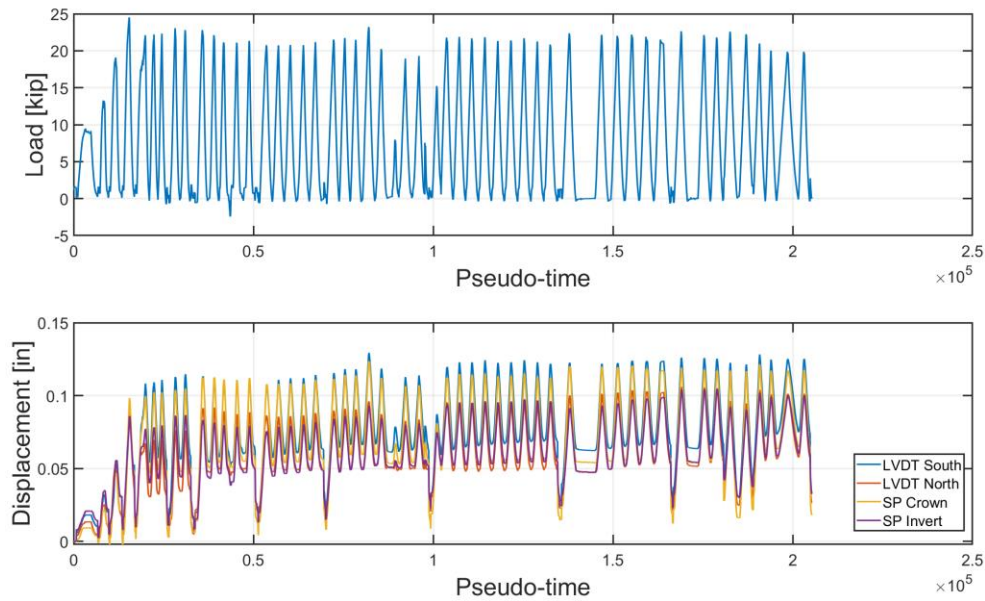
Figure 50. Load and CODs in axial cycling for C01

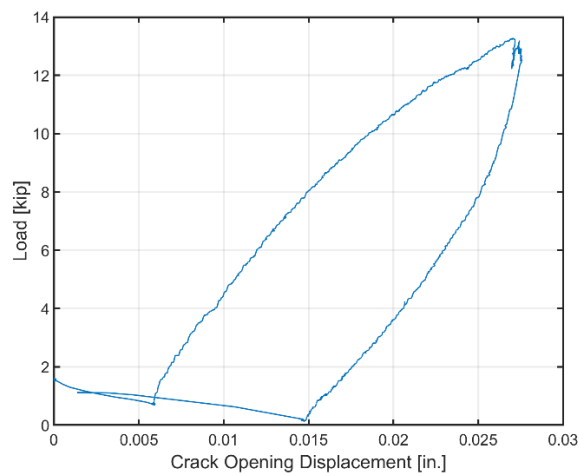
Figure 51. Early axial cycle, load vs. COD for C01

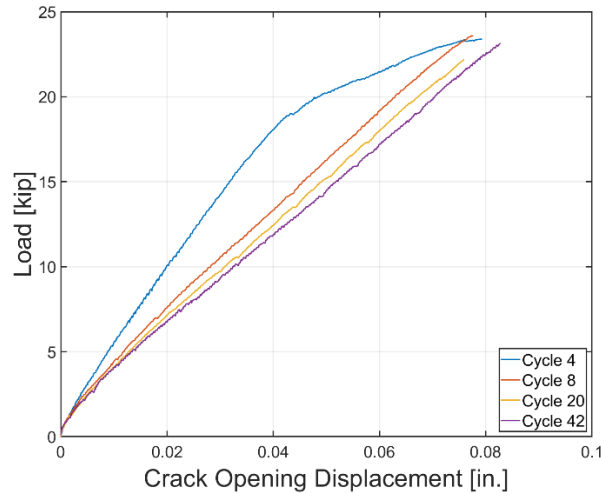
Figure 54. Initial axial loading cycles of C01 showing the first cycle

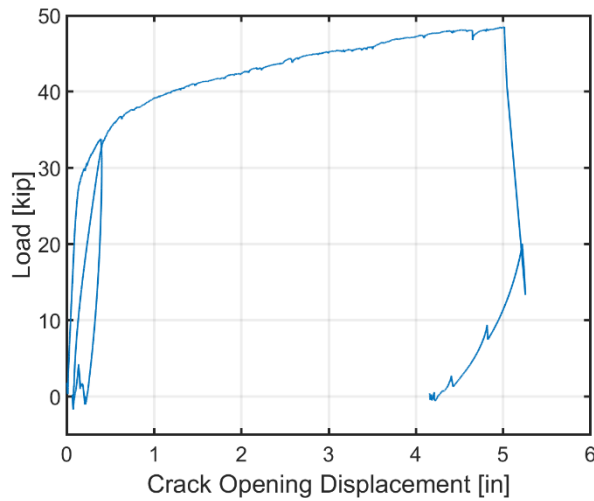
Figure 55. Load vs. COD: pull to failure inclusive of initial cycle of 0.4 in. (25.4 mm) displacement for C01

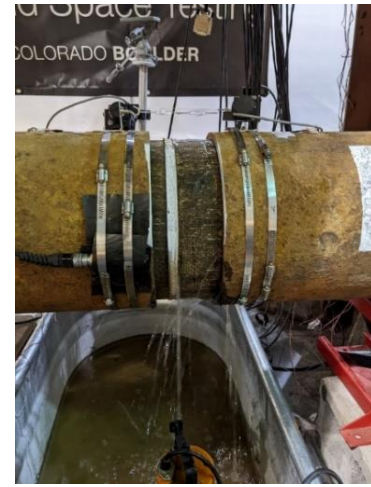
Figure 56. The gap opening in the failed specimen for C01

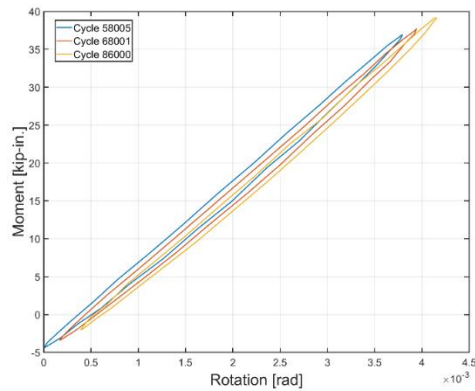
Figure 58. Measured moment vs. global rotation curves from a single block of traffic loading for S02

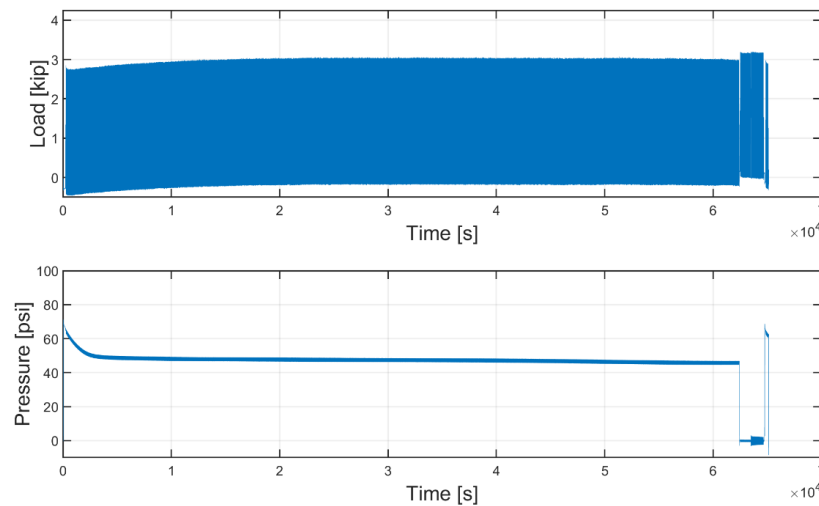
Figure 59. Load and pressure vs. time for S02

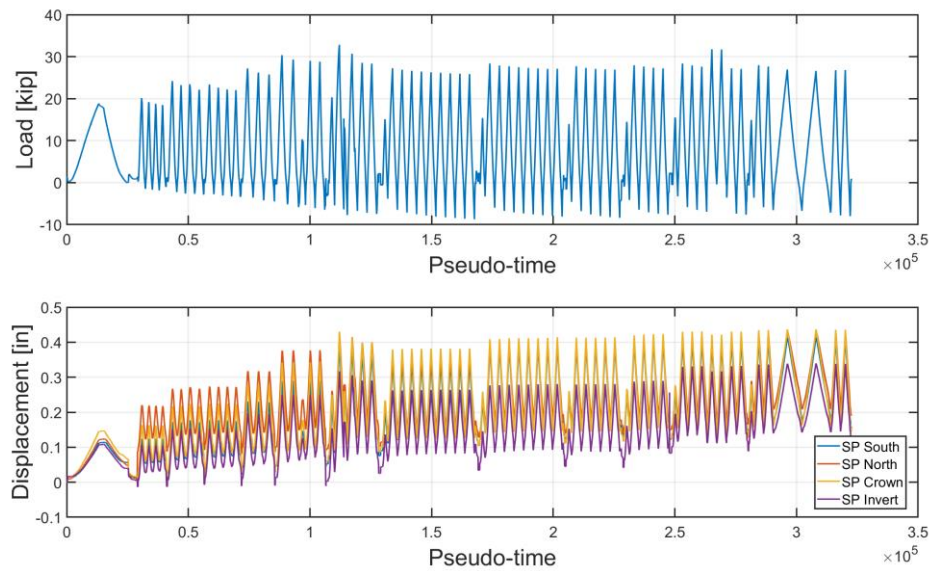
Figure 66. Load and CODs in axial cycling for S02

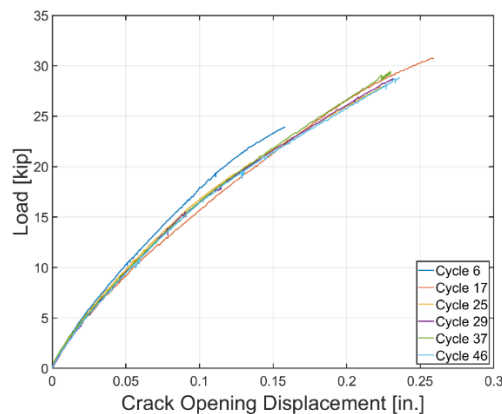
Figure 72. Select axial cycles of S02 showing loading portions

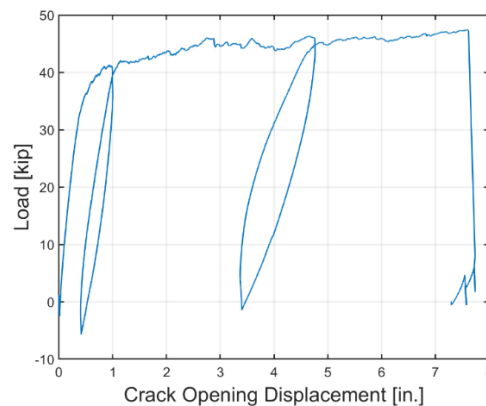
Figure 73. Large axial pulls of S02, load vs. COD

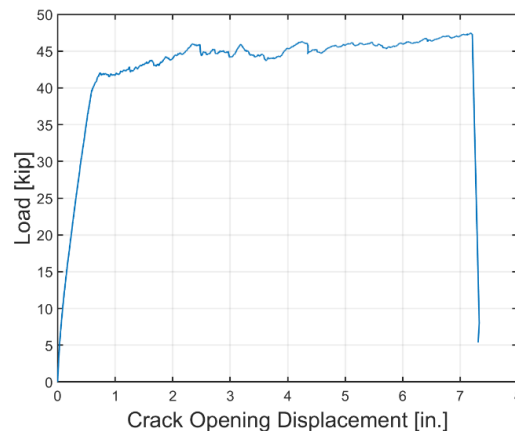
Figure 74. Pull to failure of S02, load vs. COD

The pull to failure, now zeroed from the start of this pull and with the unloading and reloading for string pot detachment removed is shown in Figure 74.

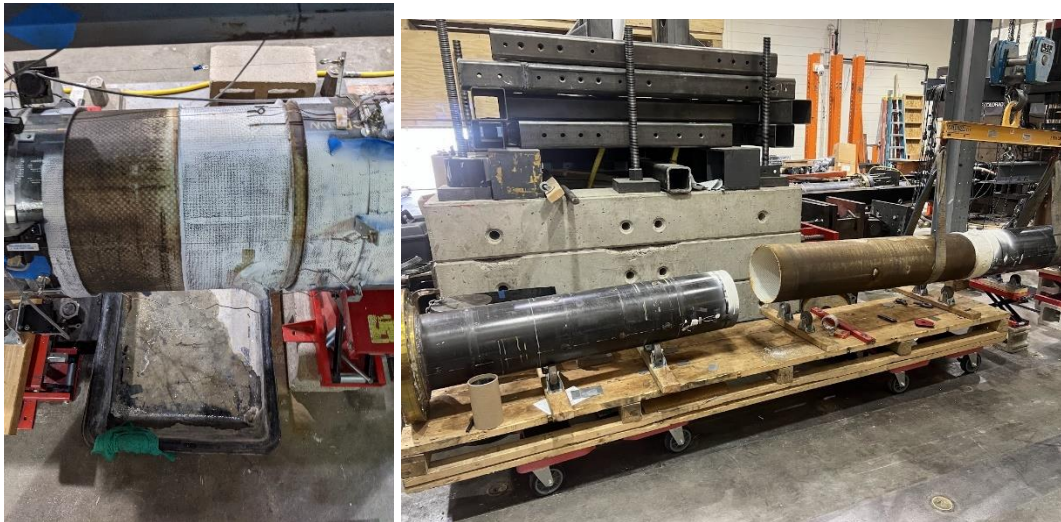
Figure 75. Image of (a) gap opening after S02 pull to failure and (b) removal of liner from host pipe after test

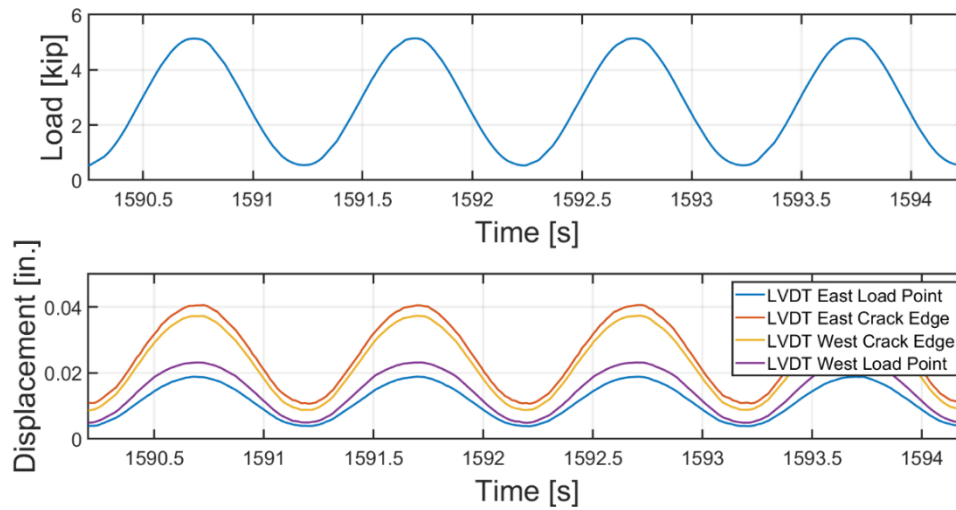
Figure 78. Measured load and LVDT displacements for four cycles against time

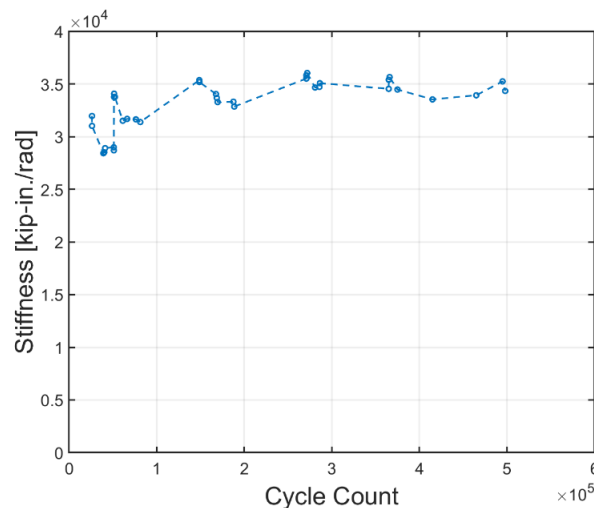
Figure 81. Stiffness measured from moment vs. rotation responses of traffic cycles prior to the adjacent excavation

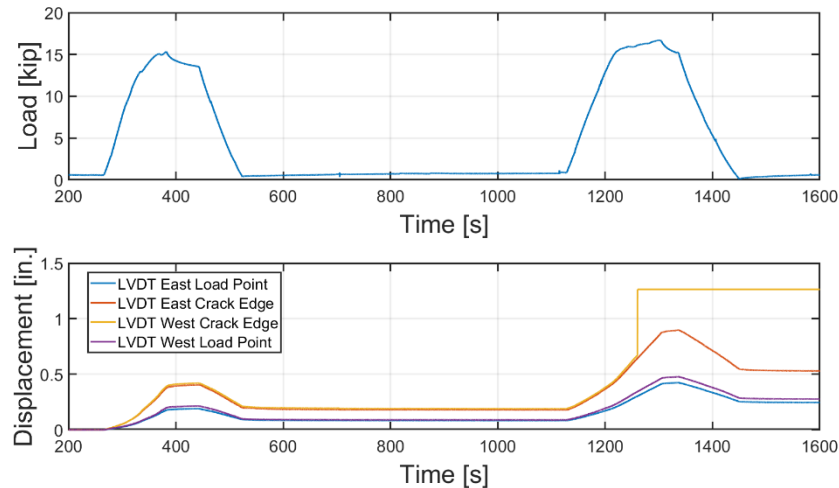
Figure 82. load and LVDT displacements against time in the parallel excavation bend testing

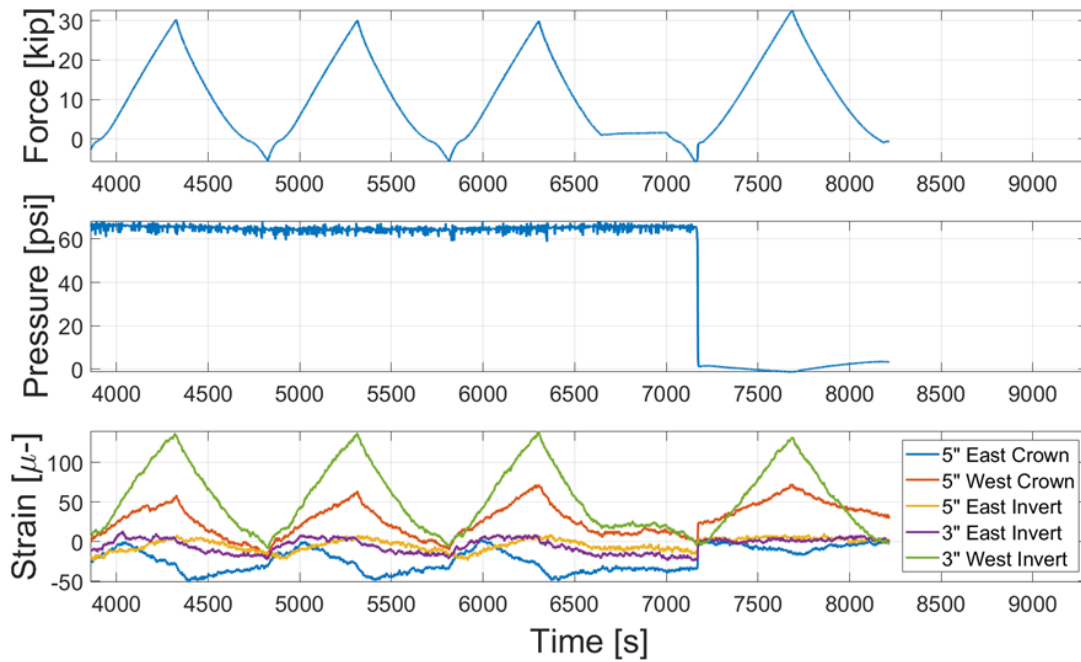
Figure 87. Axial force, pressure, and strain against time for axial cycles 8 to 14
