Service Life Assessment of Internal Replacement Pipe: External Load Testing of AQUA-PIPE™

Final Report

**DOE/ARPA-E REPAIR
COREAQUA**

November 2024

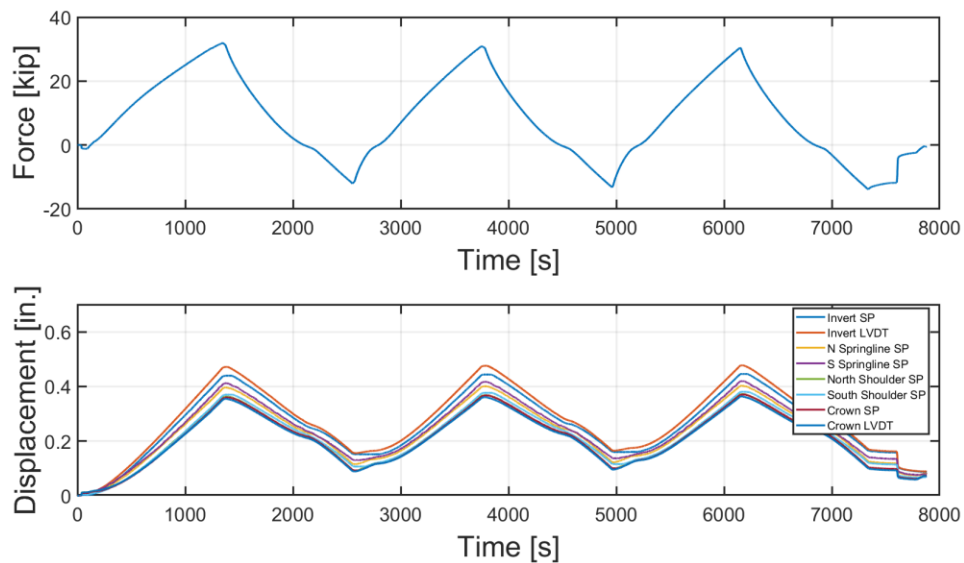
Figure 89. Load (a) and COD measures (b) against time for mid-procedure axial cycles

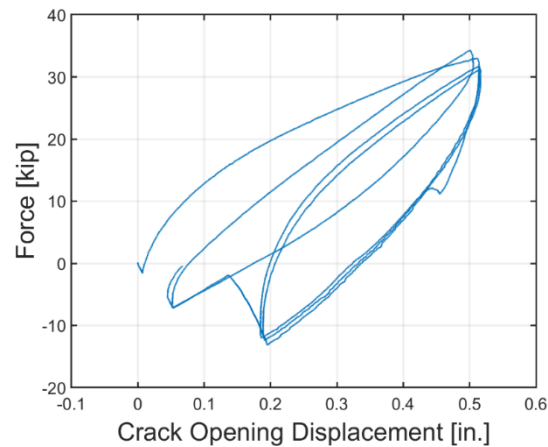
Figure 90. Later S03 axial cycles: force vs. COD

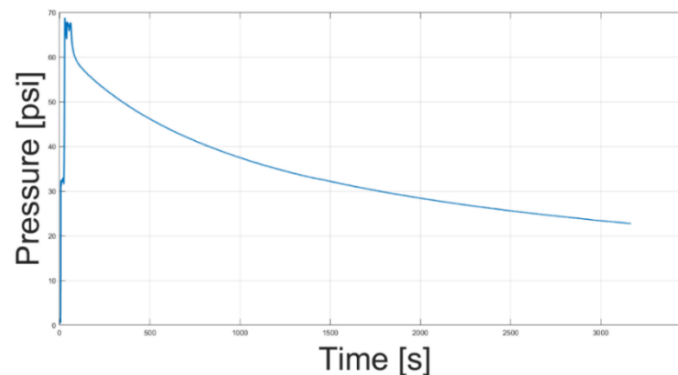
Figure 91. Pressure (Dead) vs. time after leak observed post 38th axial cycle

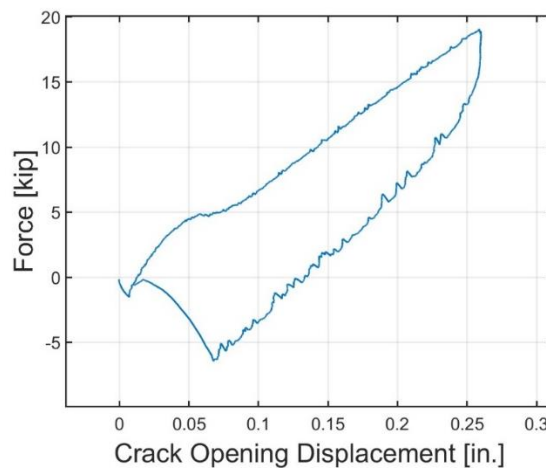
Figure 92. Force vs. COD for 50th axial cycle

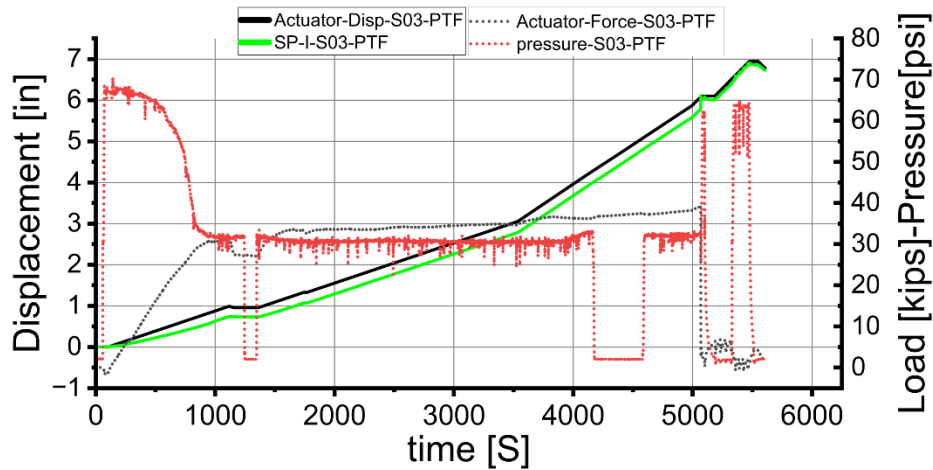
Figure 93. Crack Opening Displacement (COD)-Force vs. Pseudotime for large axial pull of S03 specimen.

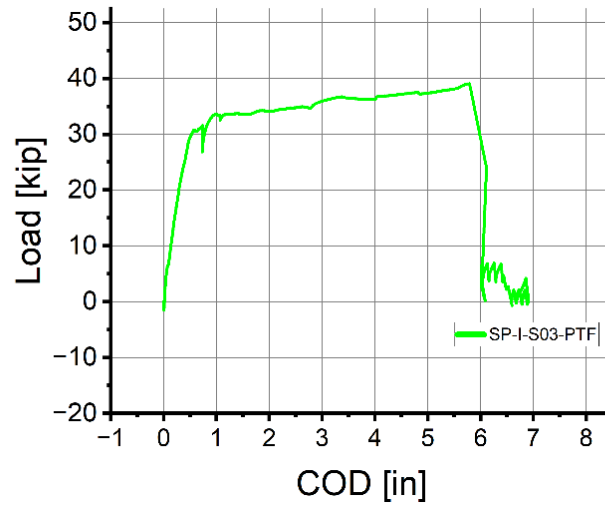
Figure 94. S03 force vs COD for pull to failure

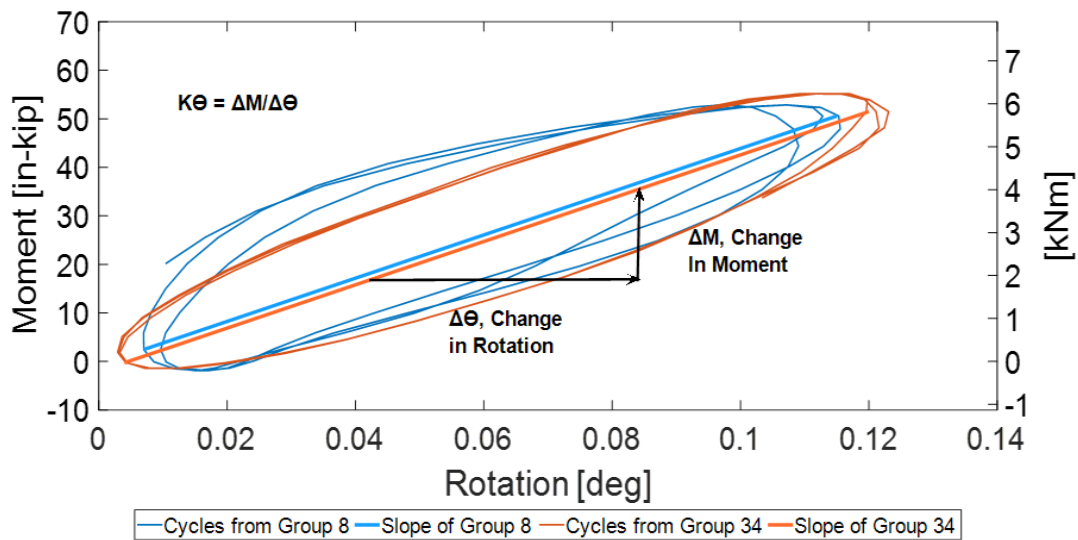
Figure 97. Typical moment vs rotation and definition of rotational stiffness, k_{θ}

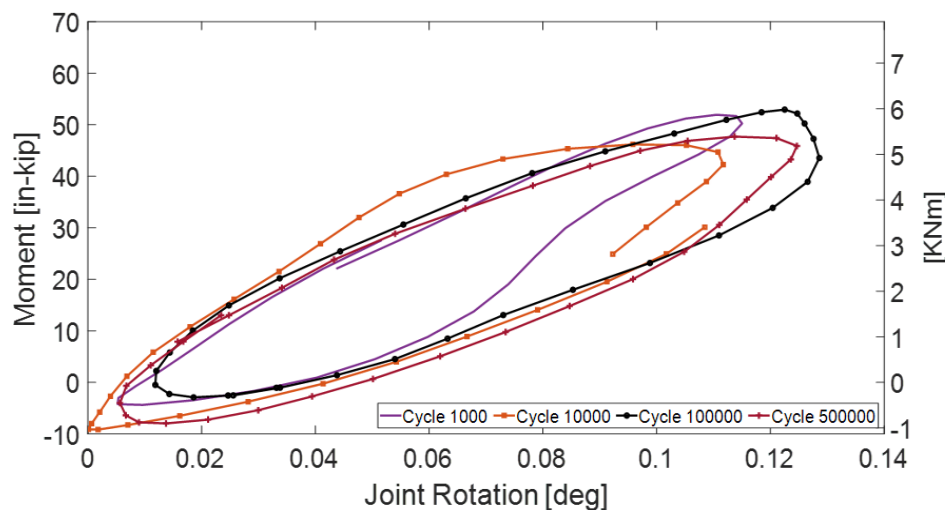
Figure 98. Moment vs rotation for various cycles of traffic load

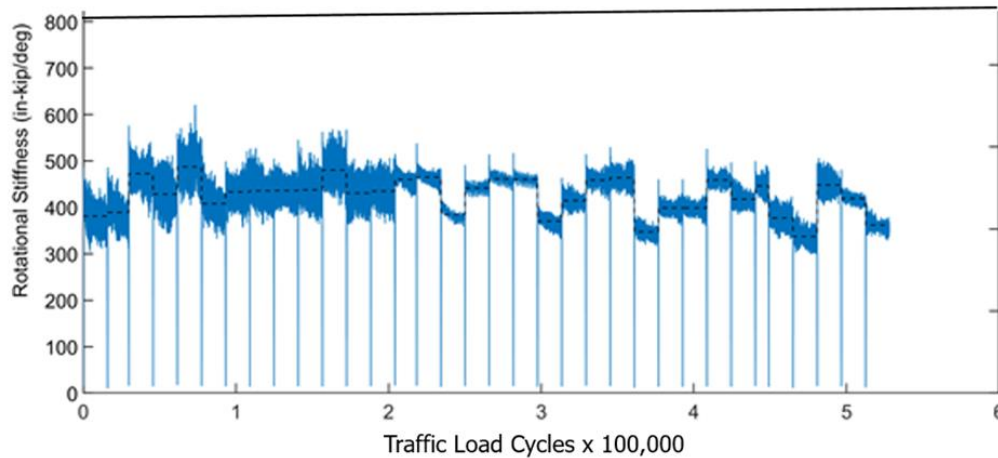
Figure 99. Rotational stiffness relative to number of cycles of traffic load

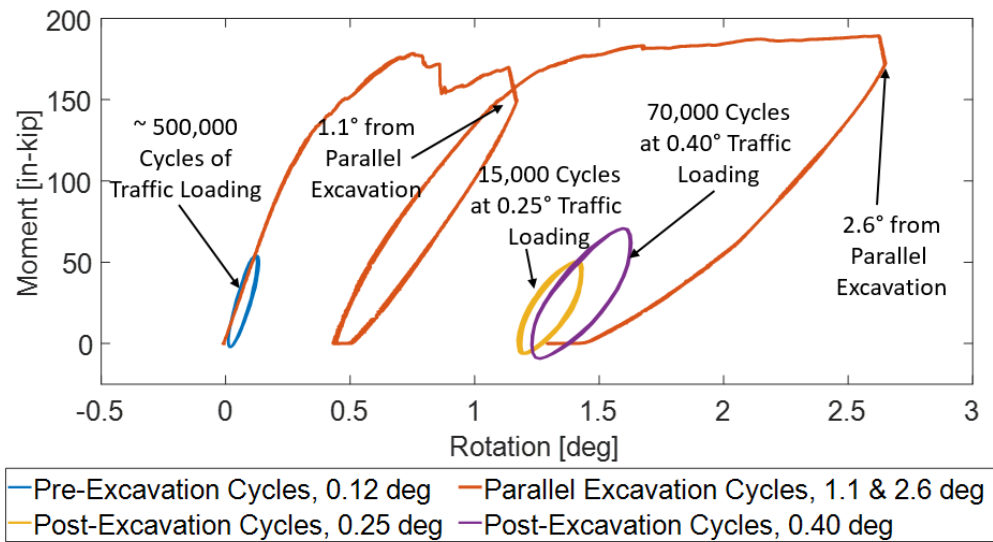
Figure 100. Moment vs. rotation of pre-excitation cycles for 0.18 degrees rotation, parallel excavation cycles for 1.1 and 2.6 degrees rotation and post excavation cycles for 0.25 and 0.40 degrees rotation

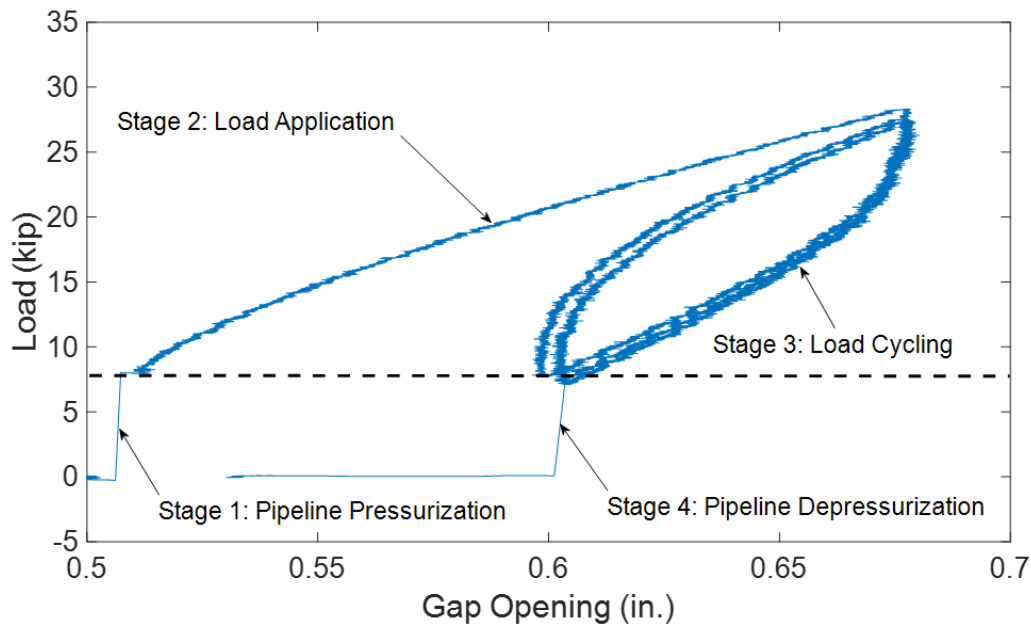
Figure 101. Typical axial load vs gap opening including pipeline pressurization and depressurization

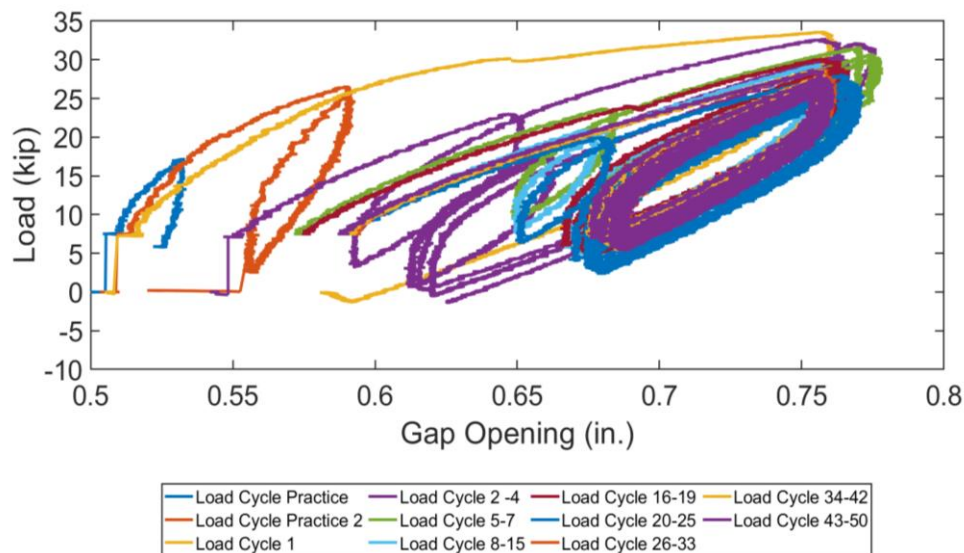
Figure 102. Load vs gap opening for various load cycles

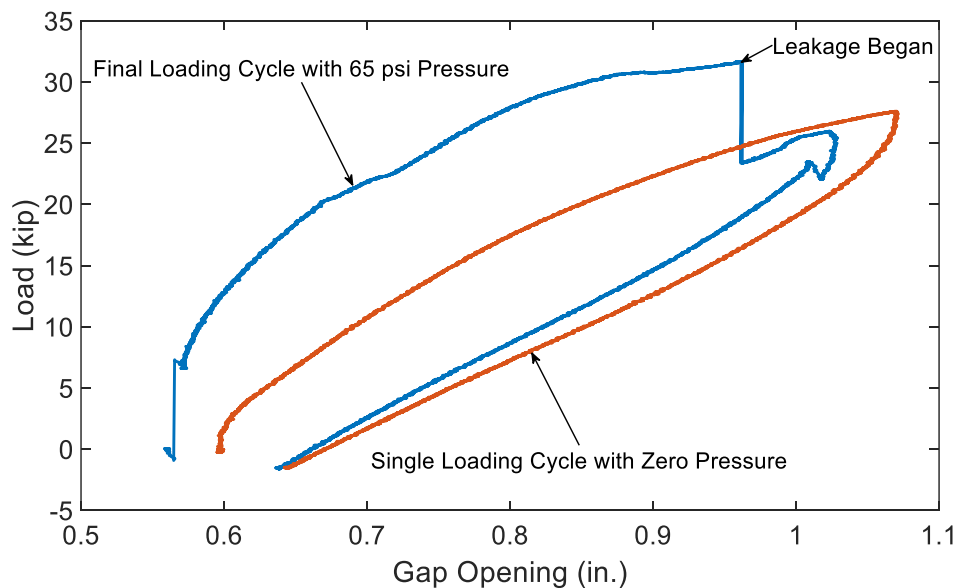
Figure 103. Final loading cycle with pressure and single loading cycle with zero pressure

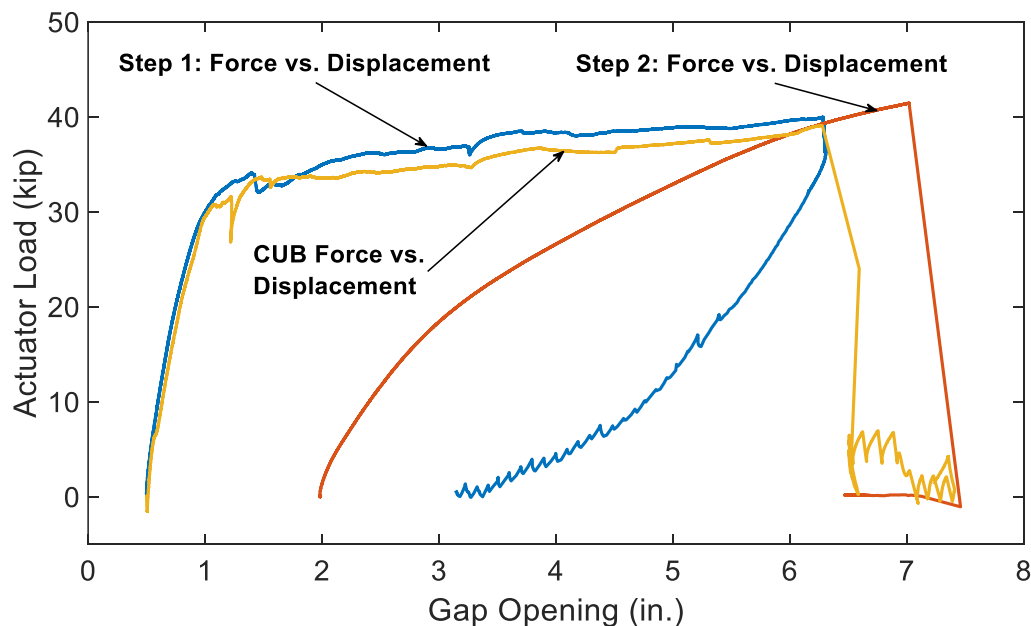
Figure 104. Actuator load vs gap opening

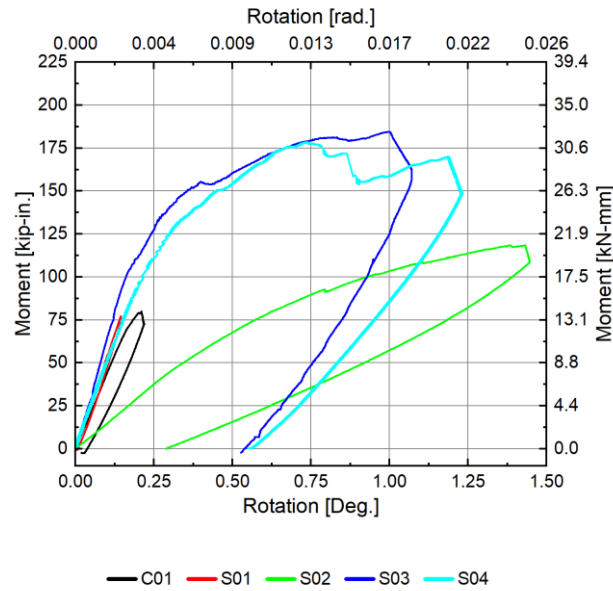
Figure 105. Moment vs. rotation results for small adjacent excavation events for each specimen

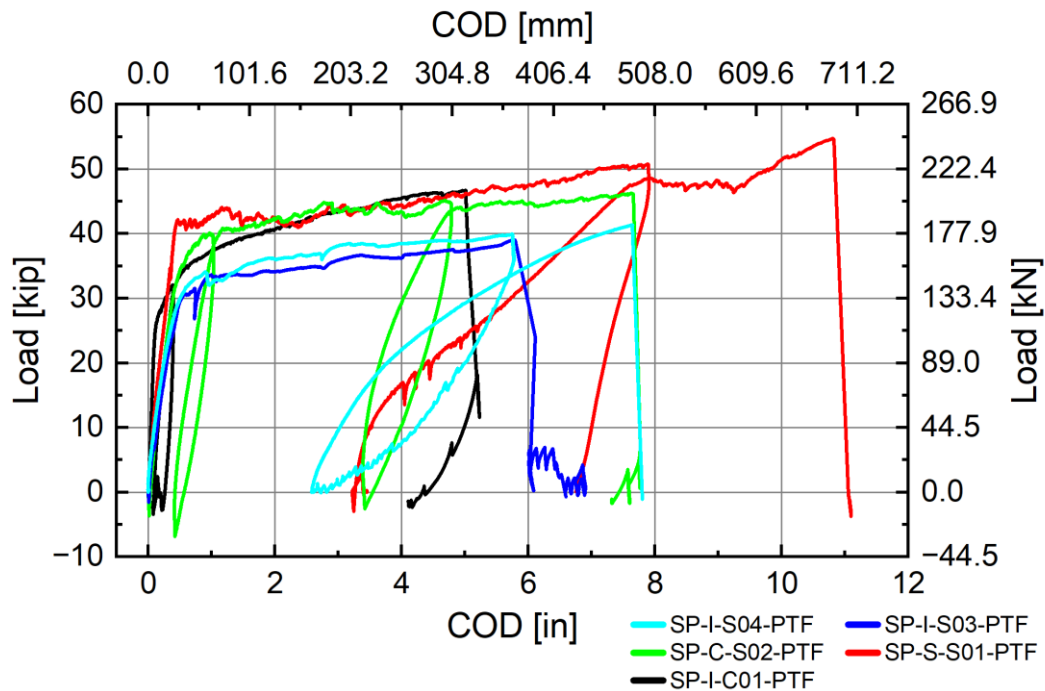
Figure 107. Pull to failure comparison for all specimens

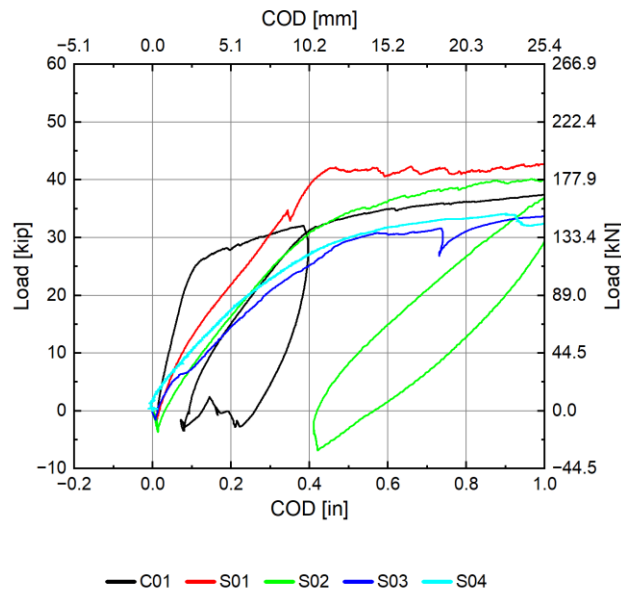
Figure 108. Pull to failure comparison for all specimens magnified at initial loading

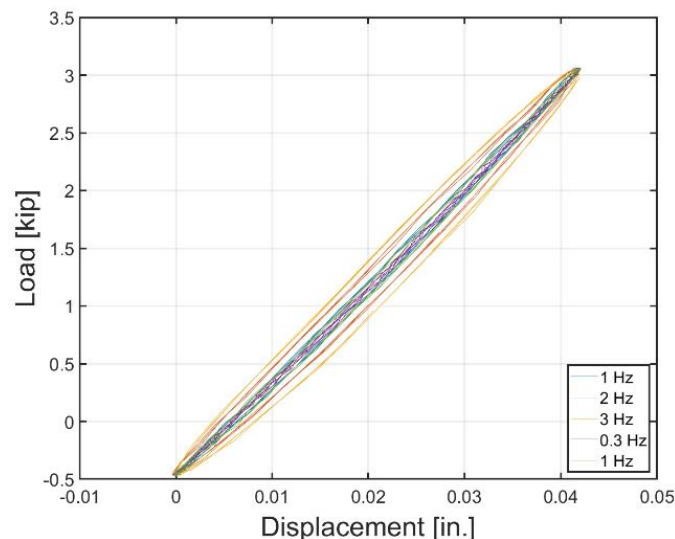
Figure 109. Load and displacement at various frequencies for S01

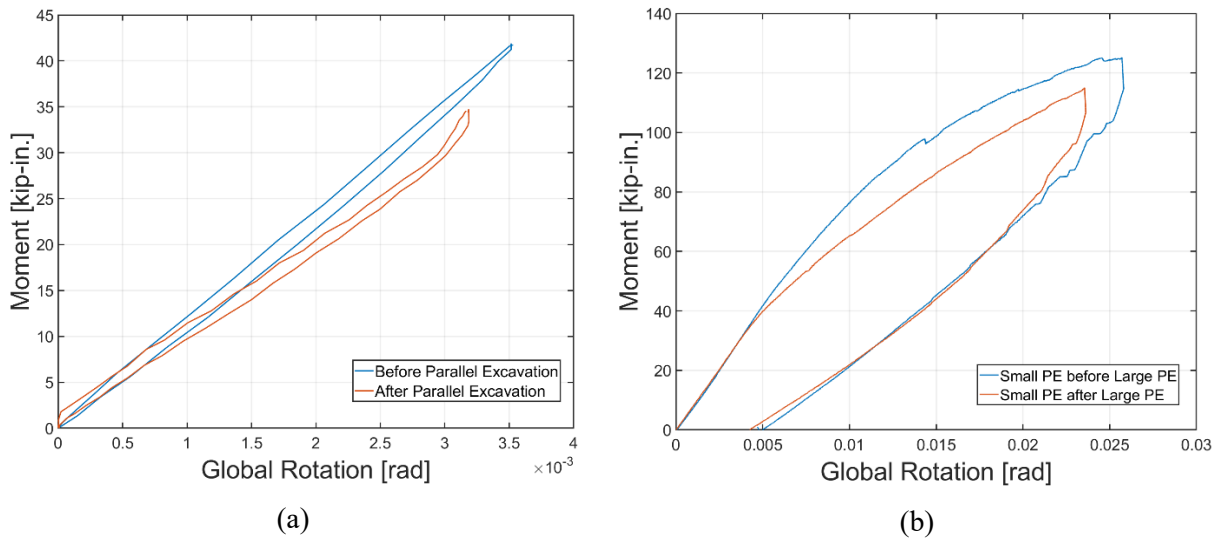
Figure 112. S02 moment vs. rotation curves before and after the large adjacent excavation of (a) traffic loading cycles and (b) small parallel excavation deformations

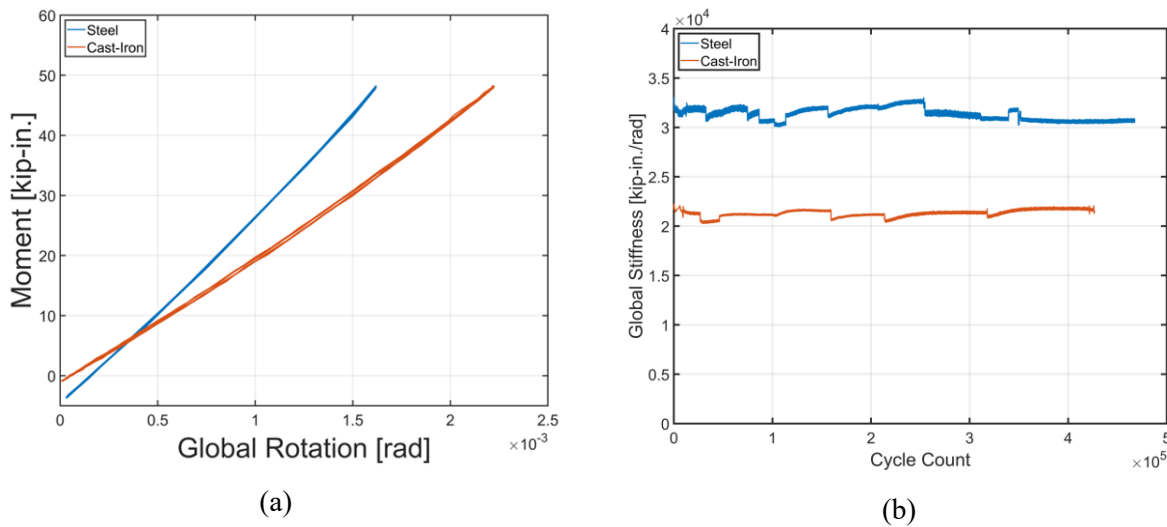
Figure 113. S01 vs. C01 in traffic loading, (a) moment-rotation behavior for the ~5000th traffic cycle (b) stiffness from the traffic loading cycles prior to parallel excavation deformation

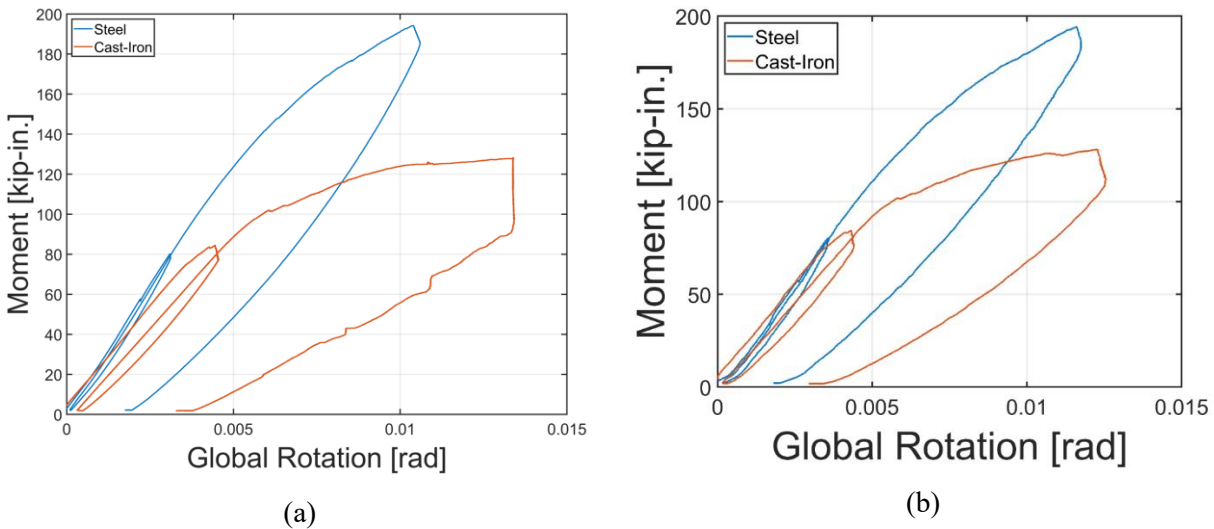
Figure 114. Moment vs. rotation behavior in parallel excavation deformation for S01 and C01, (a) rotation from LVDT measures (b) rotation from SP measures

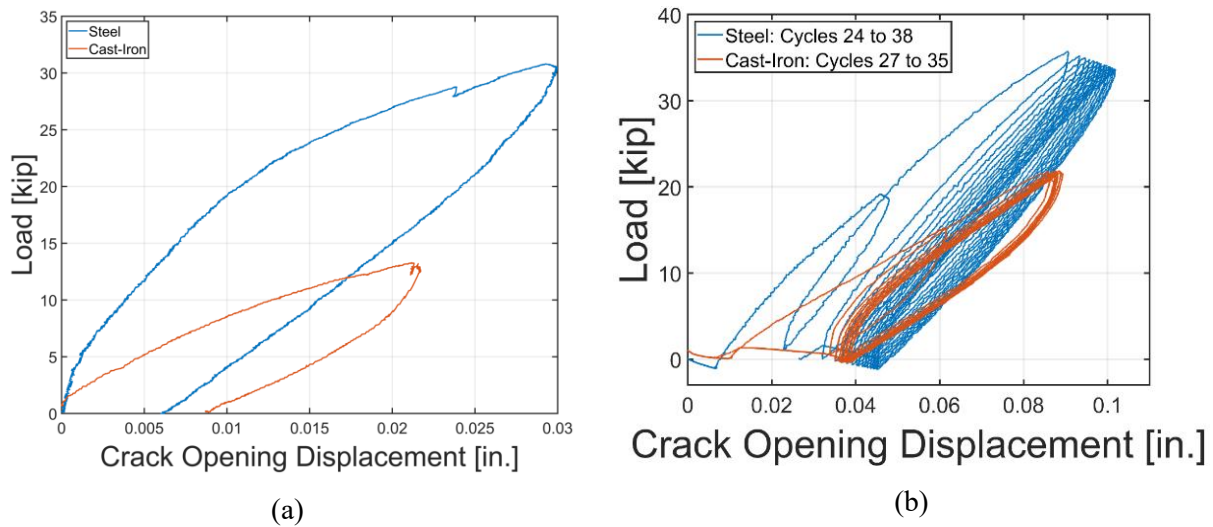
Figure 115. Axial behavior comparison of S01 and C01, (a) second axial cycles, (b) typical axial cycles in testing

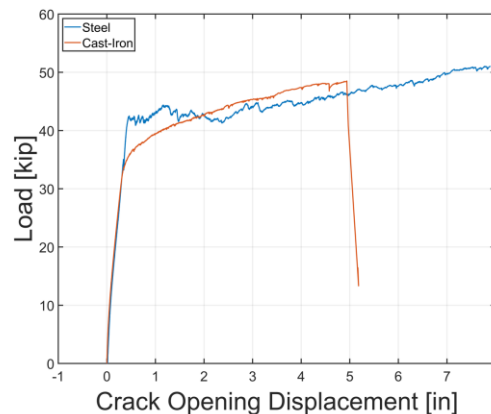
Figure 116. First large axial pull of S01 (attempt to pull to failure) and pull to failure of C01 (x-axis begins below 0 in. for ease in viewing slopes on large x-axis scale --- data is zeroed)

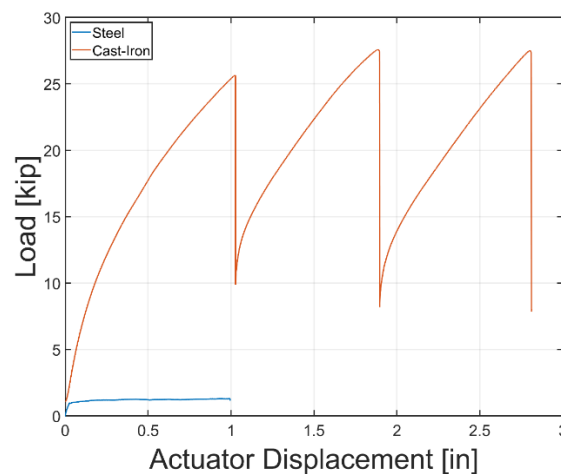
Figure 117. Post-failure tension without pressure for S01 and C01
