# Seismic Evaluation of Hazard-Resistant Pipelines: PVC, PVCO, and iPVC Pipe with Coupling

## Axial Testing Report

Timothy Harris & David Katzev  
East Bay Municipal Utility District

December 2019

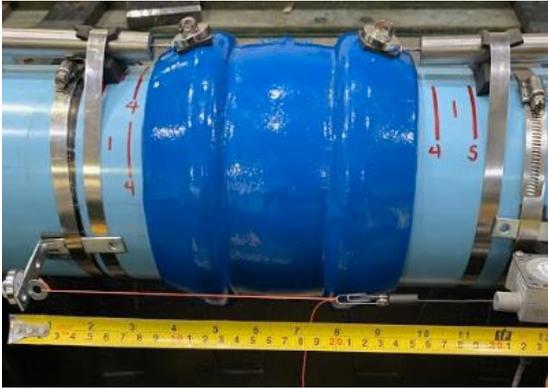
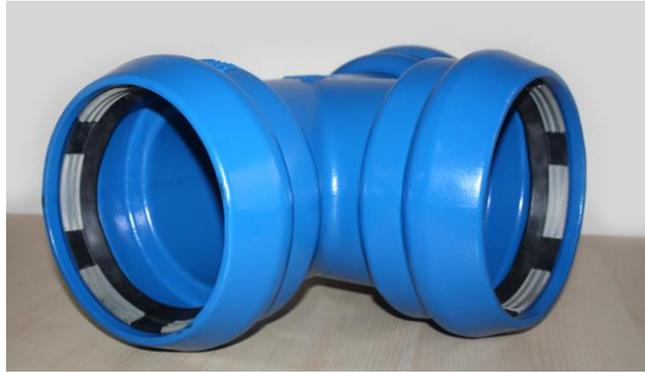
Figure 1.1. Examples of the RCT Flex-Tite (a) coupling and (b) tee

Pipe specimens consisted of AWWA C900 polyvinyl chloride (PVC) (AWWA, 2007), AWWA C900 iPVC (AWWA, 2007), and AWWA C909 molecularly oriented polyvinyl chloride (PVCO) (AWWA, 2016). The connection under investigation is the RCT Flex-Tite coupling which is a self-restraining fitting with an integrated restraining gasket constructed primarily of ductile iron per ASTM A536. Flex-Tite fittings are pressure rated to 350 psi and available in a variety of tees, bends, and reducers, an example of which is provided in Figure 1.1. This program specifically examines the straight coupling and the results are intended to be representative of the connection between pipe and restrained gasket connection for any 150-mm (6-in.) diameter fitting configuration.

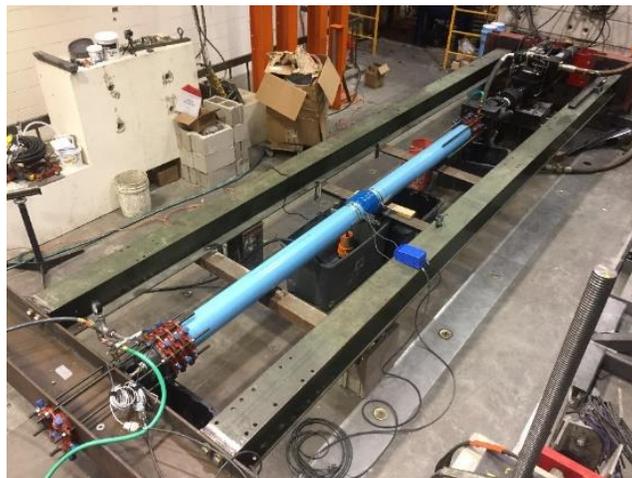
Figure 2.1. Pipe specimen in axial test frame

This section outlines the test setup procedure for axial loading of a given pipe specimen. Figure 2.1 shows an image of the axial tension test setup and equipment. A 255.17 Materials Testing System (MTS) actuator, 110-kip load cell, and load frame were used to apply tensile and compressive load to the test specimen (Figure 2.2). The test specimens consisted of nominal 6 in (150 mm) diameter pipe with coupling.

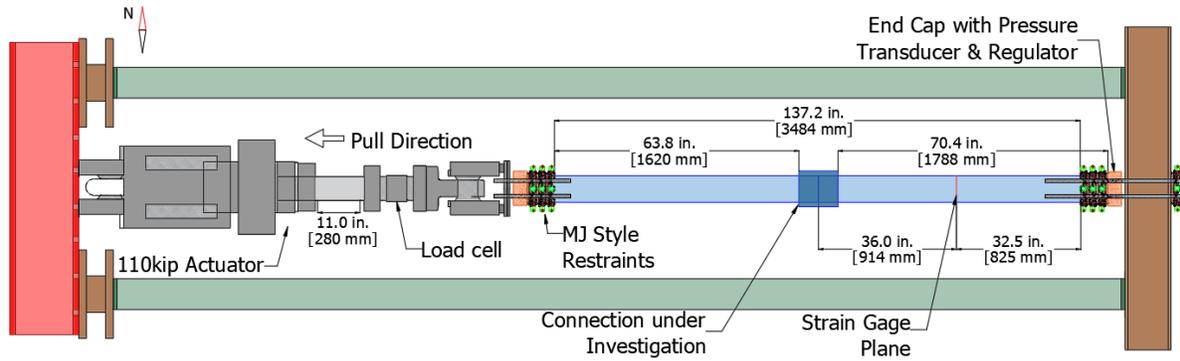
Figure 2.2. Dimensioned drawing of axial test setup

A level and crowning tool are used to identify the top (crown), bottom (invert), and spring lines of the pipe (Figure 2.4). Strain gauge planes are marked at approximately 36 in (910 mm) from either side of the specimen center line, as shown in Figure 2.2.

A total of eight strain gauges are fixed to the exterior of the specimen at one of two planes, designated as SG+36 and SG-36, as shown in Figure 2.2. The plane locations are positioned approximately halfway between the joint restraint (specimen centerline) and gripping restraints. At either plane, the strain gauges are placed at the crown, east springline, invert, and west springline. Gauge plane SG+36 is positioned 36

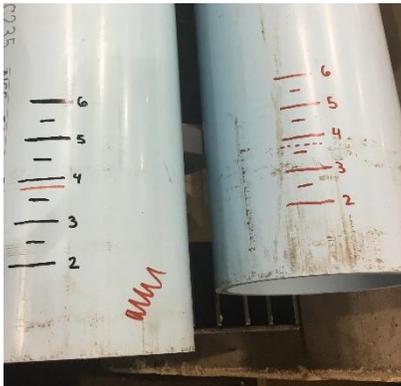
Figure 2.3. Marked measurements on non-cut ends of the pipe.

The pipe specimen is prepared at a length of approximately 13 ft (4 m) for tensile testing (two 78-in. (1980-mm) segments). The length varies depending on the loading direction (tension or compression) and coupling or joint under investigation. The pipe was cut using standard field installation practices outlined in appendix B. Measurements are provided at 0.5 in (13 mm) increments on the factory prepared pipe ends, which are inserted into the coupling or joint, as shown in Figure 2.3.

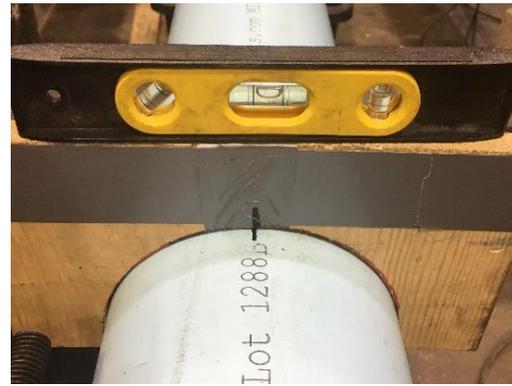
Figure 2.4. Identifying the pipe coordinates (crown, invert, springlines)

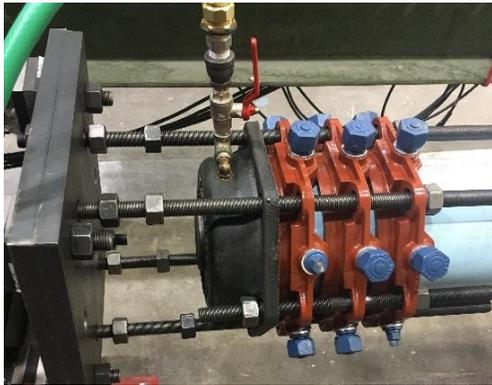
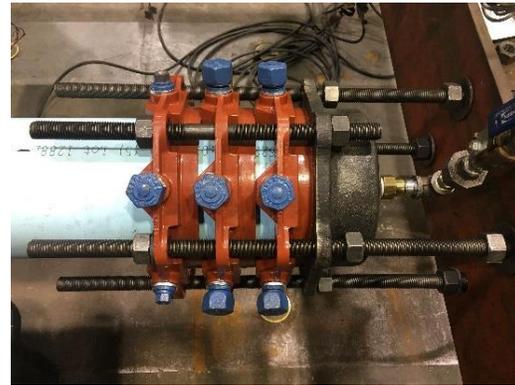
(a) Loading (west) end

(b) Fixed (east) end

Figure 2.5. Pipe connections to loading frame

Three (3) 2006PV Megalug restraints are used at either end of the specimen to transfer the externally applied axial load. Figure 2.5 shows the restraints positioned at the loading (west) end and fixed (east) end of the specimen. The outer-most restraint for each end is aligned 2 in. (50 mm) from the end pipe and hand tightened into place. Each set of restraints are aligned with their respective end loading arrangements. The east side, fixed to the load frame, is positioned with a threaded rod located at the crown of the specimen, and the west side (actuator or loading side) is aligned with restraint nuts located at the crown. Two short threaded rods are used to pull the remaining two restraints into contact with the first, as shown in Figure

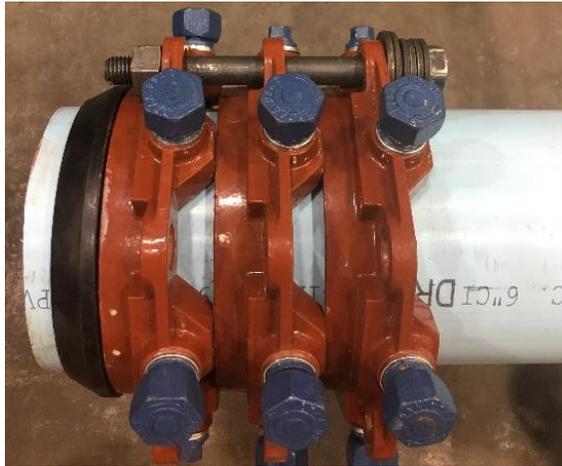
Figure 2.6. Megalug restraints on “cut” ends of pipe

2.6, two provide a composite 3-restraint end condition. The clamping nuts of the remaining Megalugs are then hand tightened into place.

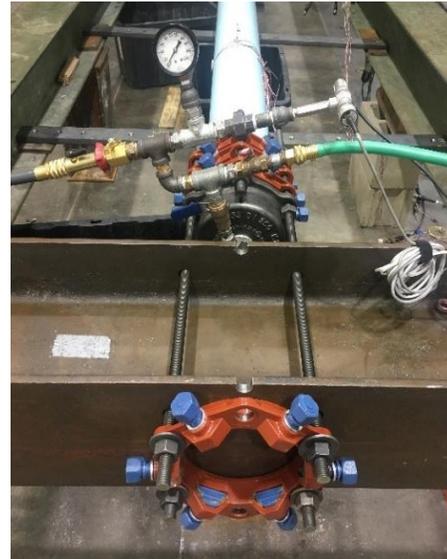
Figure 2.7. Fixed end (east) with water intake and pressure valve

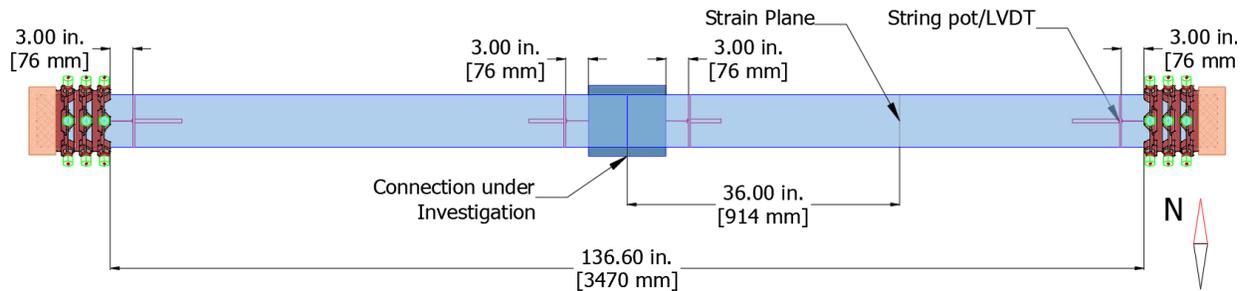
Figure 2.8. Specimen instrumentation

Figure 2.8 shows a plan view of the tension test setup and key instrumentation. Four string potentiometers (string pots) or Linearly Varying Differential Transducers (LVDTs) were attached to the specimen at several locations to measure axial displacements. A string pot/LVDT is used at each end of the specimen to measure relative movement between the pipe specimen and end restraints. Two additional string pots/LVDTs were installed at the center of the specimen to measure localized relative displacement between the pipe and coupling. An electronic pressure transducer is installed on the east end to measure internal water pressure during the test.

in. (910 mm) east of the specimen centerline and includes four x-y gauges, oriented in the axial and circumferential direction. Plane SG-36 was positioned 36 in. (910 mm) west of the specimen centerline and includes two x-y pairs located at the specimen springlines.

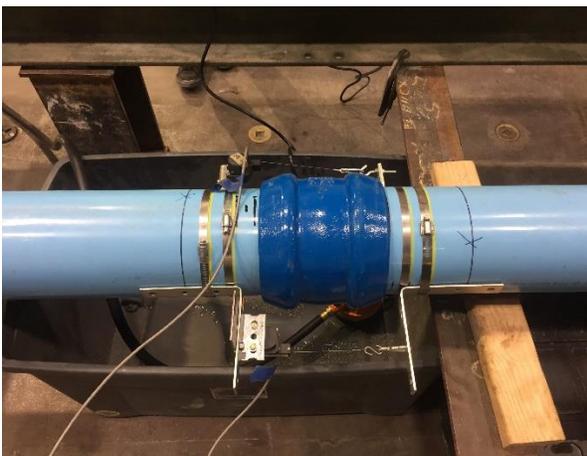
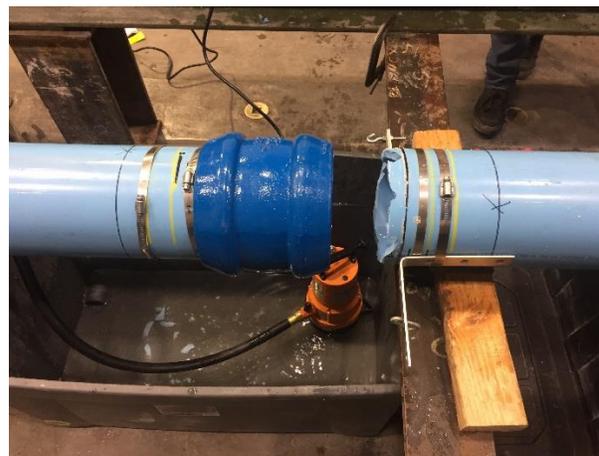
Figure 3.1. Specimen PT01 (a) before and (b) after axial tension test

The first axial tension test consisted of iPVC pipe with an RCT coupling at the midpoint. Figure 3.1 shows photos taken before the test and after specimen failure. As shown by the blue line in Figure 3.2, internal pressure for PT01 ranged between 0 and 7 psi (0 – 48 kPa), representing negligible water pressure. Figure 3.2 also shows actuator force and displacement relative to time during the test. The internal pressure fluctuation is a function of the increasing internal volume during applied tensile load and the pressure regulator's inefficiency at sustaining low levels of pressure. Note that pressure regulator performance was improved in subsequent tests and had negligible impact on PT01 test results.

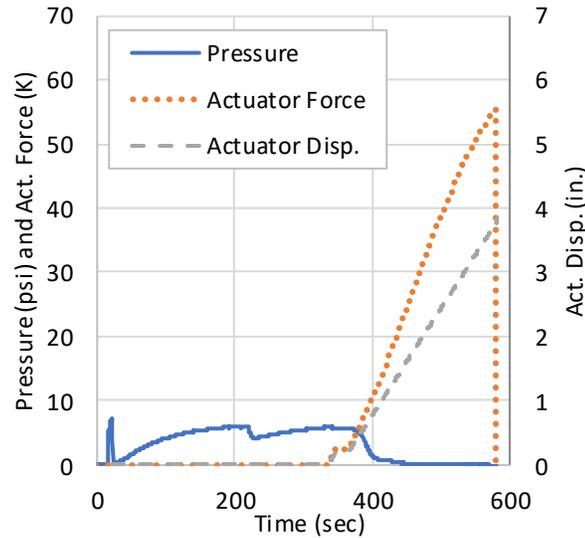
Figure 3.2. PT01 results for internal pressure, actuator displacement and axial force vs. time

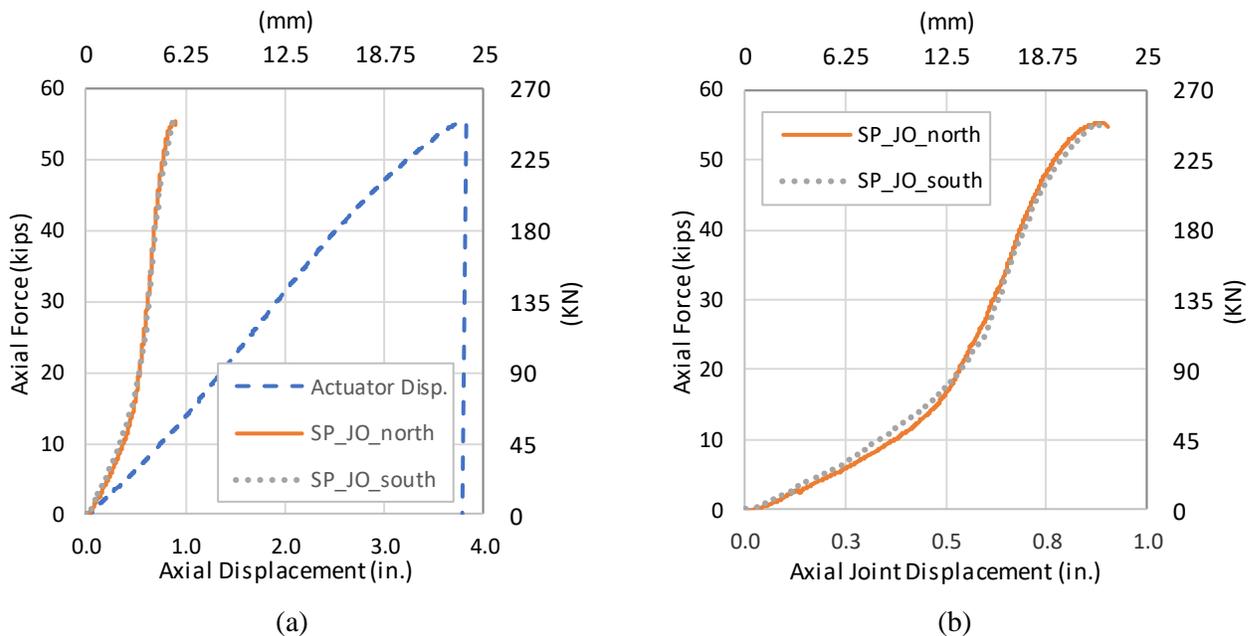
Figure 3.3. Specimen PT01 actuator force vs. (a) measured axial displacements and (b) total joint displacement at north and south springline string pots

Force vs. displacement plots of PT01 are provided in Figure 3.3 (a) and (b). The difference in displacement between the imposed actuator displacement and measured joint opening represents the stretch in the pipe combined with additional sources of slip and movement at either end restraint. The measurements of joint opening provide a localized representation of the relative movement between the coupling and pipe. Strain gages were not employed for this first tension test but are included in all subsequent tests. At an actuator displacement of 3.82 in. (97 mm) and an average joint opening of 0.89 in. (23 mm) PT01 reached a maximum axial force of 55.3 kips (246 kN), followed immediately by fracture of the specimen. No leakage or loss of water from the RCT connection was observed prior to ultimate failure. As shown in Figure 3.4,

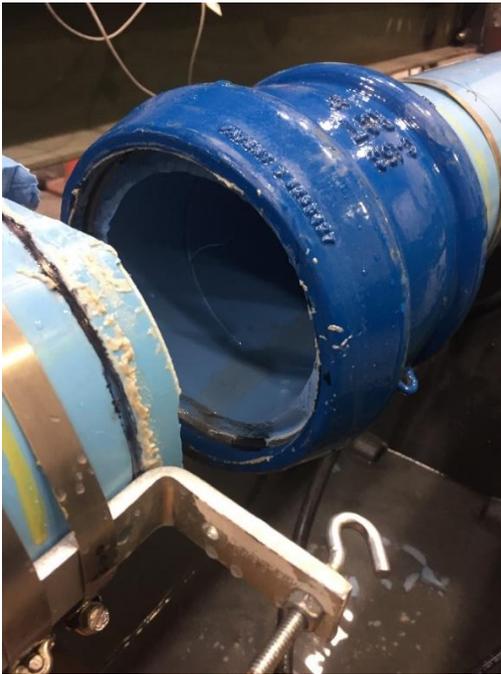
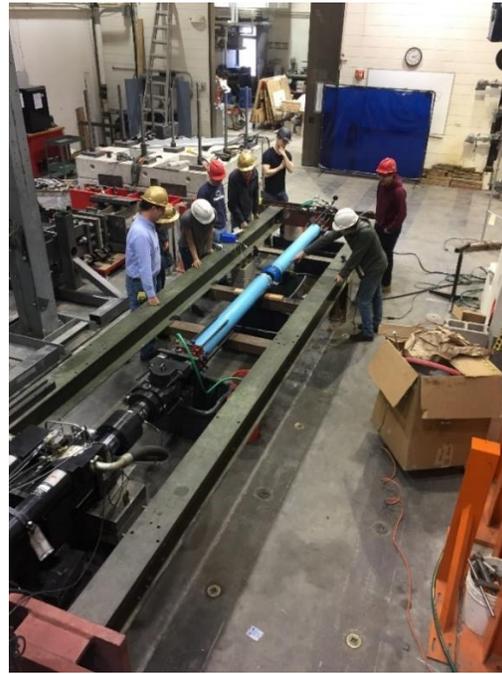
the specimen failed by circumferential fracture at the stress concentrations imposed by the RCT's serrated teeth digging into the pipe wall.

Figure 3.4. Specimen PT01 after failure: (a) circumferential fracture and (b) test overview

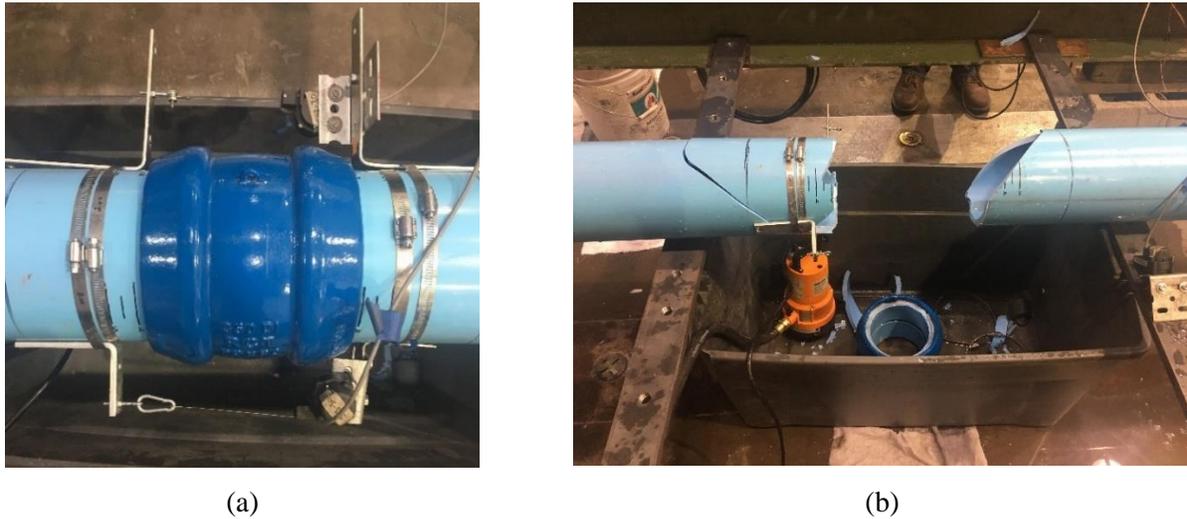
Figure 3.5. Specimen PT02 (a) before and (b) after axial tension test

south springline recorded 0.92 in (23 mm) just before failure. Failure occurred on both sides of the RCT coupling simultaneously, shown in Figure 3.5 (b).

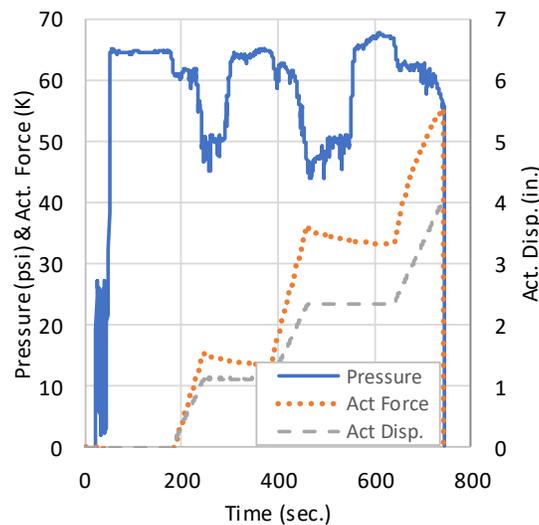
Figure 3.6. PT02 pressure, axial load, and actuator displacement vs. time

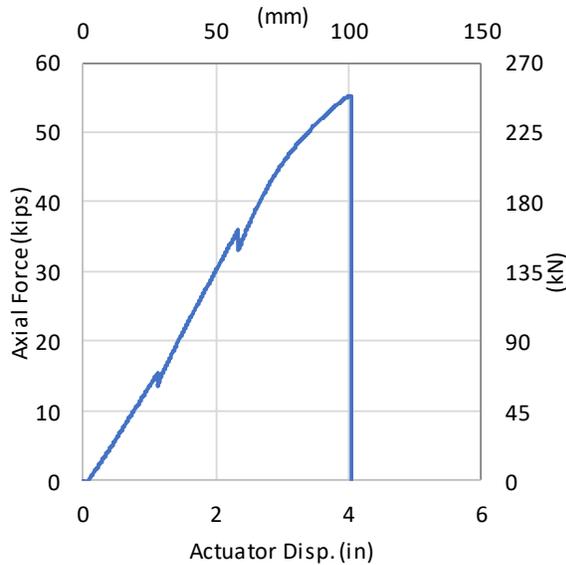
Figure 3.7. PT02 Axial Force vs Actuator Displacement

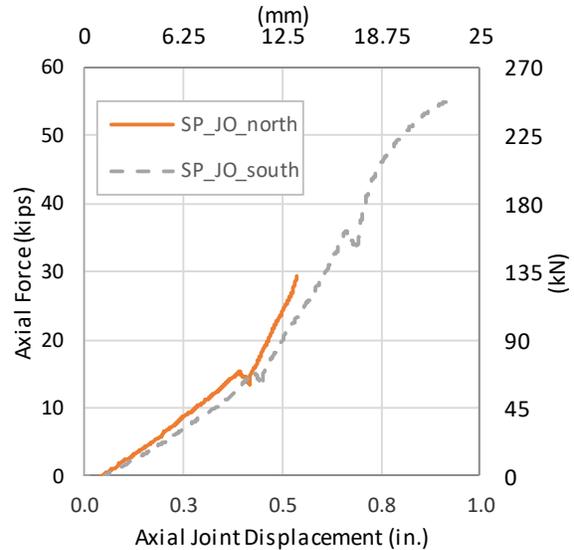
Figure 3.8. PT02 Force vs Joint Displacement

Figure 3.8 shows the actuator force vs. the joint displacement. Joint displacement was measured using two string potentiometers located on the north and south springline, measuring across the RCT coupling, shown in Figure 3.5(a). The north string potentiometer began slipping at about 0.5 in. (12.7 mm) of joint displacement, after which data was unreliable and removed from the figure. The joint displacement on the

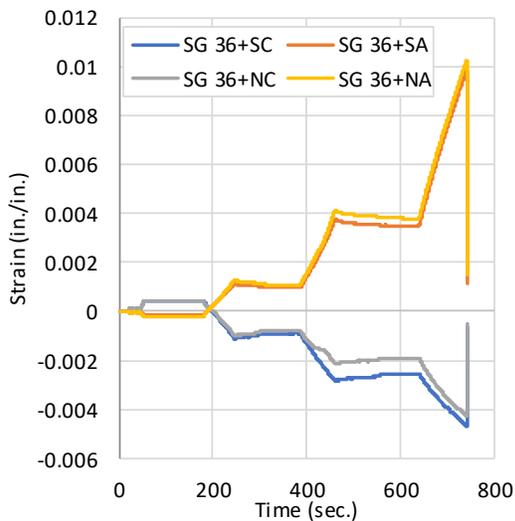
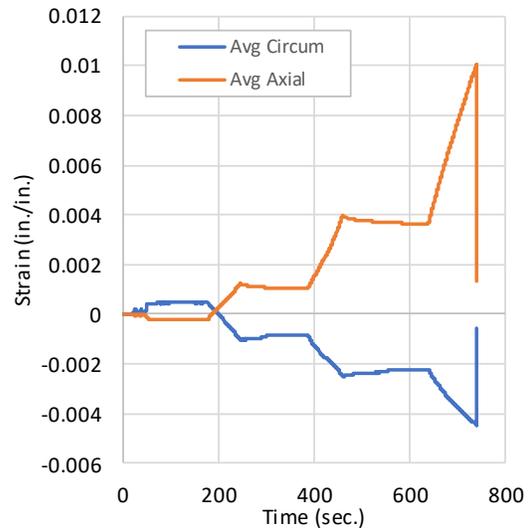
(a) Measured strains vs. time

(b) Average strains vs. time

Figure 3.9. PT02 axial and circumferential strains

Figure 3.9 shows the average axial and circumferential strains for the duration of the test. At a time of about 50 seconds into data acquisition, the system was fully pressurized, and an increase in circumferential strain was observed. Once loading began at about 175 seconds, the circumferential strains began to decrease, while the axial strains increased. As the actuator applied tensile loading to the system, the pipe began to elongate, causing an increase in axial strains. Due to Poisson's effect, the circumferential strain

decreased as tensile load was applied. The magnitude of the measured axial strains shown in Figure 3.9 was determined, after the test was completed, to be inaccurate. A measuring error associated with the axial strain gauge calibration occurred. The authors anticipate the strain gauges to measure approximately 60% greater strain at failure, similar to the results gained from the cyclic test reported in Section 5 of this report. The strains are reported herein to illustrate the trends imposed during the test.

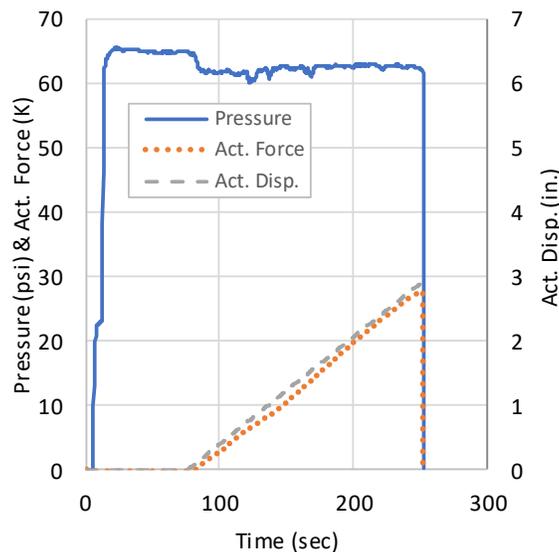
Figure 3.10. Specimen PT05 results for pressure, axial force, and actuator displacement vs. time

Molecularly oriented PVC (PVCO) pipe with an RCT coupling was used for this test. Figure 3.10 shows the relationship between actuator force, internal pressure, and actuator displacement vs time. Actuator forces and displacements are direct measurements of the actuator load cell and piston, respectively. Displacement was applied at a rate of 1.0 in./min. (25 mm/min.), and the force feedback of the load cell was recorded. Figure 3.11 shows the maximum force recorded in the load cell was 27.8 kips (124 kN) at an actuator displacement of 2.9 in. (74 mm). There was no leakage of the endcaps throughout the duration of the test, which resulted in a constant internal water pressure of about 63 psi (434 kPa).

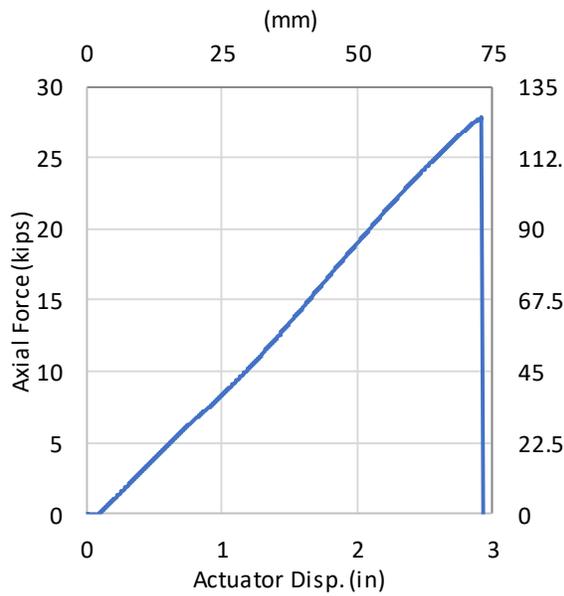
Figure 3.11. PT05 Force vs Actuator Displacement

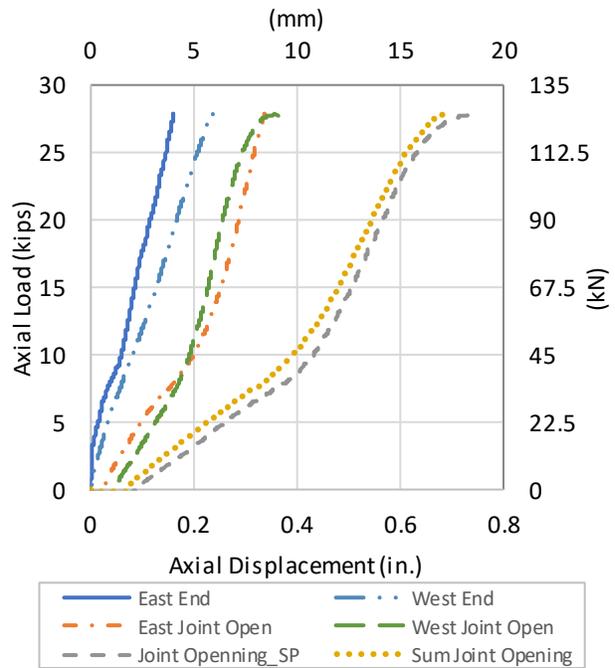
Figure 3.12. PT05 Force vs Joint Displacements

Figure 3.12 shows the actuator force vs. various displacement measures. Displacements between the pipe and end restraints (Megalugs in series) at either end of the specimen, denoted by “east end” and “west end” in the figure, indicate relatively minor movement [ $<0.25$  in. (6.4 mm)] at the fixed ends. Joint displacement was measured using two LVDTs located at either end of the coupling, and one string potentiometer along the north springline, shown in Figure 3.13. The joint displacement reached an average of about 0.73 in (18 mm) just before failure. Each of the LVDTs measured relative joint displacement for each side of the RCT coupling, which were summed to calculate the total joint displacement. This value was checked against the string potentiometer measurement, resulting in reasonably consistent values. Failure occurred on the West side of the coupling, fracturing at the contact point between the pipe and the coupling, shown in Figure 3.14.

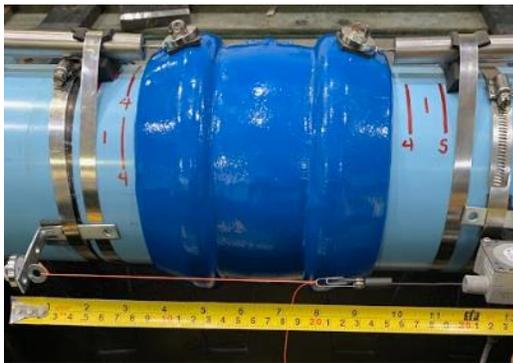
Figure 3.13. LVDTs (top) and string potentiometer (bottom) locations for PT05

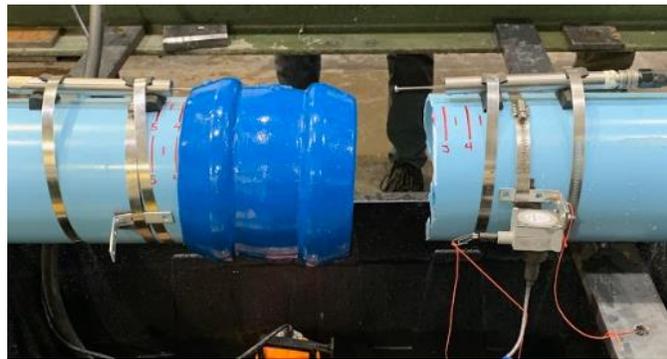
Figure 3.14. Failure at east joint for PT05

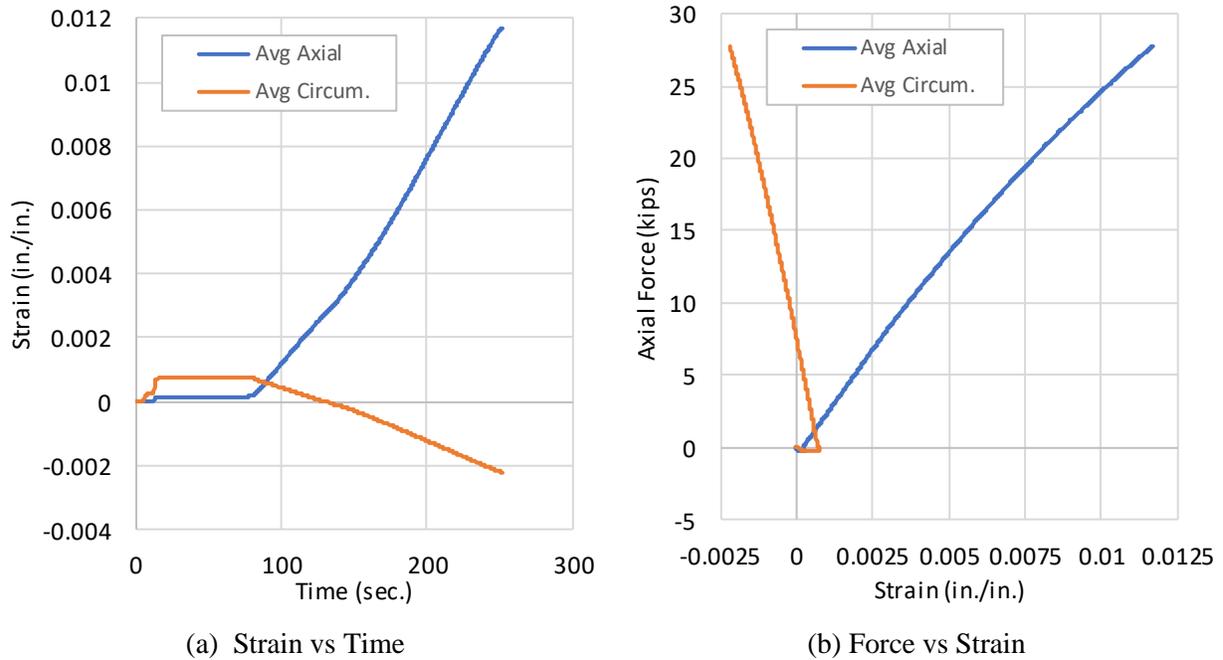
Figure 3.15. PT05 Average axial and circumferential strains vs. (a) time and (b) axial force

Figure 3.15 shows the average axial and circumferential strains for the duration of the test. At a time of about 20 seconds into data acquisition, the system was fully pressurized, and an increase in circumferential

strain was observed. Once loading began at about 80 seconds, the circumferential strains began to decrease, while the axial strains increased. As the actuator applied tensile loading to the system, the pipe began to elongate, causing the increase in axial strains. However, due to Poisson's effect, the circumferential strain decreased as the tensile load was applied. The maximum axial strain was measured at about 1.17% prior to failure.

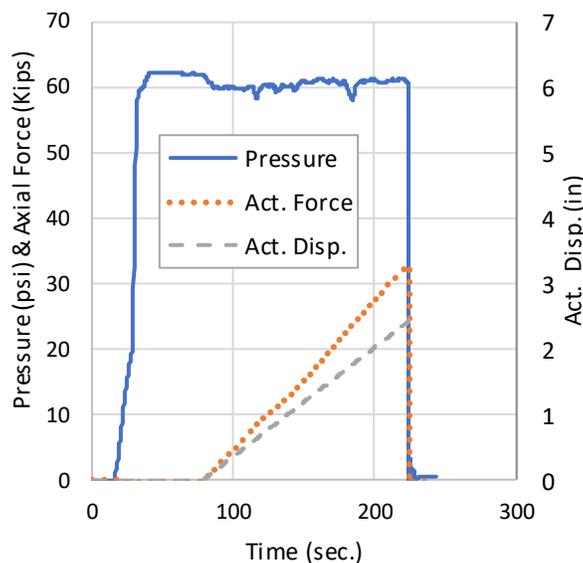
Figure 3.16. Specimen PT09 results for pressure, axial force, and actuator displacement vs. time

PVC C900 standard pipe with an RCT coupling restraint was used for test PT09. Figure 3.16 shows the relationship among actuator force, internal pressure, and actuator displacement. Actuator forces and displacements are direct measurements of the hydraulic load cell and piston, respectively. Displacement

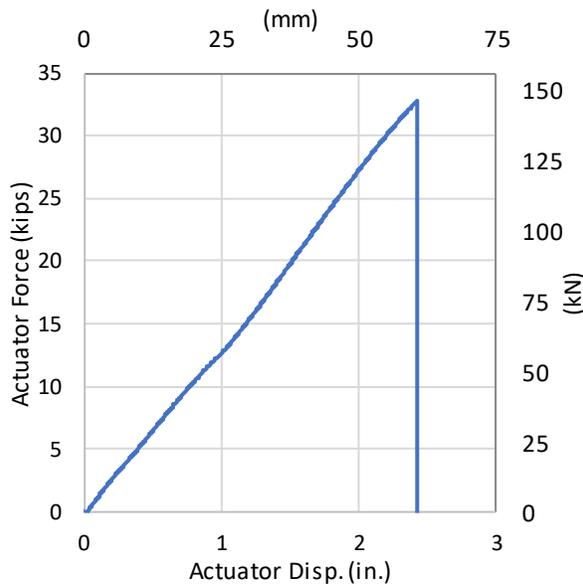
Figure 3.17. PT09 Force vs Actuator Displacement

was applied at a rate of 1.0 in./min. (25 mm/min.), and the force feedback of the load cell was recorded. Figure 3.17 shows that the maximum force recorded in the load cell was 32.8 kips (146 kN) at an actuator displacement of 2.43 in. (61 mm). There was no leakage of the endcaps during the duration of the test, which resulted in a constant internal water pressure of about 63 psi (434 kPa). Figure 3.18 shows the actuator force vs. the joint displacement. Joint displacement was measured using two LVDTs located on both ends of the coupling, shown in Figure 3.19. The joint displacement reached an average of about 0.54 in (14 mm) just before failure. Each of the LVDTs measured relative joint displacement for each side of the RCT coupling, which were summed to calculate the total joint displacement. Failure occurred on the East side of the coupling, fracturing at the contact point between the pipe and the coupling, shown in Figure 3.20.

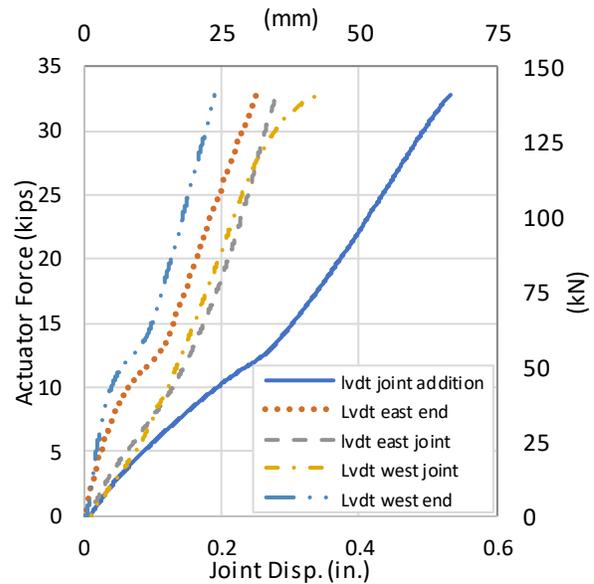
Figure 3.18. PT09 Force vs Joint Displacements

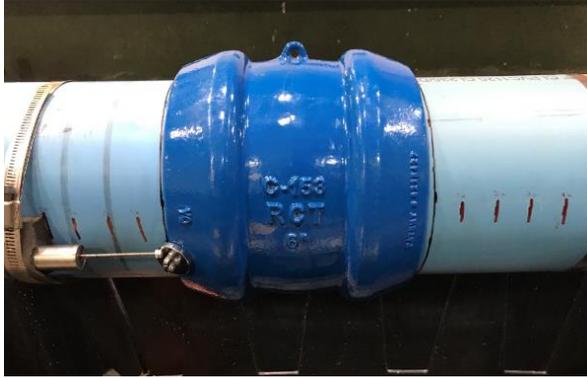
Figure 3.19. LVDT locations for PT09

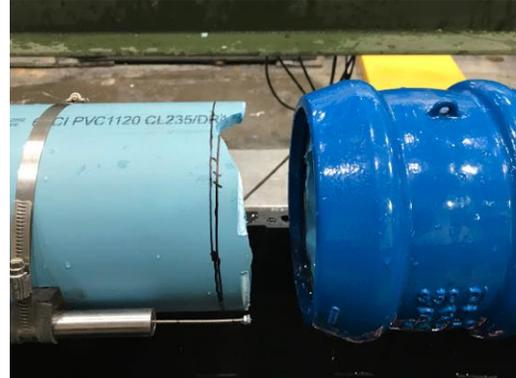
Figure 3.20. Failure at west joint for PT09

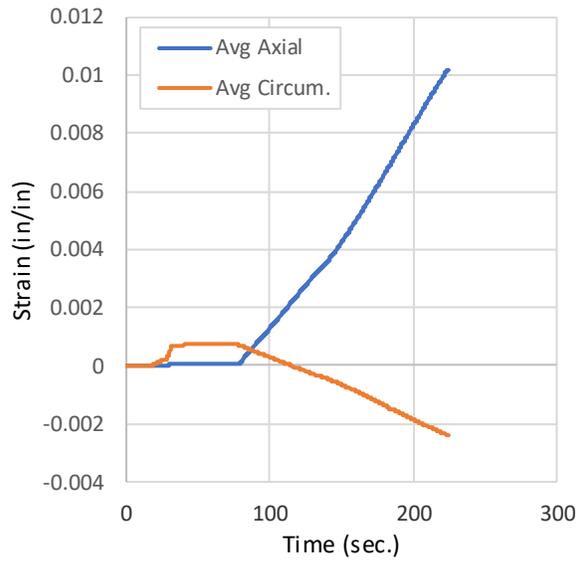
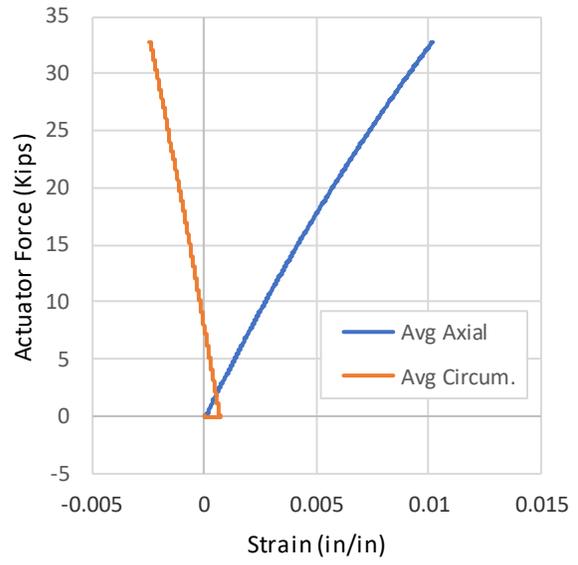
Figure 3.21. PT09 Average axial and circumferential strains vs. time and axial force

Figure 3.21 shows the average axial and circumferential strains for the duration of the test. At a time of about 30 seconds into data acquisition, the system was fully pressurized, and an increase in circumferential strain was observed. Once loading began at about 80 seconds, the circumferential strains began to decrease, while the axial strains increased. As the actuator applied tensile loading to the system, the pipe began to elongate, causing the increase in axial strains. However, due to Poisson's effect, the circumferential strain decreased as the tensile load was applied. The maximum axial strain was measured at about 1.0% prior to failure.

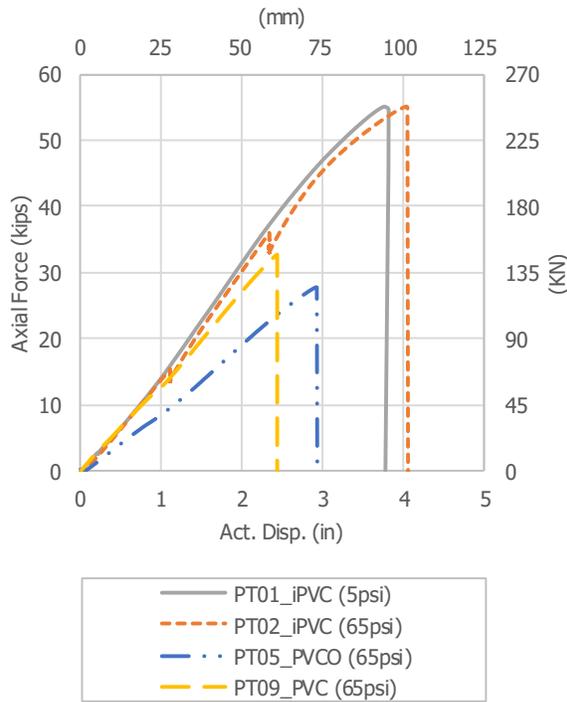
Figure 3.22. Tension Test Comparison for Axial Force vs Act. Disp.

Figure 3.22 shows the relationship between the axial force and the actuator displacement for all four tensions tests. Results from the iPVC were very consistent in both the low and high-pressure test. Each test resulted in a maximum force of 55.3 kips (246 kN), show in Figure 3.22. The PVCO and PVC recorded maximum forces of 28 and 33 kips (125 and 147 kN), respectively. Although the PVCO did not record as high of a force, it reached a higher actuator and joint displacement of 2.96 in (75 mm) and 0.70 in (18 mm), respectively, as opposed to the PVC, which recorded an actuator displacement of 2.47 in (63 mm) and a joint displacement of 0.53 in (14 mm).

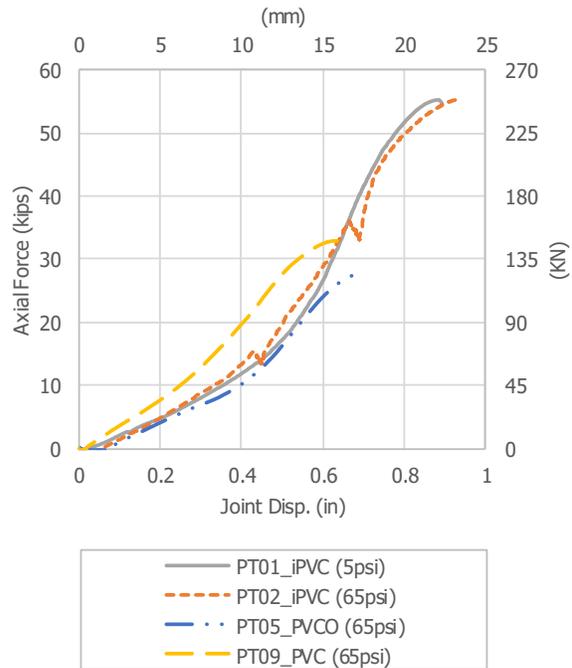
Figure 3.23. Tension Test Comparison for Axial Force vs Joint Disp.

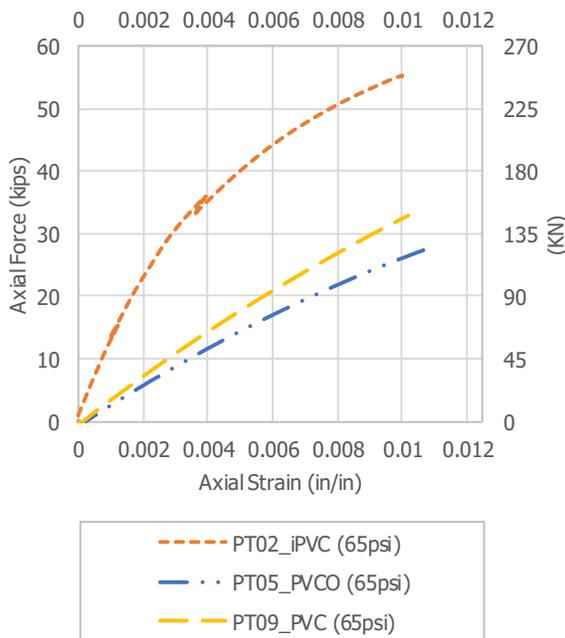
Figure 3.24. Tension Test Comparison for Axial Force vs Axial Strain. [Note PT02 measured strain is inaccurate]

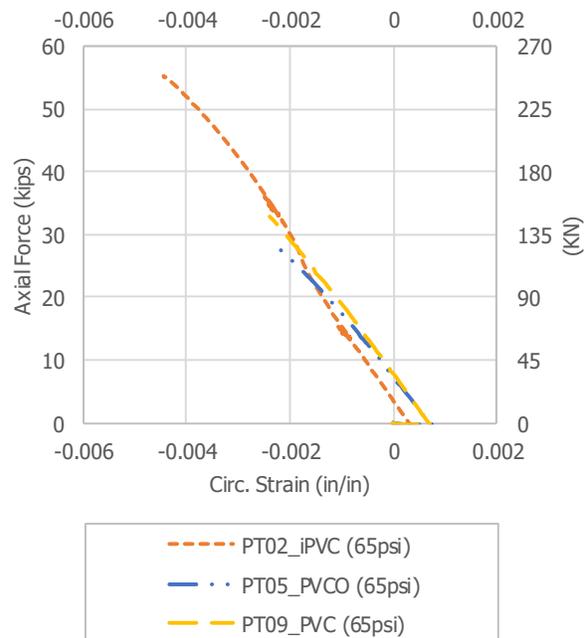
Figure 3.25. Tension Test Comparison for Axial Force vs Circ. Strain.

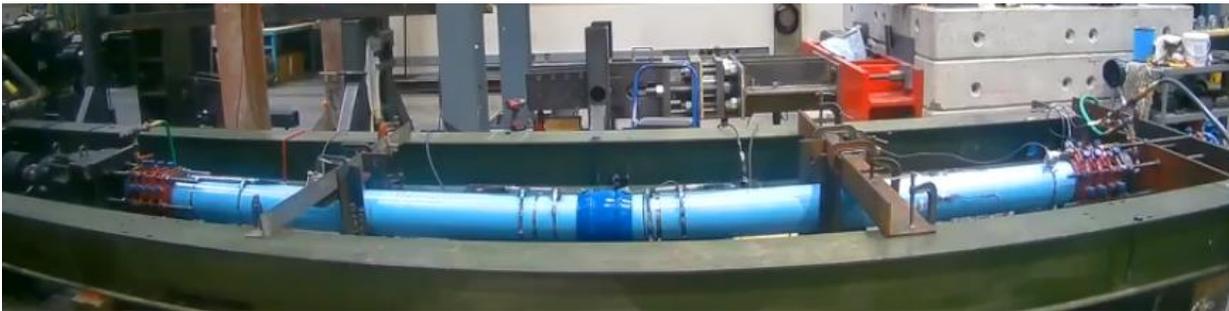
Figure 4.1. Compression test setup

One axial compression test was conducted and reported herein. The compression test was setup similarly to the tension test, shown in Figure 4.1. The setup varied from the previously reported tension tests in the following ways. Lateral supports were provided to limit out-of-plane (global) buckling of the specimen. End restraints were orientation opposite of the tension tests (as shown in Figure 4.2) to mobilize the needed loading direction of Megalug end restraints. The specimen was approximately 12 in. (300 mm) longer to reduce the buckling length of the threaded rods while the stroke of the piston (11.2 in.) was fully retracted.

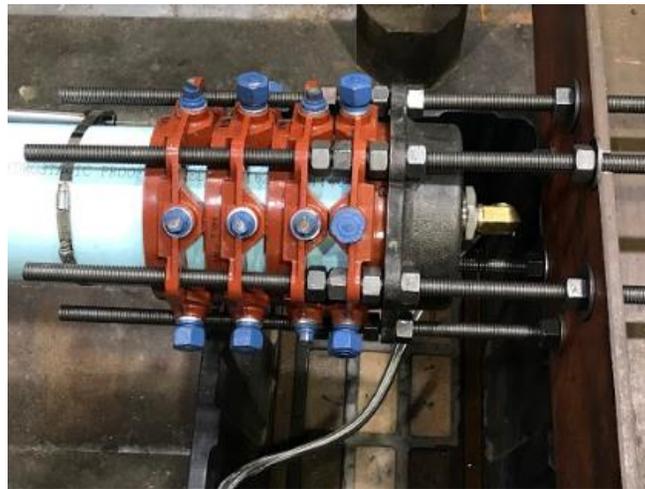
Figure 4.2. Megalug end restraint orientation for compression

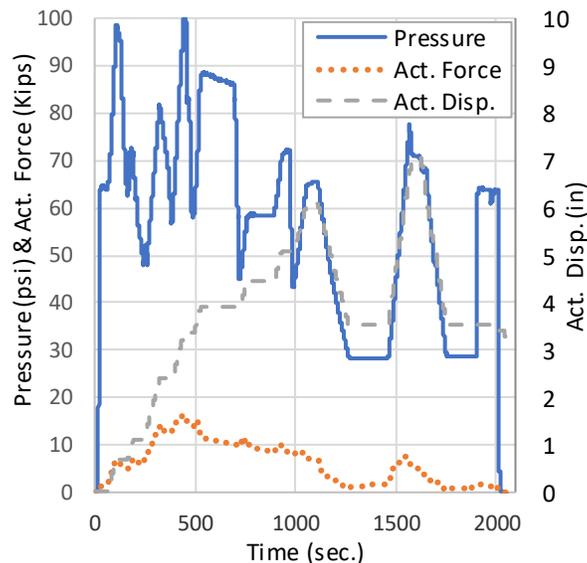
Figure 4.3. Specimen PC06 results for pressure, axial force, and actuator displacement vs. time

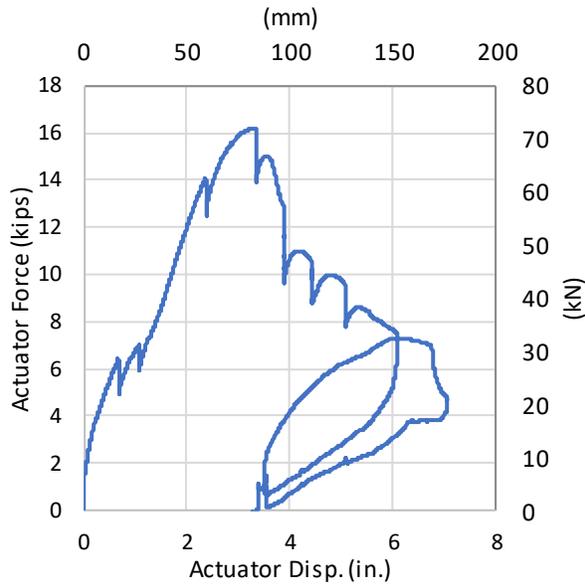
Figure 4.4. PC06 Force vs Actuator Displacement

Figure 4.4 shows that the maximum force recorded in the load cell was 16.2 kips (146 kN) at an actuator displacement of 3.1 in. (79 mm) and the maximum displacement recorded was 7.06 in (61 mm). Due to bending in the specimen, the maximum force and displacement did not occur at that same time. Pressure varied throughout the test, as reduced volume caused spikes in the pressure that needed to be manually released throughout the procedure. The average pressure was about 63 psi (434 kPa) but ranged from 30 to 100 psi (207 to 690 kPa). Figure 4.5 shows the actuator force vs. joint displacement. Joint displacement was measured using two LVDTs located at either end of the coupling, and a string pot placed on the north springline, shown in Figure 4.6. However, severe buckling at the joint led to removal of the LVDTs during the test, which left only the string pot measurements. The maximum joint displacement was 2.2 in (56 mm). Buckling occurred at the contact point between the pipe and the coupling, shown in Figure 4.7. The test was stopped prior to failure due to instabilities caused by the knuckle of the actuator.

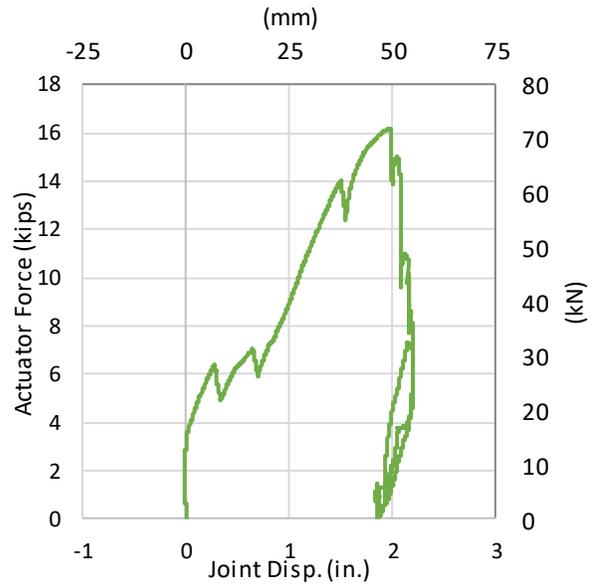
Figure 4.5. PC06 Force vs Joint Displacements

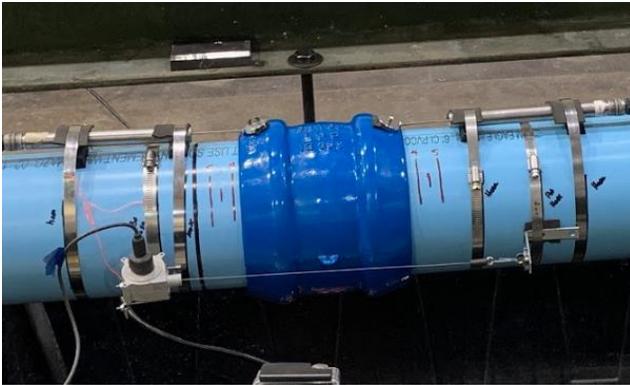
Figure 4.6. LVDT and String Potentiometer locations for PC06

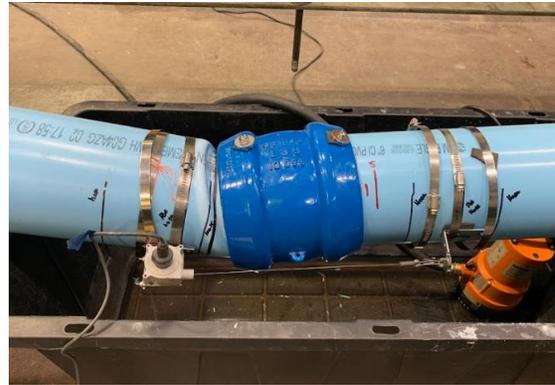
Figure 4.7. Buckle at east joint for PC06

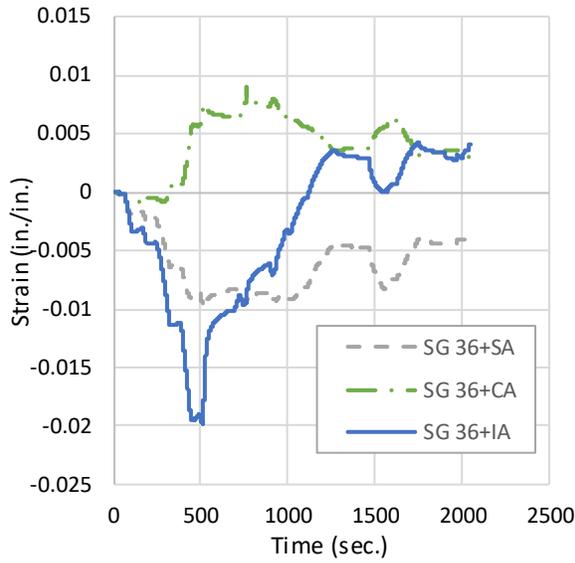
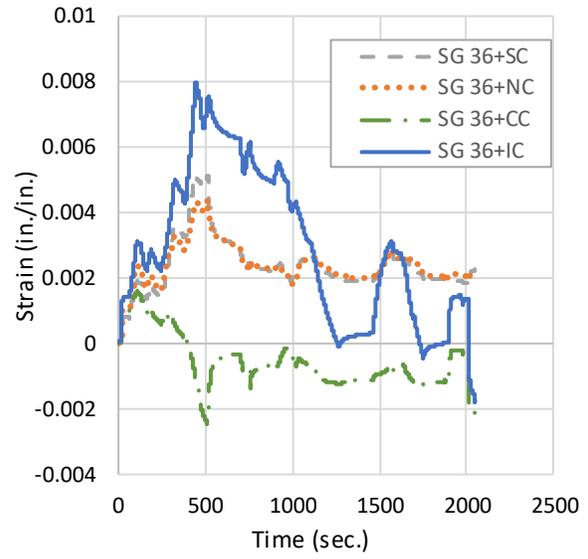
(a) axial strains

(b) circumferential strains

Figure 4.8. PC06 axial strain (a) and circumferential strain (b) vs. time

Figure 4.8 shows the axial and circumferential strains for the duration of the test. The axial strain gage placed on the north spring line did not record data during the test. Due to bending of the pipe, axial strains recorded on the crown were positive (elongated) and axial strains on the invert were negative (compressed). There is an inverse relationship between the axial strain circumferential strains due to Poisson's effect. Figure 4.9 shows the progression of the compression test at four instances in time. The specimen experienced progress out of plane buckling, which is represented by the widely varying strain

measurements. Despite significant levels of imposed actuator compression, the coupling performed well and did not experience leakage or ultimate failure.

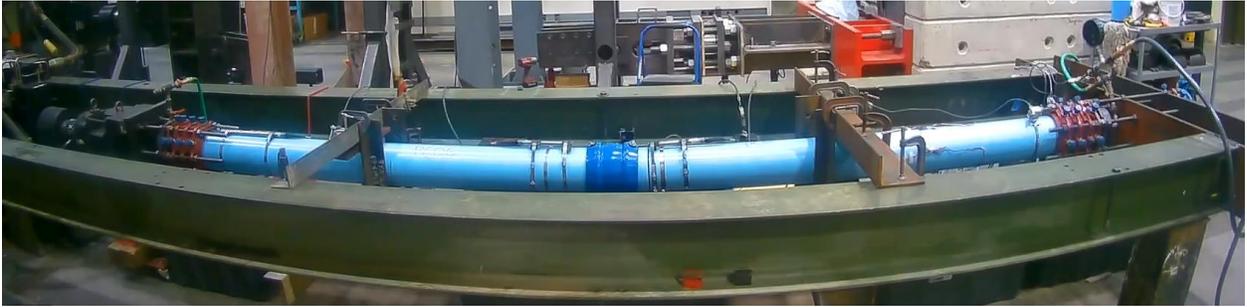
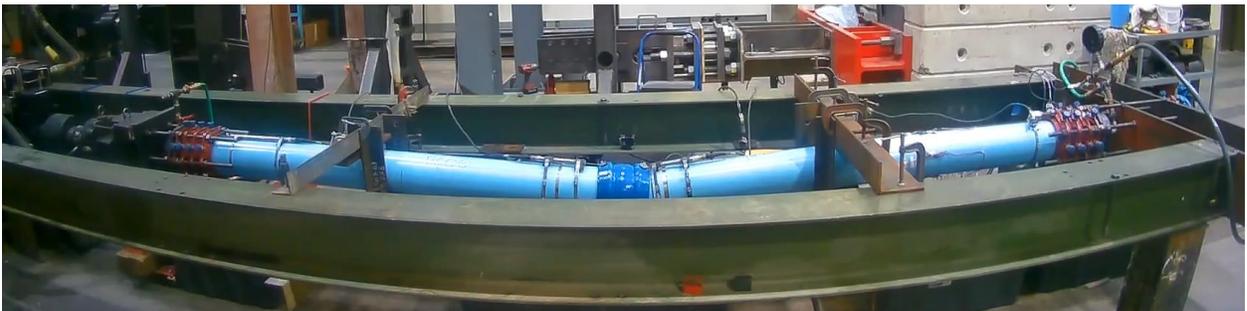
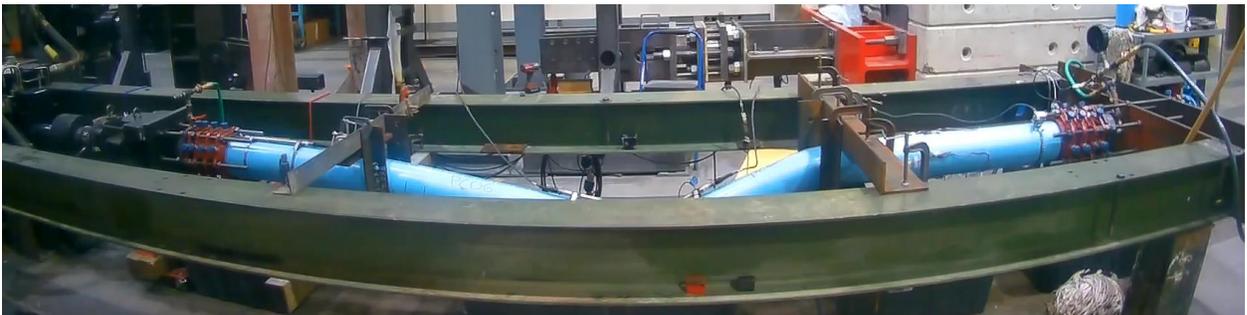
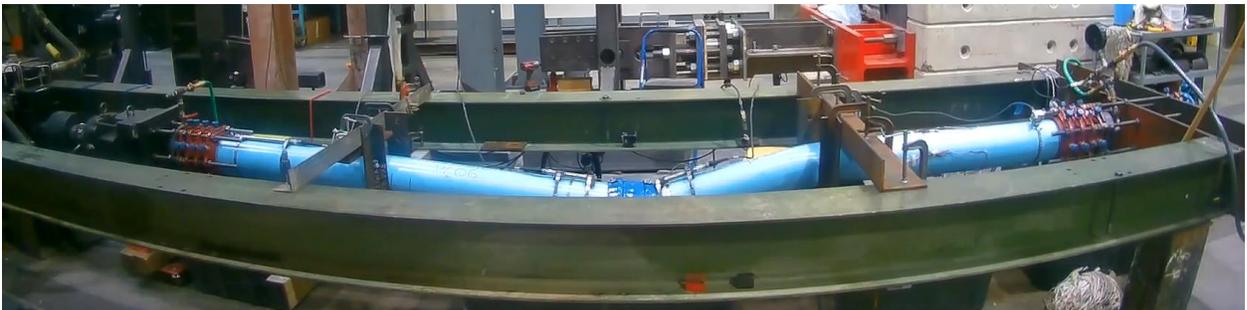
(a) Initial condition

(b) Mid-loading

(c) Max loading

(d) Unloaded

Figure 4.9. Images of PC06 loading progression
