# Seismic Evaluation of Hazard-Resistant Pipelines: PVC, PVCO, and iPVC Pipe with Coupling

## Axial Testing Report

Timothy Harris & David Katzev  
East Bay Municipal Utility District

December 2019

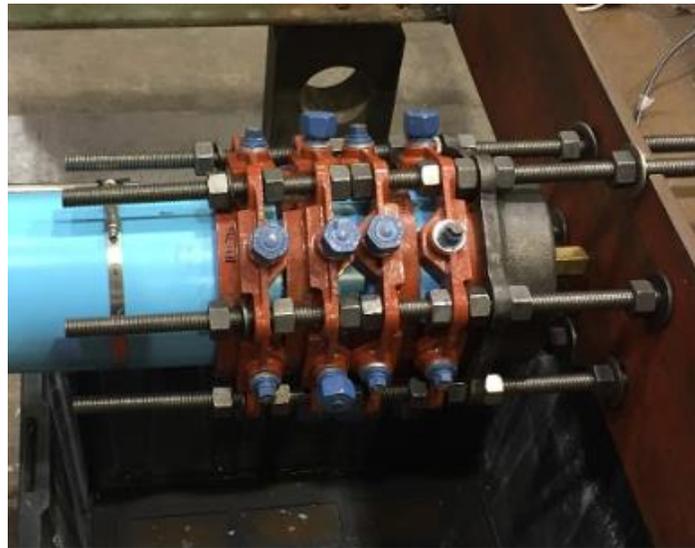
Figure 5.1. Megalug end restraint orientation for cyclic loading

One axial cyclic test was conducted and reported herein. The cyclic test was setup identical to the compression test, generally depicted in Figure 4.1. This setup was used to account for the compressive loads during the cyclic motions, and does not interfere with the tension loading on the specimen. A balanced Megalug pattern (alternating directions) was used on the end restraints to ensure that both tensile and compressive loads could be accounted for, shown in Figure 5.1.

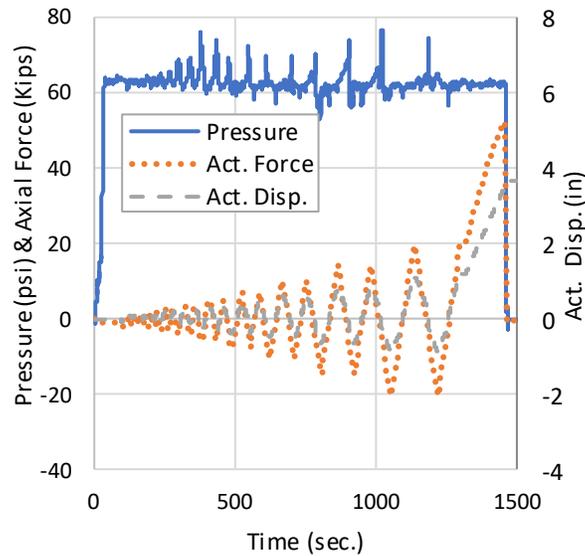
Figure 5.2. Specimen PS12 results for pressure, axial force, and actuator displacement vs. time

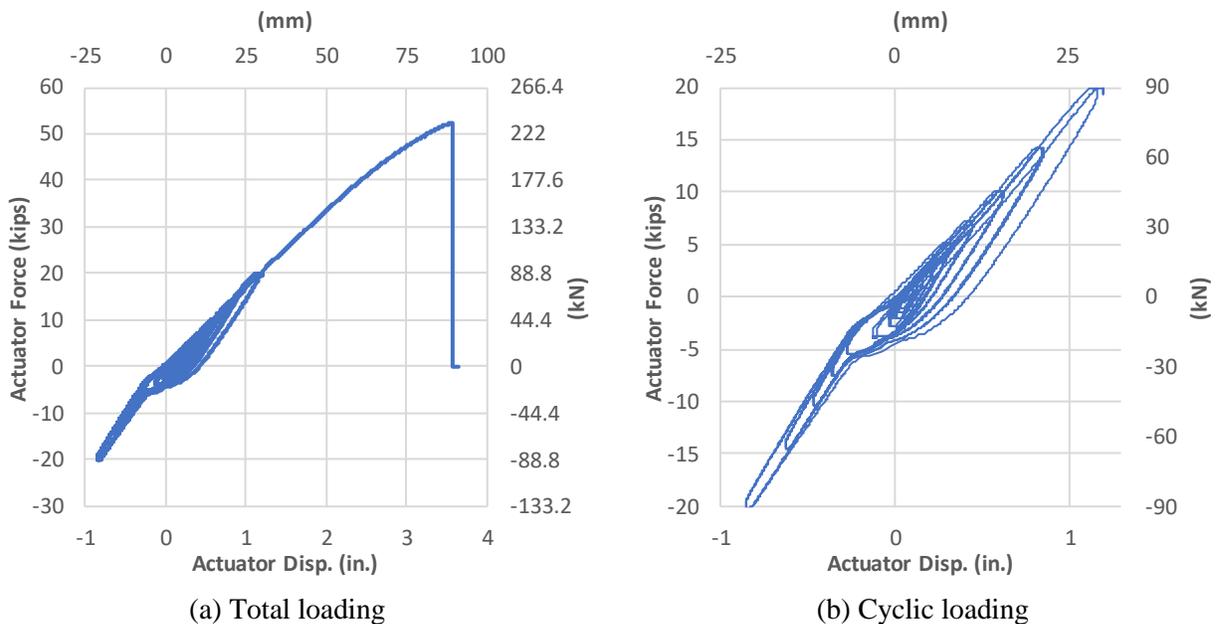
Figure 5.3. PS12 force vs actuator displacement

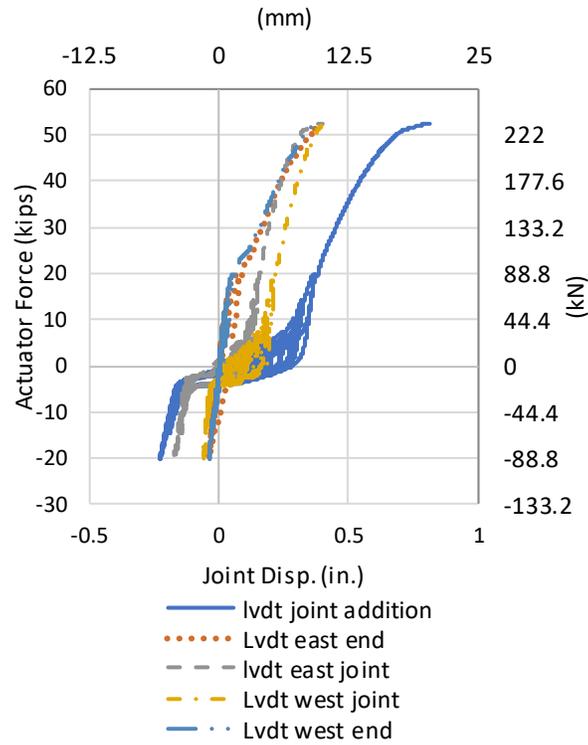
Figure 5.4. PS12 force vs axial displacements

manually released throughout the duration of the test. The average pressure was about 63 psi (434 kPa) but ranged from 50 to 75 psi (345 to 517 kPa). Figure 5.4 shows the actuator force vs. the joint displacement. Joint displacement was measured using two LVDTs located on both ends of the coupling, shown in Figure 5.5. The joint displacement was measured at 0.82 in (21 mm). Failure occurred at both contact points between the pipe and the center coupling, shown in Figure 5.6.

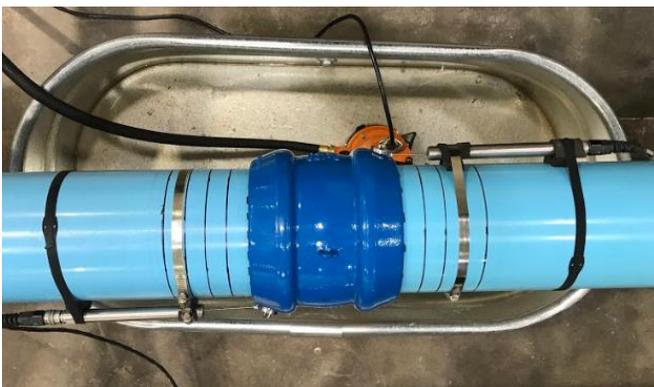
Figure 5.5. LVDT locations for PS12

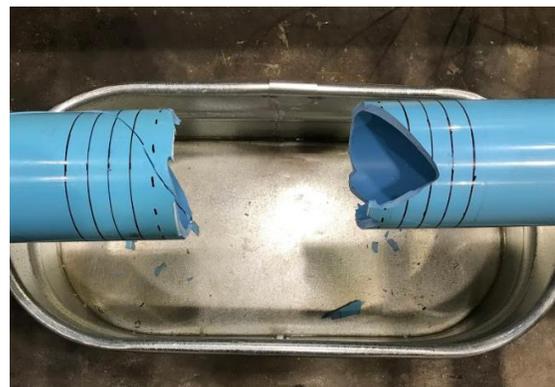
Figure 5.6. Failure at joint for PS12

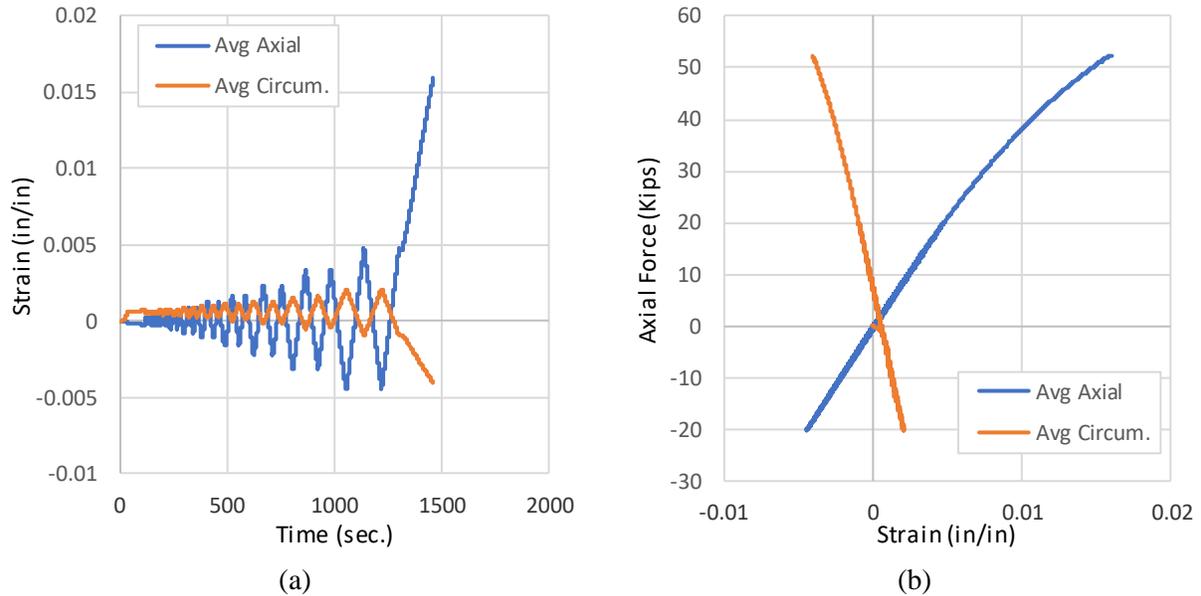
Figure 5.7. PS12 axial strain (a) and circumferential strain (b) vs. time

Figure 5.7 shows the axial and circumferential strains for the duration of the test. There is an inverse relationship between the axial strain circumferential strains due to Poisson's effect. The maximum axial strain was recorded at 1.6%.

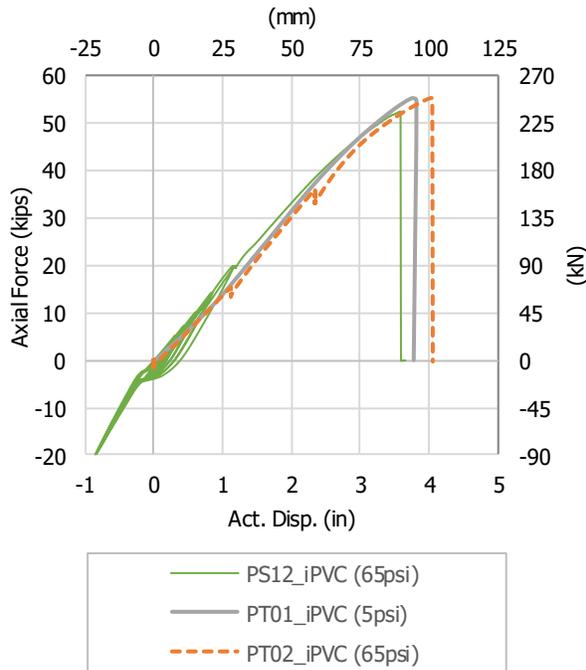
Figure 5.8. Tension Test Comparison for Axial Force vs Act. Disp.

This section provides comparison of the cyclic test to the axial tension tests, all performed on PC 305 iPVC pipe. Figure 5.8 shows excellent agreement among actuator force vs. displacement, with the cyclic test reaching a marginally reduced level of force and displacement. Similarly, Figure 5.9 shows the maximum joints displacement between cyclic and monotonic tests was similar, however the cyclic joint displacement follows a stiffer response. This stiffer response is likely due to moderate scraping of the restraining teeth along the pipe wall during the initial cyclic sequences. Although the response varies, the maximum obtained values suggest the cyclic displacements did not have a significant effect on the ultimate performance of the system. The axial strain comparison, shown in Figure 5.10, suggest some variation in axial strain development among the thermoplastic materials. The PVC and PVCO material reached similar levels of axial strain at failure with the PVC material exhibiting a stiffer initial response and the PVCO reaching greater total strain. Figure 5.11 shows excellent agreement amount circumferential strains in response to axial loading.

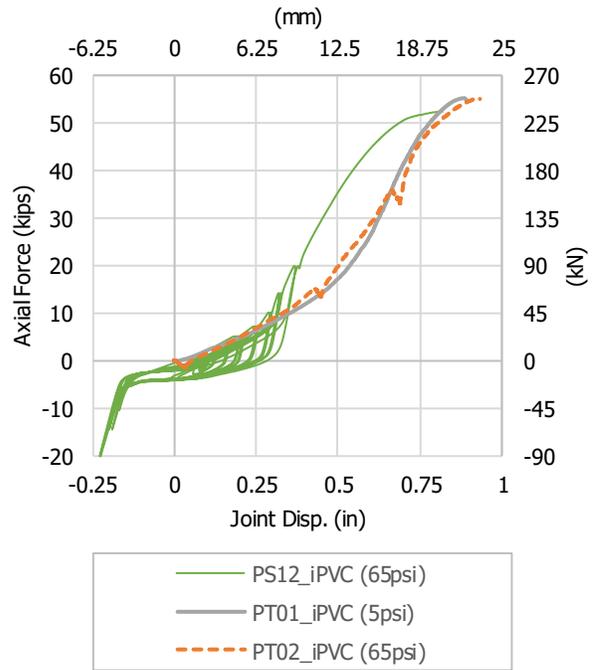
Figure 5.9. Tension Test Comparison for Axial Force vs Joint Disp.

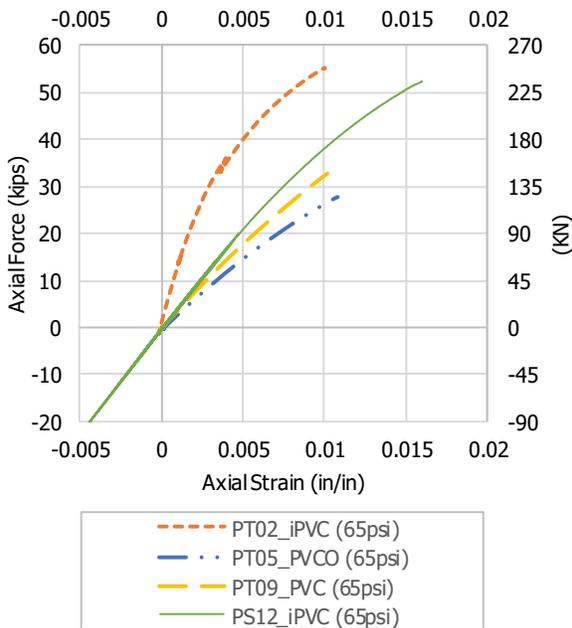
Figure 5.10. Tension Test Comparison for Axial Force vs Axial Strain. [Note PT02 measured strain is inaccurate]

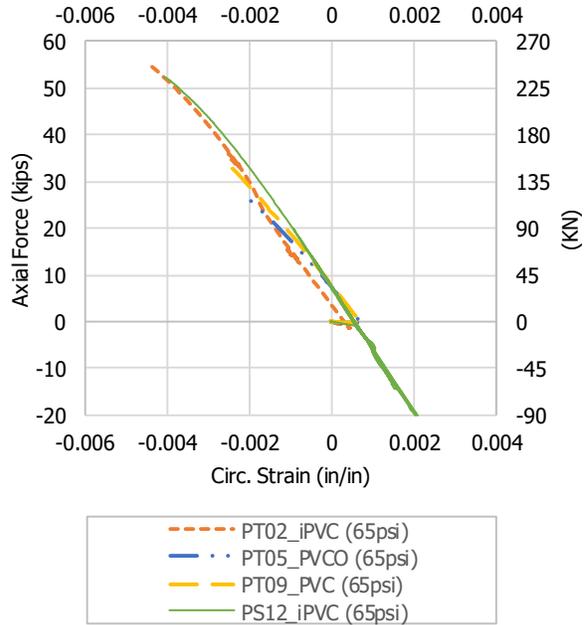
Figure 5.11. Tension Test Comparison for Axial Force vs Circ. Strain.

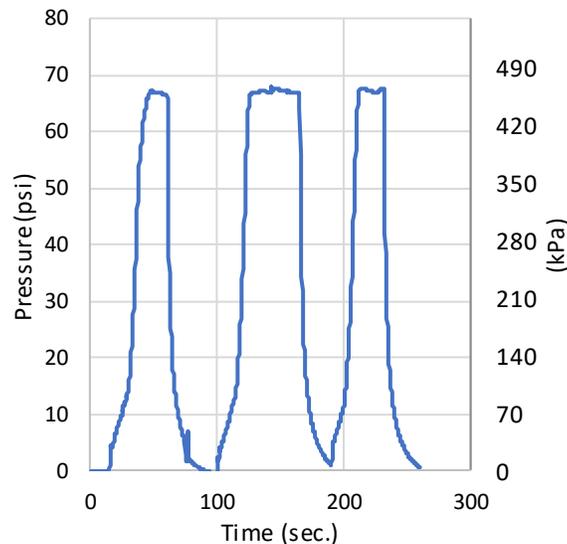
Figure 6.1. PS12 pressurization sequence, pressure vs time

iPVC pipe with an RCT coupling at the center joint was used for this study. The pipe was unrestrained axially to ensure true strain behavior under pressure. The specimen was filled with water and pressurized to ~65 psi (~450 kPa) three times per trial, shown in Figure 6.1. Strain data was recorded and compared to theoretical calculations, per Figure 6.2. The maximum circumferential strain recorded from the gages was 0.00059 in/in (0.059%) and the maximum axial strain recorded was 0.00012 in/in (0.012%).

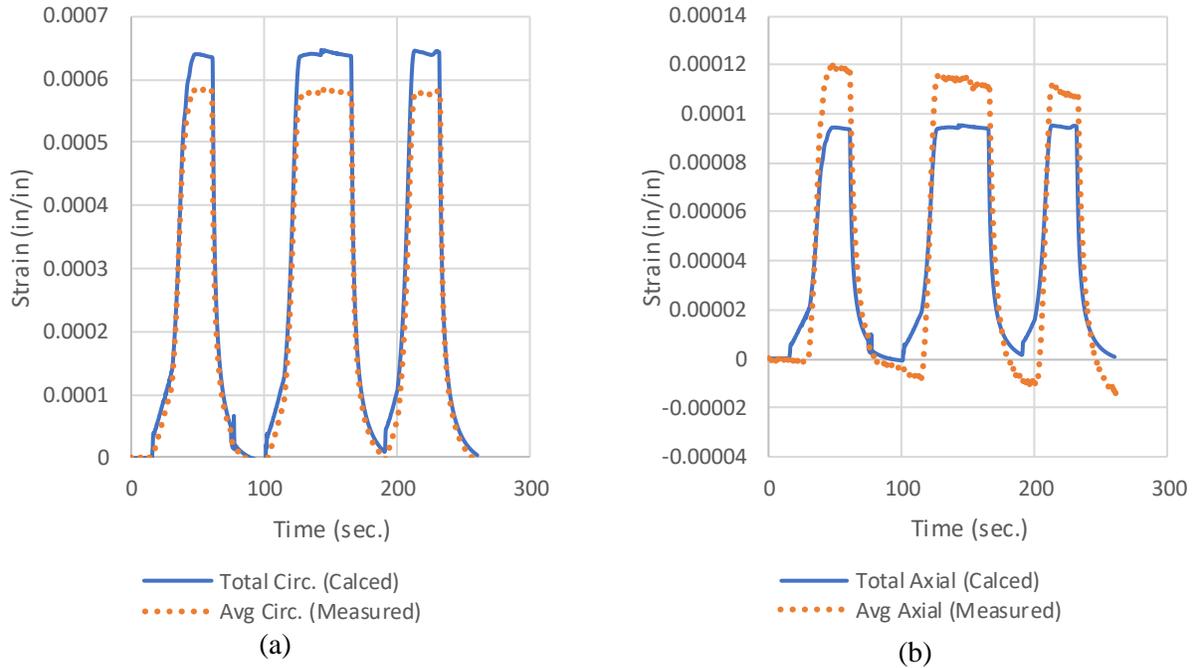
Figure 6.2. Circumferential (a) and Axial (b) strain vs time

The maximum theoretical circumferential strain was found to be 0.00065 in/in (0.065%) which was 8% more than the recorded value. The maximum theoretical axial strain was found to be 0.000096 in/in (0.0096%) which was 20% less than the recorded value. Considering the small scale of pressure applied to the specimen, the differences in strain can be a result of minor imperfections within the system. These results indicate that the strain gages used for testing record accurate data. This process was completed several times per test to ensure that the strain gages were installed properly.
