Performance Assessment of iPVC Pipe and Couplings for Large Ground Movement

This report is submitted to East Bay Municipal Utility District (EBMUD) and Denver Water (DW). It presents results from a program to investigate the axial and transverse performance of nominal 6 in. (150mm) diameter iPVC pipe with hazard resilient connections. The work was undertaken in the Center for Infrastructure, Energy, and Space Testing (CIEST) which is affiliated with the Civil Environmental, and Architectural Engineering Department at the University of Colorado Boulder.

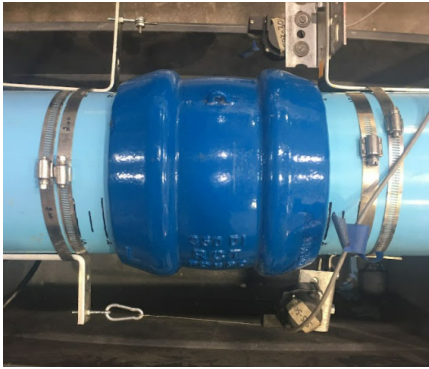
Figure 1.1. Typical RCT Connection

The first set of tests was performed to investigate the response of an RCT Flex-Tite coupling. The connection consists of a self-restraining fitting with an integrated restraining gasket constructed primarily of ductile iron per ASTM A536. The fitting is pressure rated to 305 psi. The gasket is designed to grip the spigot under tensile loading, preventing slip-out at the connection. An example of an installed RCT connection is shown in Figure 1.1. This study focuses on the response of the straight coupling, and the results are intended to be representative of the pipe and gasket interaction. The second set of tests was performed on iPVC pipe with an internal TurnerLok gasket connection. The connection consists of a rubber gasket equipped with twelve toothed wedges designed to grip the spigot in tension. The gasket is designed to be manually inserted into a standard bell section of pipe, replacing the factory-installed gasket. An image of the restraining gasket is provided in Figure 1.2. The third set of tests investigated the response of an iPVC system restrained at the connection by EBBA C1900 Restraint Harnesses. The EBBA C1900 consists of two split ring restraints that are positioned on either side of the connection. The restraints are connected

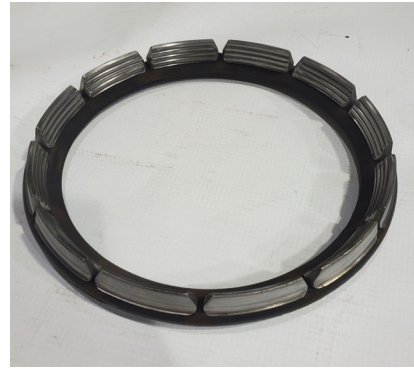
Figure 1.2. Typical TurnerLok Gasket

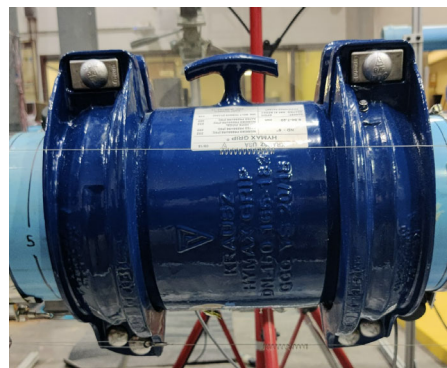
Figure 1.5. Typical Hymax Grip Connection

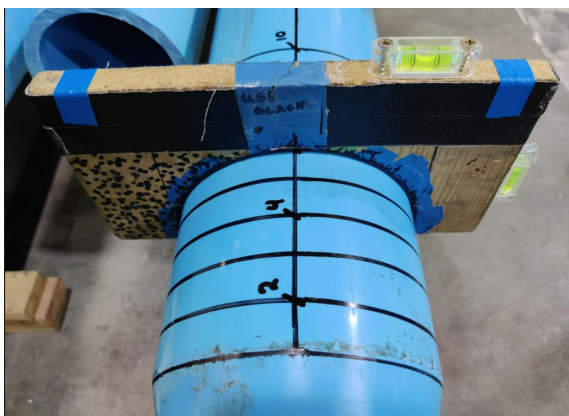
Figure 2.2. Half Moon crowning tool (Identifying pipeline crown, invert, and spring lines)

typical bending test. The crown of the pipe is defined on the pipe by material designation written along the pipe. The crown, invert, and spring lines are defined along the pipe specimen using a half-moon leveling tool. Once the crown, invert, and spring lines are appropriately marked along the specimen, the connection under investigation is installed following field installation guidelines. End caps, shown in Figure 2.9, are then installed at each end of the specimen and tightened to 110 ft-lb (149 N-m). Load and support saddle locations, shown in Figure 2.10, are then defined from the centerline of the specimen and installed. Strain gauges are then fixed to the crown and invert of the specimen. Once strain gauges are installed, the actuator in the loading frame is fully retracted and the test specimen is placed inside the loading frame. The specimen is then centered in the frame and shims are placed at both supports, preventing lateral movement of the specimen.

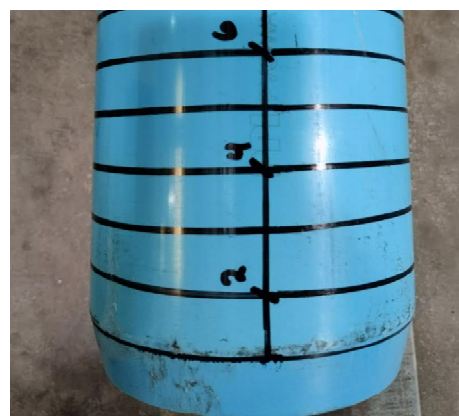
Figure 2.3. Measurements along the pipe spigot

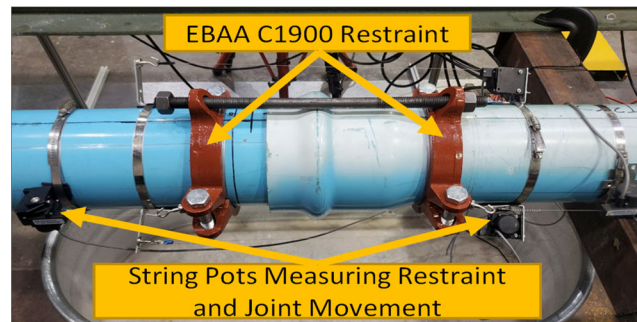
Figure 2.6. Typical String Pot Installation (PT30)

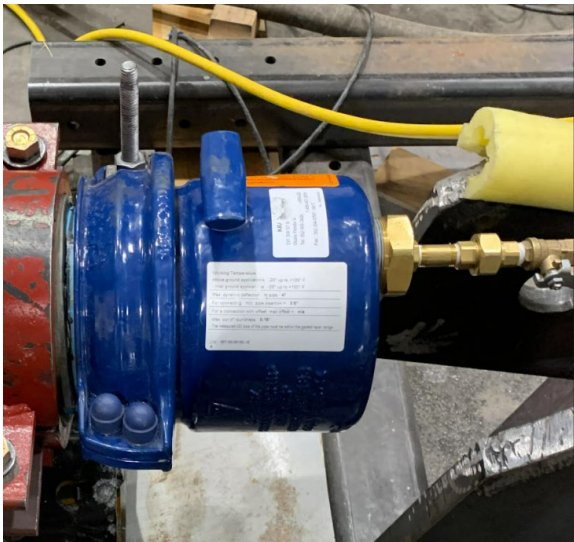
Figure 2.9. Bending Test – End Cap

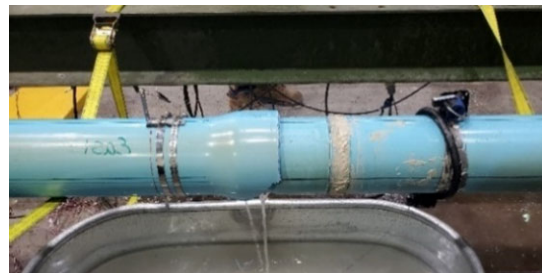
(b) Failure at Connection

Figure 3.8. Specimen PT27 (a) Setup and (b) after Failure

Pipe specimen PT27 consisted of an iPVC pipe with an internal TurnerLok gasket restraining the bell and spigot connection at the midpoint. The specimen was pulled in axial tension at a consistent rate until failure occurred at the bell and spigot connection. Figure 3.8 shows photos for the pre-test setup of specimen PT27 as well as the specimen just after failure at the connection.

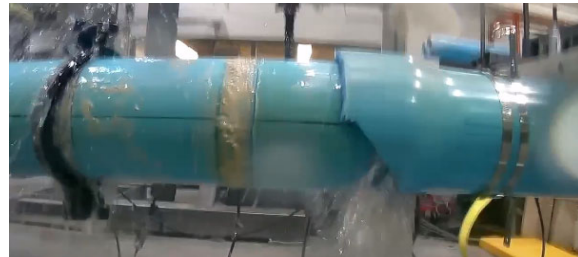
(d) Fracture of the bell resulting in loss of pressurization

Figure 3.14. Images of PT27 during the test progression

Just before fracture a maximum axial force of 34.6 kips (154 kN) and a maximum actuator displacement of 2.96 in. (75.2 mm). As shown in Figure 3.14 (a-d), yielding and circumferential cracking along the bell of the specimen was observed during failure. The sudden fracture of the bell resulted in an abrupt loss of pressure and ejection of the internal TurnerLok gasket, resulting in the conclusion of the test. Gouges from the gasket's toothed wedges were visible along the spigot of the specimen, shown in Figure 3.15. Prior to fracture, there were no signs of leakage.

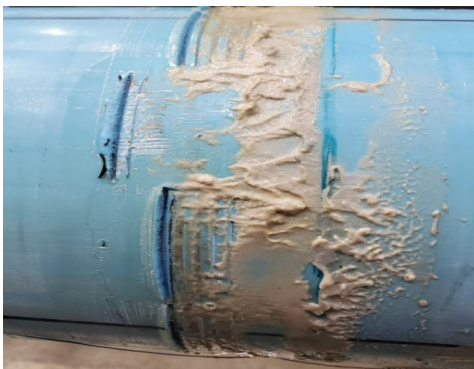
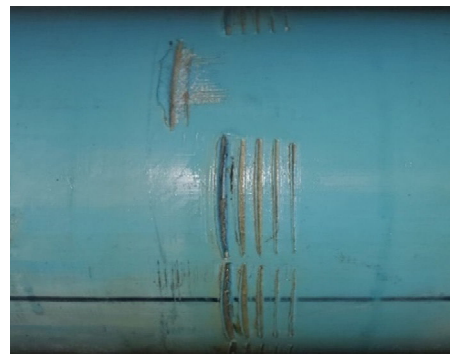
(a) Gouging in Spigot after Specimen Failure

(b) Gouging in Spigot after Specimen Failure

Figure 3.15. Spigot Gouging post PT27

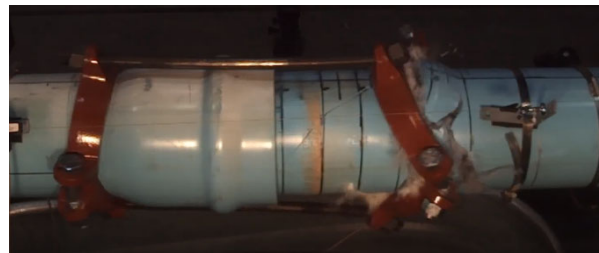
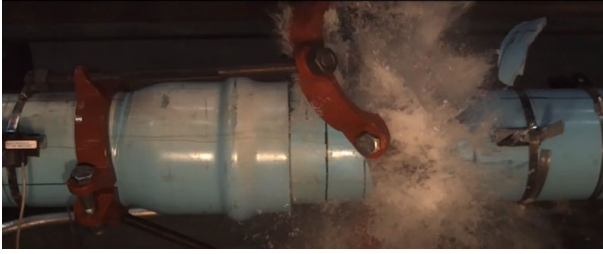
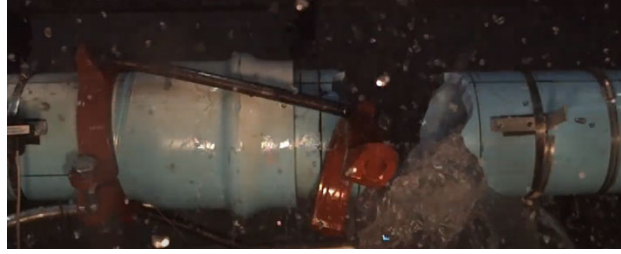
(b) Fracture of Spigot and Shearing of Restraint Bolts

(c) Immediately after Failure

(d) After Failure

Figure 3.23. Images of PT30 failure progression

At a maximum axial force of 38.1 kips (170 kN) and a maximum actuator displacement of 6.07 in. (154 mm), the spigot and west C1900 vertical bolt simultaneously fracture, causing a loss of pressurization in the system. Prior to this fracture, there were no signs of leakage. Images taken during the failure process are presented in Figure 3.23 (a-d).

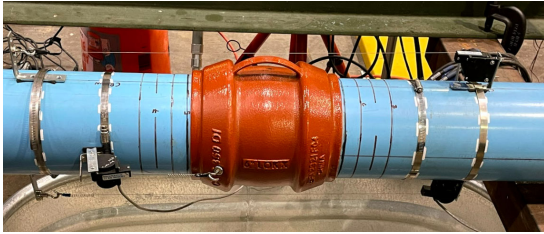
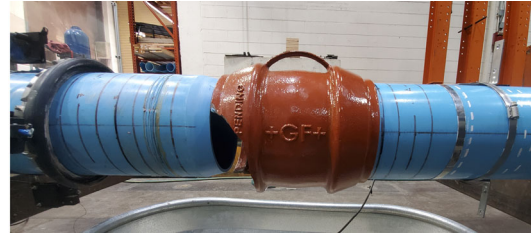
(a) Pre-Test Setup

(b) Failure at Connection

Figure 3.24. Specimen PT33 (a) Setup and (b) Failure

Pipe specimen PT33 consisted of an iPVC pipe with a Lokx coupling located at the midpoint. Axial tension was applied to the specimen at 1 in./min (25.4 mm/min) until failure occurred at the coupling. Figure 3.24 shows photos for the pre-test setup of specimen PT33 as well as the specimen after failure at the connection.

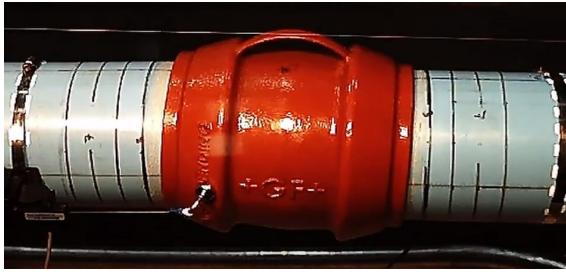
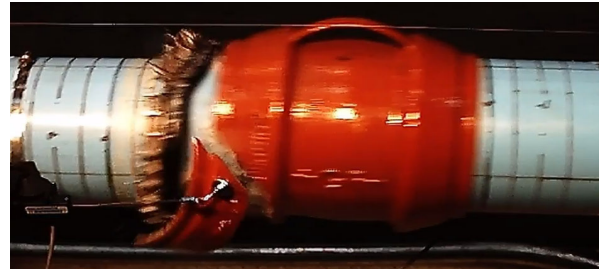
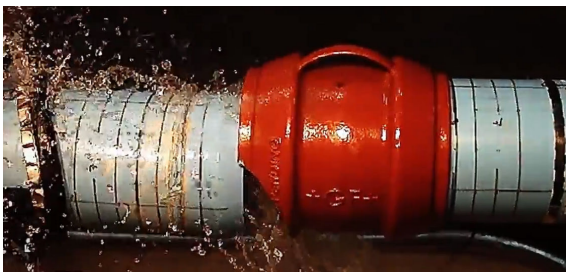
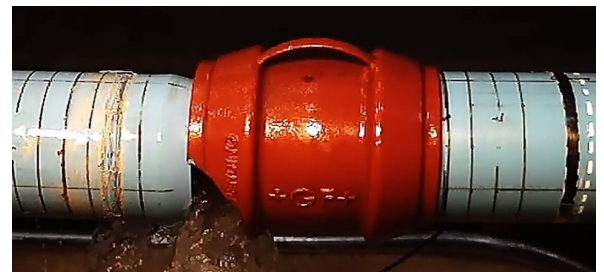
(a) Just before specimen failure

(b) Fracture of the lower east section of the coupling and ejection of the gasket

(c) Loss of pressure just after coupling fracture

(d) Specimen at rest after completion of the test

Figure 3.30. Images of PT33 during the test failure

A maximum axial force of 60.3 kips (268 kN) and a maximum actuator displacement of 4.27 in. (108 mm) were recorded before the fracture of the connection. The sudden fracture of the coupling resulted in an abrupt loss of pressurization and ejection of the east Lokx gasket. Gouges from the gasket's toothed wedges were visible along the spigot of the specimen after failure. After the test, there were no signs of axial or circumferential cracking along the specimen. A series of photos taken during the specimen's failure can be viewed in Figure 3.30 (a-d). Gouges from the gasket's wedged teeth left on the spigot are visible in Figure 3.31. Prior to fracture, there were no signs of leakage.

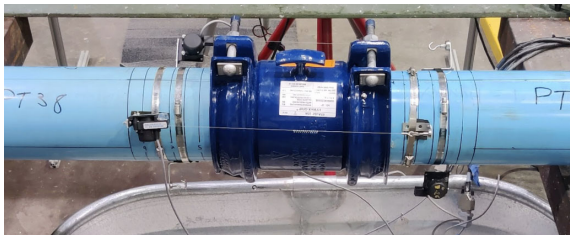
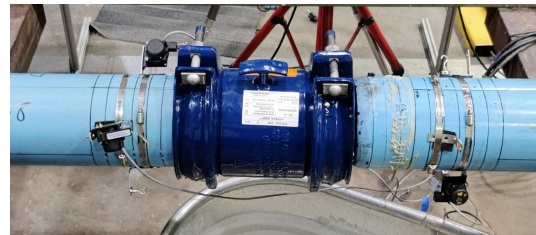
(a) Pre-Test Setup

(b) Failure at Connection

Figure 3.32. Specimen PT38 (a) Setup and (b) Failure

Pipe specimen PT38 consisted of an iPVC pipe with a Hymax Grip coupling located at the midpoint. Pipe segments were inserted 4 in. (102 mm) into each end of the Hymax coupling. Restraint bolts, located at the top of the coupling, were tightened to the minimum required torque specifications for 6 in. (152 mm) nominal diameter pipes [110 lb.-ft (149 N-m)]. Tensile load was applied to the specimen at a constant rate of 1 in./min (25.4 mm/min) until slippage and ultimate failure occurred at the coupling. Just before failure, leaking was observed at the east end of the coupling. Figure 3.32 shows photos for the pre-test setup of specimen PT38 as well as the specimen after failure at the connection.

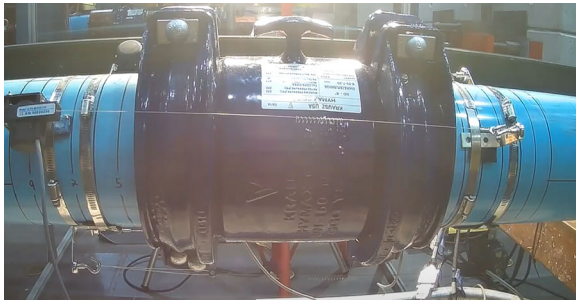
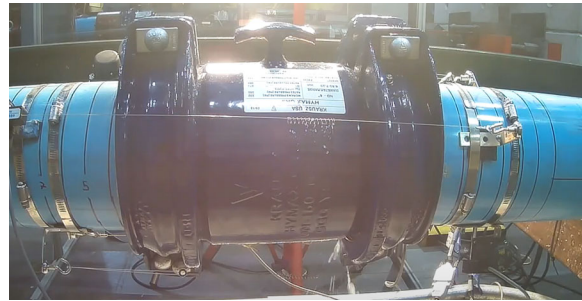
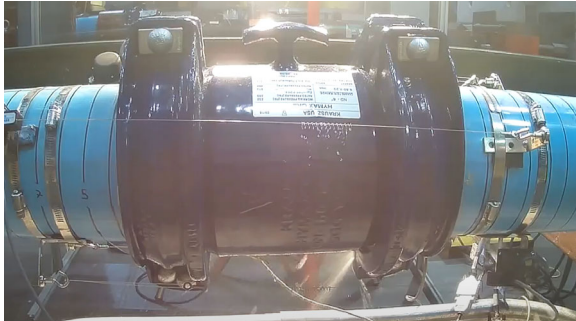
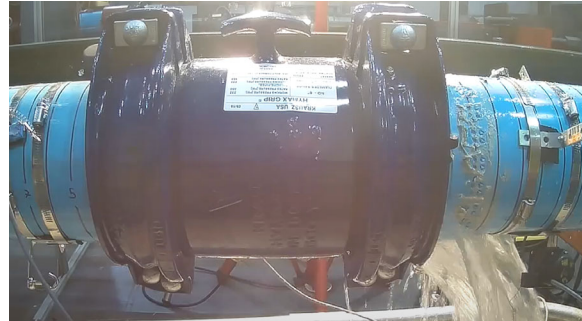
(a) Specimen at the Start of the Test

(b) Specimen at the Onset of Leaking

(c) Just before Failure

(d) Just after Fracture of Internal Grip Gasket
Resulting in Loss of Pressure

Figure 3.38. Images of PT38 during the test

A maximum axial force of 27.9 kips (124 kN) and a maximum actuator displacement of 2.47 in. (63 mm) were recorded before fracture of the connection's internal grip gasket. The sudden fracture of the gasket resulted in an abrupt loss of pressure in the system. Gouges from the gasket's toothed wedges were visible along the spigot of the specimen after failure and are shown in Figure 3.39. The fractured gasket, responsible for the ultimate failure of the system is presented in Figure 3.40. After the test, there were no signs of axial or circumferential cracking along the specimen. A series of photos taken during the test can be viewed in Figure 3.38 (a-d).

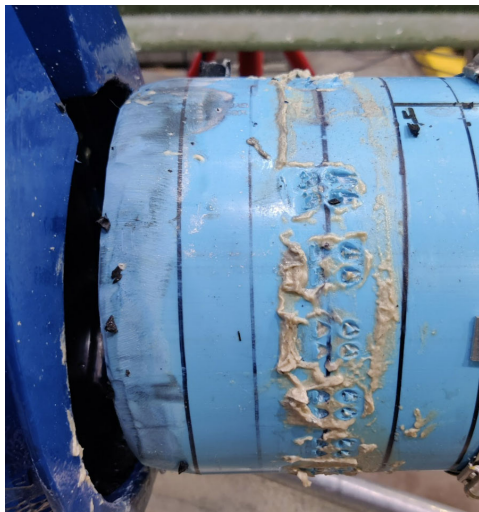
Figure 3.39. PT38 – Gouges along the Spigot

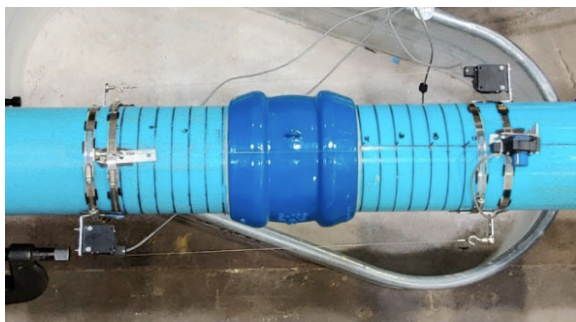
(a) Pre-Test Setup

Figure 3.46. Specimen PC37 (a) Setup and (b) End of Test

Pipe specimen PC37 consisted of an iPVC pipe with an RCT coupling located at the midpoint. Compressive load was applied to the specimen at a constant rate until local buckling occurred at the connection warranted conclusion of the test. Figure 3.46 shows photos for the pre-test setup of specimen PC37 as well as the specimen just after completion of the test.

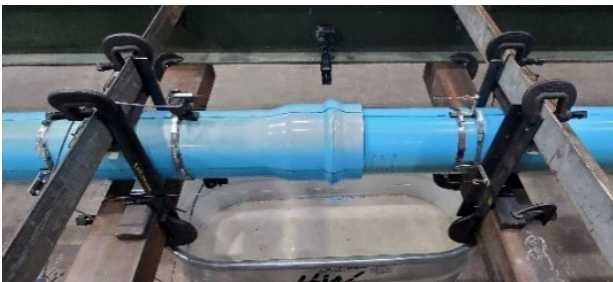
(a) Pre-Test Setup

Figure 3.57. Specimen PC28 (a) Setup and (b) End of Test

Pipe specimen PC28 consisted of an iPVC pipe with an internal TurnerLok gasket restraining the bell and spigot connection located at the midpoint. Compressive load was applied to the specimen until the maximum stroke limit of the actuator was reached. Figure 3.57 shows photos for the pre-test setup of specimen PC28 as well as the specimen just after completion of the test.

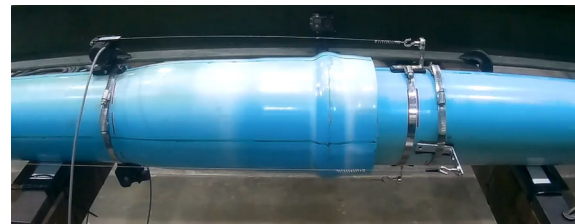
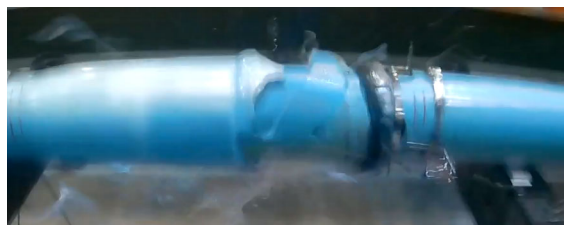
(b) Just before Fracture

(c) Fracture of Bell and Spigot

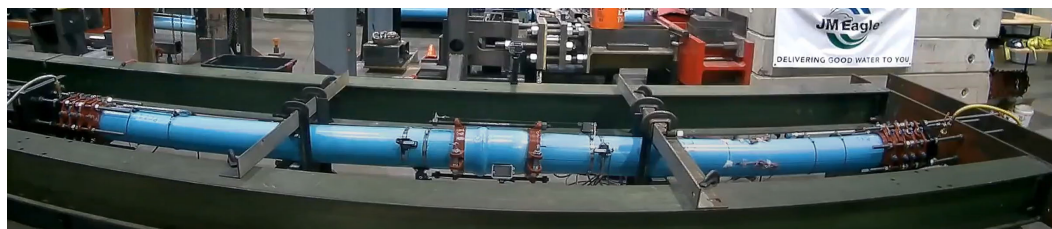
(c) Onset of Out of Plane Bending

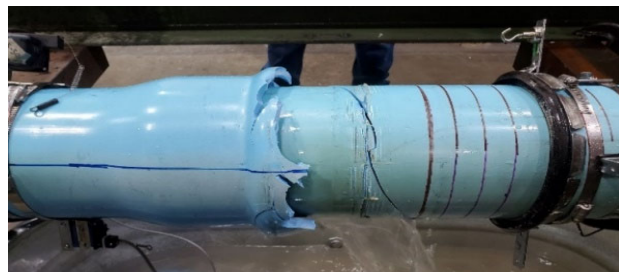
(b) Failure of Bell and Spigot

Figure 3.93. Specimen PS29 (a) Setup and (b) After Failure

Pipe specimen PS29 consisted of an iPVC pipe with an internal TurnerLok gasket restraining the bell and spigot connection located at the midpoint. The specimen was subjected to cyclic loading following Quasi-Static Cyclic Testing protocols outlined in FEMA-461. During the test, fifteen tensile and compressive loading cycles were applied to the specimen using force control. Loading cycles were increased by 40% until a cycle of 20 kips (89 kN) was reached. After the 20-kip cycle was completed, actuator force control was switched to displacement control and the specimen was pulled in tension to failure. Figure 3.93 shows photos for the pre-test setup of specimen PS29 as well as the specimen just after failure at the connection.

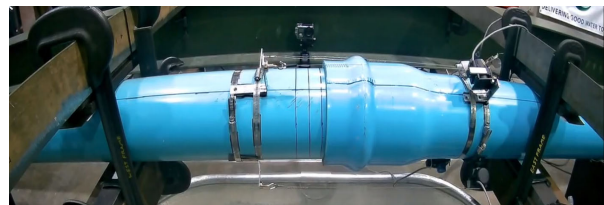
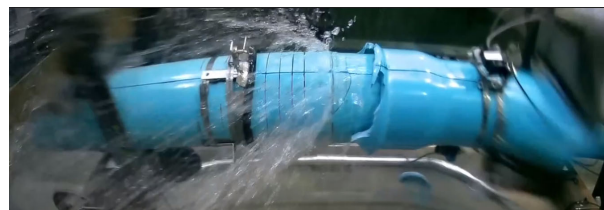
(b) Maximum Compression Cycle

(d) Fracture of Bell and Cracking of Spigot

Figure 3.99. Images of PS29 during the test progression

At a maximum axial force of 36.8 kips (164 kN) and a maximum actuator displacement of 2.61 in. (66.3 mm), the bell suddenly shatters causing a loss of pressurization and the ejection of the internal TurnerLok gasket. Just before failure, yielding and discoloration of the bell was observed. Circumferential cracking was visible along the spigot after the failure of the specimen. There were no signs of leaking before failure. A series of photos taken during the test are presented in Figure 3.99 (a-d).

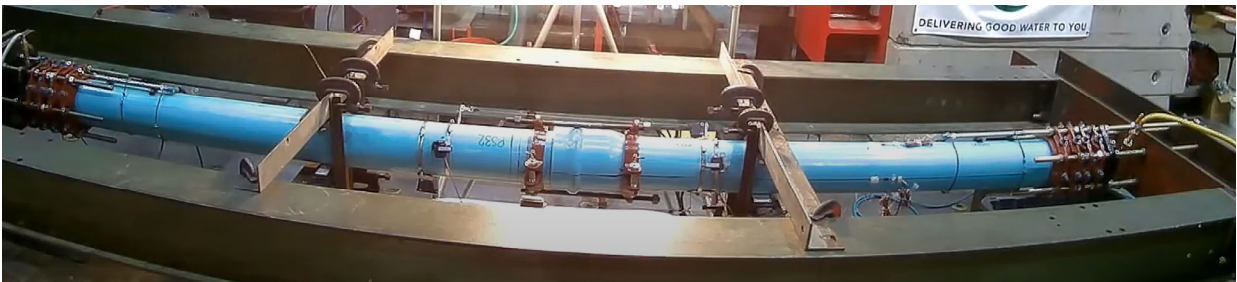
(c) Maximum Compression Cycle

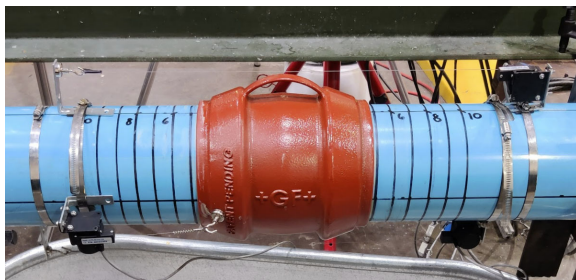
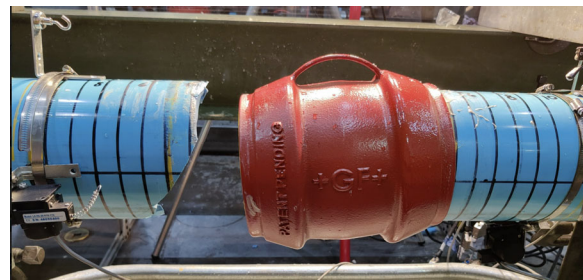
(a) Pre-Test Setup

(b) Circumferential Failure at Coupling

Figure 3.108. Specimen PS36 (a) Setup and (b) After Failure

Pipe specimen PS36 consisted of an iPVC pipe with a Lokx coupling connection at the midpoint. The specimen was subjected to cyclic loading following Quasi-Static Cyclic Testing protocols outlined in FEMA-461. During the test, fifteen tensile and compressive loading cycles were applied to the specimen using force control. Loading cycles were increased by 40% until a cycle of 20 kips (89 kN) was reached. After the 20-kip cycle was completed, actuator force control was switched to displacement control and the specimen was pulled in tension to failure. Figure 3.108 shows photos for the pre-test setup of specimen PS36 as well as the specimen just after failure at the connection.

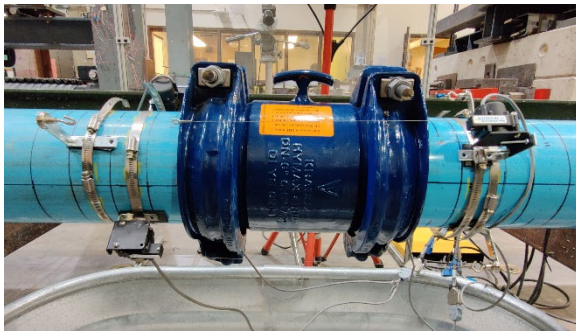
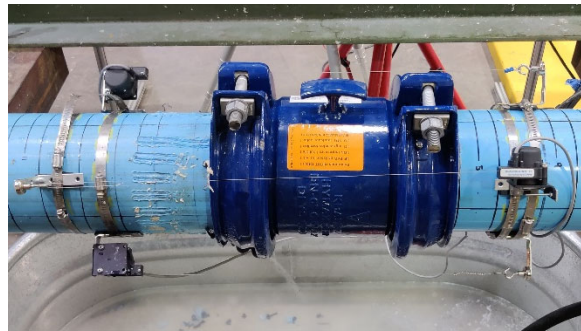
(a) Pre-Test Setup

(b) Failure of the Bell and Spigot

Figure 3.115. Specimen PS39 (a) Setup and (b) Failure of the Bell and Spigot

Pipe specimen PS39 consisted of an iPVC pipe with a Hymax Grip Coupling located at the specimen's midpoint. Pipe segments were inserted 4 in. (102 mm) into each end of the Hymax coupling. Restraint bolts, located at the top of the coupling were tightened to the minimum required torque specifications for 6 in. (152 mm) nominal diameter pipes [110 lb.-ft (149 N-m)]. The specimen was subjected to cyclic loading following Quasi-Static Cyclic Testing protocols outlined in FEMA-461. During the test, fifteen tensile and compressive loading cycles were applied to the specimen using force control. Loading cycles were increased by 40% until a cycle of 20 kips (89 kN) was reached. After the 20-kip cycle was completed, actuator force control was switched to displacement control and the specimen was pulled in tension to failure. Figure 3.115 shows photos for the pre-test setup of specimen PS39 as well as the specimen just after the conclusion of the test.

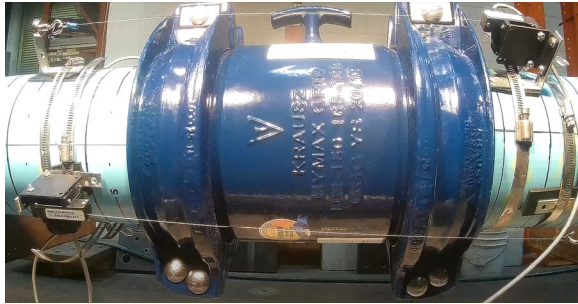
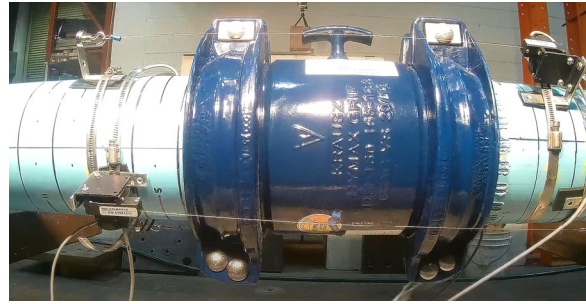
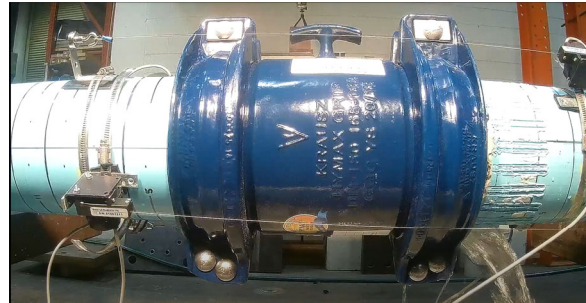
Figure 3.121. Images of PS39 during the test progression

(a) Start of Test

(b) Onset of Leaking

(d) End of Test

At the conclusion of the test, a maximum axial tension force of 22.5 kips (100 kN) and a maximum actuator displacement of 3.26 in. (83 mm) was reached. As shown in Figure 3.122, gouges from the gripper gaskets teeth were visible along the spigot of the specimen. A series of photos taken during the test are presented in Figure 3.121 (a-d).
