Rover on The Red Horizon

University of Colorado, Colorado Springs

SolidWorks Drawings of Lil' Clyde Structural Elements

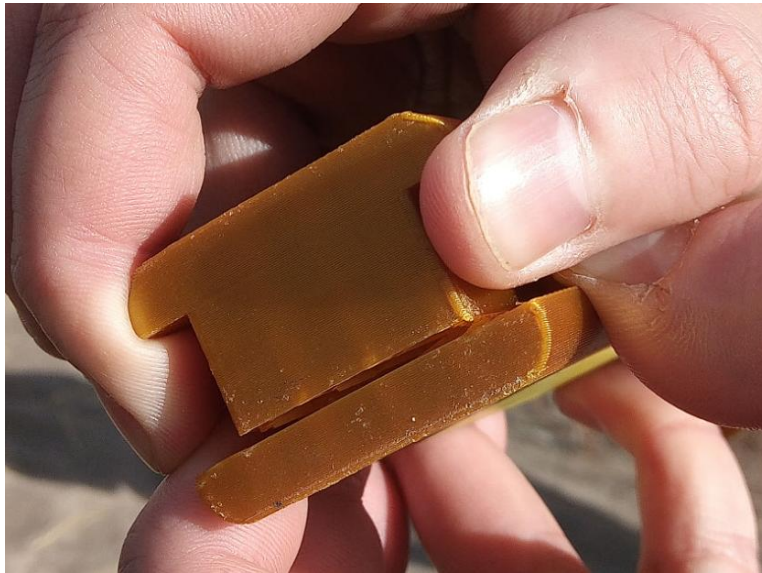
Figure. 3: Example of layer separation failure

The rover was damaged several times. Most frequently the breaks occurred at the joint are between the motor mounts and legs. Increasing the amount of material in these areas

either by changing the geometry or using a higher infill would have increased the strength of the parts involved. However, the failures always manifested as cracks along layer lines, and these cracks were also present in other areas of the rover. So, this issue could also potentially be resolved by changing the print orientation of the parts so that the expected tensile and shear loads act parallel to the layer orientation rather than creating forces that pull layers apart, which results in far lower strength of the material. Aluminum reinforcements were added to joint areas that were weak, but unfortunately the weakness of the central leg joints was not seen as a potential issue prior to challenge day.
