# ARES DemoSat Final Report

August 13, 2019

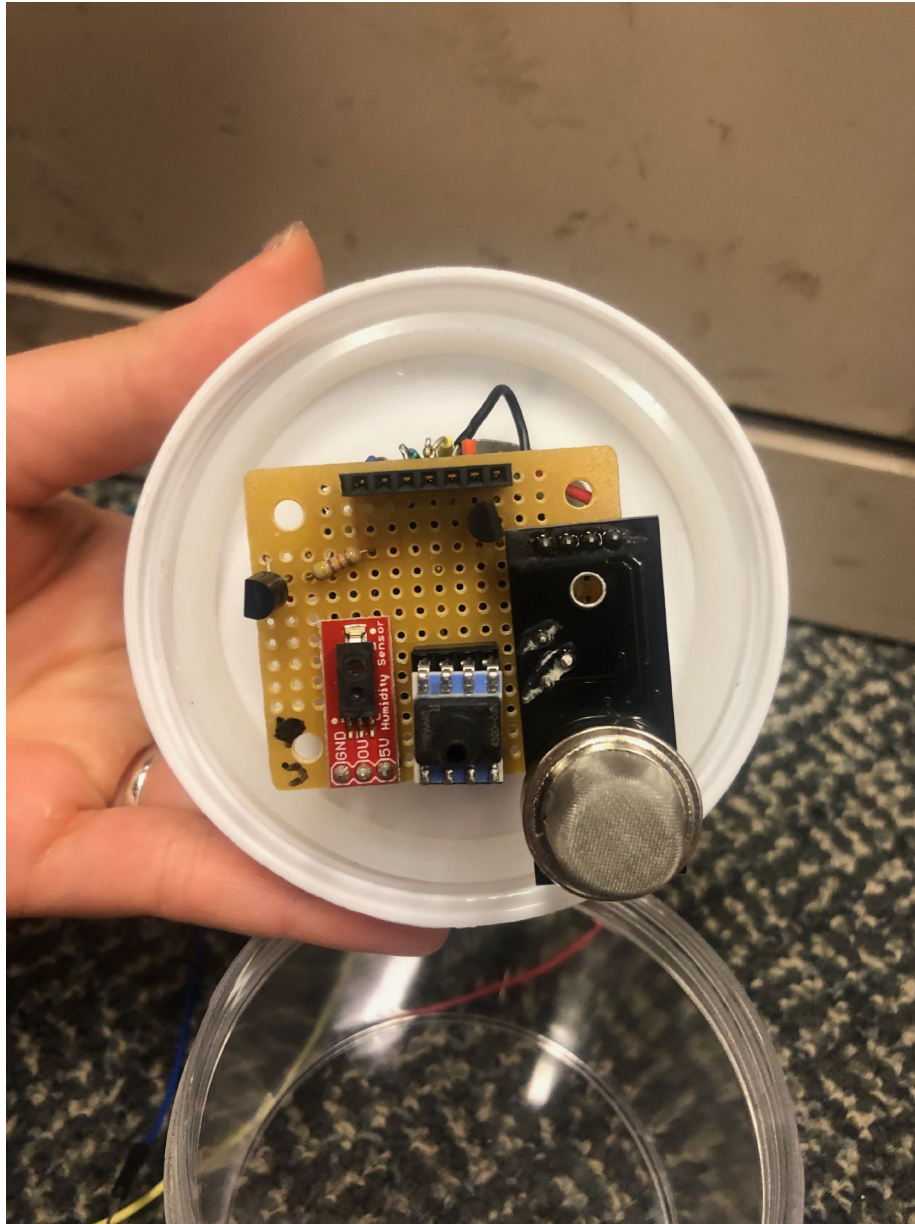
Figure 7: Sensors included within Polystyrene Jars

In each container there was an Ammonia sensor, pressure sensor, temperature sensor, and a humidity sensor, shown in figure 7. These gave us readings on what the conditions were like in our pressurized containers, and whether or not they were suitable for the bacteria to produce ammonia. Finally, we included a separate power source for our ceramic heaters since they required more current than the Arduino outputted. This necessitated the addition of a second switch to the outside of the box, with the first describing the status of the Arduino and all sensors, and the second showing whether the heaters were powered and

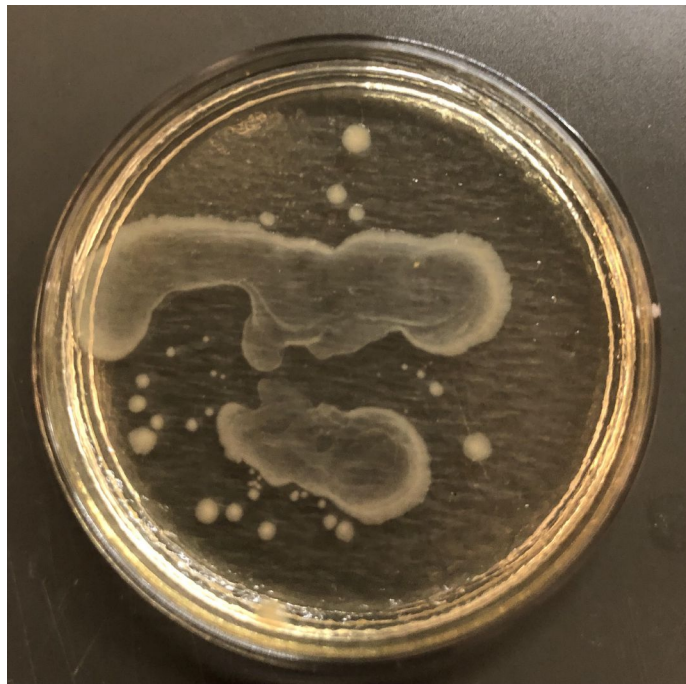
Figure 8: *E. coli* grown on Agar Plates

Due to complications with the ammonia sensor in Jar B, data from the *E. coli* samples in Jar C (3 samples) were used for the results of the ammonia production test. The bacteria survived and produced ammonia throughout the entire test. The highest level of ammonia measured was 3.58 ppm (figure 10). During the cold test, the *E. coli* froze due to a malfunction with the heater failing to stay powered for the duration of the test. The inside of the thermal chamber reached a minimum temperature  $-36.5^{\circ}\text{C}$ . The inside of the payload reached a minimum temperature of  $-7^{\circ}\text{C}$ . When the *E. coli* was frozen, it did not produce ammonia. However, both samples survived the test. This conclusion was made when the plates thawed and the *E. coli* was able to produce ammonia again. Both samples of *E. coli* that were used for the functional test survived. Ammonia production was observed throughout the 10 hour test.

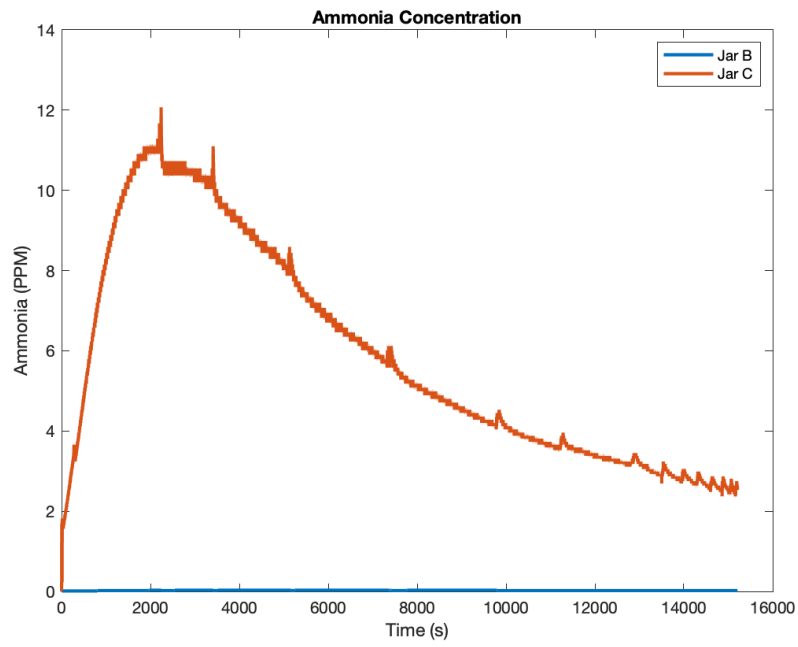
Figure 11: Ammonia production (measured in ppm) from the functional test. The *E. coli* that was used in the cold test was placed in Jar B and the *E. coli* that was not used in the cold test was placed in Jar C.

Based on the data in Figure 11, it does not appear as though any ammonia was produced from the *E. coli* in jar B. However, based on the raw data shown in Figure 12, the *E. coli* did produce ammonia. These results suggest that the RO value used to calibrate the ammonia sensor in Jar B was not correct.

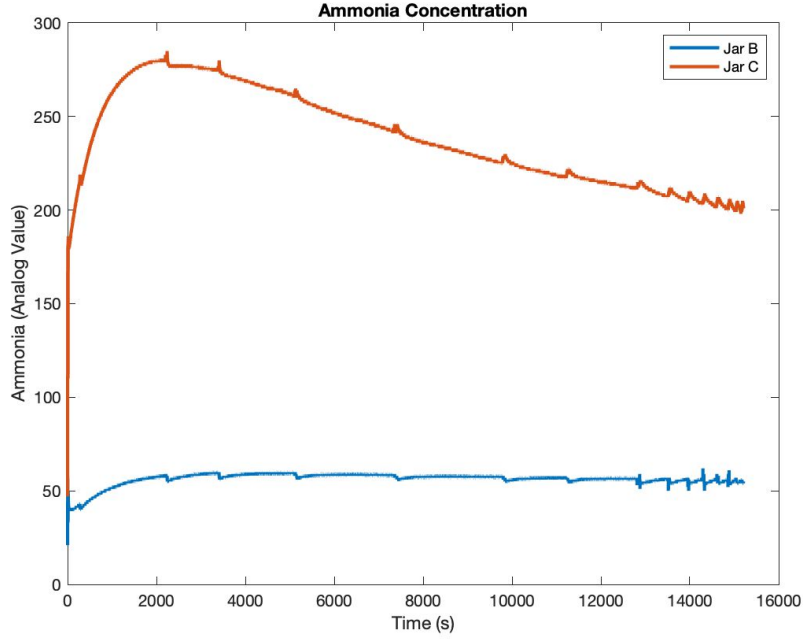
Figure 12: Raw data from the ammonia test.

The same graphs for the long functional test are shown in figure 21. The same ammonia code issue occurred so the raw ammonia data is shown in figure 12.

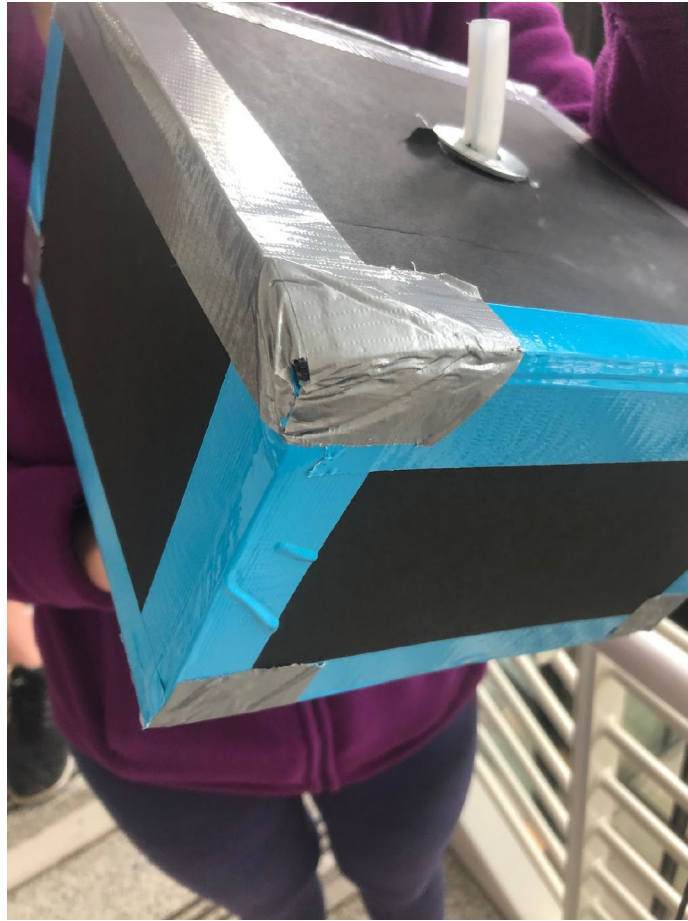
Figure 13: Damage from Stair Test

Our payload suffered minimal damage after the three structural tests were performed. After the stair and drop test the payload bent in the corners. However, during the whip test, the systems remained intact. Images from all tests can be seen in figures 13, 14, and 15.

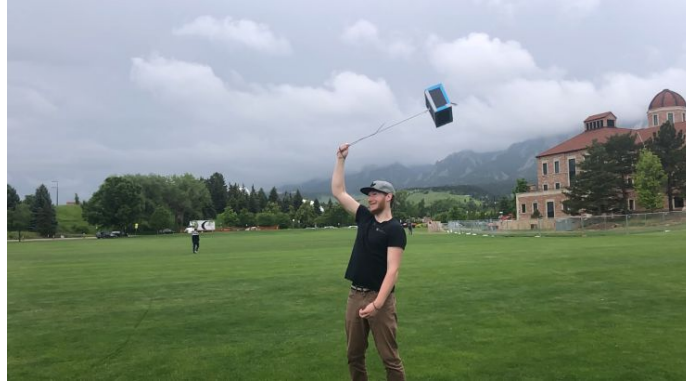
Figure 15: Whip Test

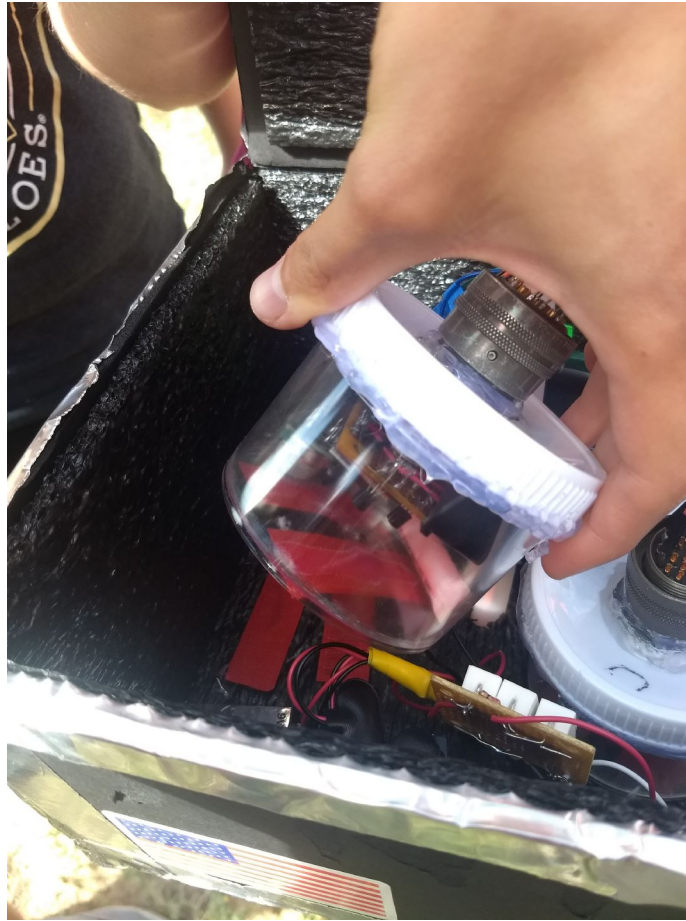
Figure 18: Final method of sealing the jar

The final method of sealing was determined to be the silicone ring, o-rings, and hot glue around the hermetic seal and where the lid and jar meet, seen in figure 18. Though the petroleum jelly method worked the best, it was decided that air leakage was better than a chance of the lid failing, which would have caused mission failure.

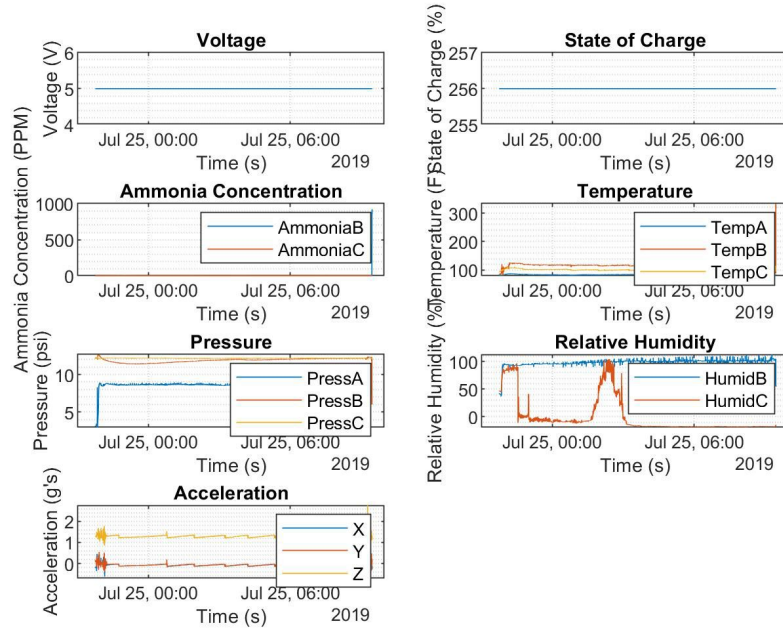
Figure 19: Graphs for Short Functional Test

All systems worked for the duration of both functional tests. The first functional test used the ammonia packets to test the sensors. This test was four hours and used the portable battery to power everything except the heaters, which were not turned on. The second functional test was done overnight (10 hours) and used *E. coli* in both jars. This was done to see if we could get ammonia readings for extended periods of time. All sensors labeled "A" are on the Arduino, sensors labeled "B" are for the jar with the ammonia packet, and sensors labeled "C" are for the jar with the *E. coli*.

The graphs for the first test can be seen in figure 19.

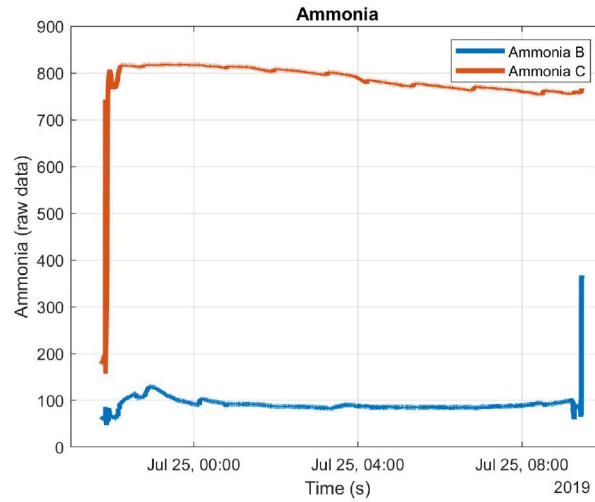
Figure 20: Raw Ammonia Data: Short Functional Test

The code converting the raw ammonia data to parts per million did not function properly but the raw data is shown in figure 20. Additionally, at this point, the team did not know the ammonia sensors needed to be calibrated each time they were used, and that the calibration value depends on both the sensor and how much it has been used. The same calibration value was being used for both sensors, providing the large difference in ammonia data shown.

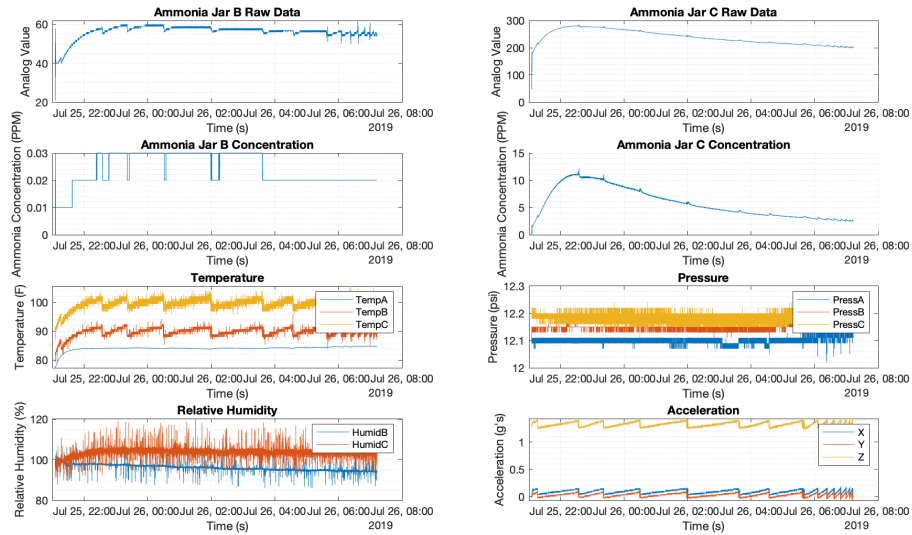
Figure 21: Graphs for the Long Functional Test

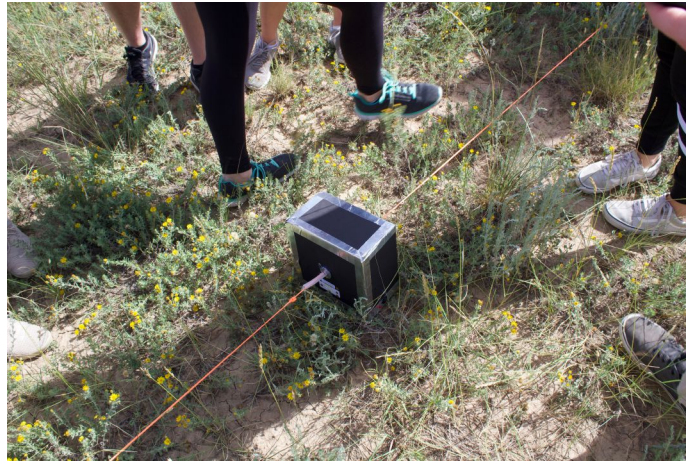
Figure 23: Payload after Launch

After the payload was retrieved, it was determined that all systems ran for the entirety of the flight. Immediate views of the internal and external structures revealed little to no damage, and all of the internal electrical components remained attached in the correct positions. Early analysis of the data revealed some interesting anomalies in the amounts of measured ammonia at different times in the flight. With the bacterial sample, large spikes occurred during burst, however, relatively constant values during both the release from the balloon and the impact with the ground were observed. When observing the raw collected ammonia data from both the bacterial jar and the jar with the ammonia packet, there were similar trends in ammonia production seen in both jars. More ground testing was needed to establish what might be causing these changes. With regards to the data received from other sensors, all the sensors worked well and produced data that was consistent with what we expected (based on previous weather balloon flight data). All of the plots from the flight are shown below.

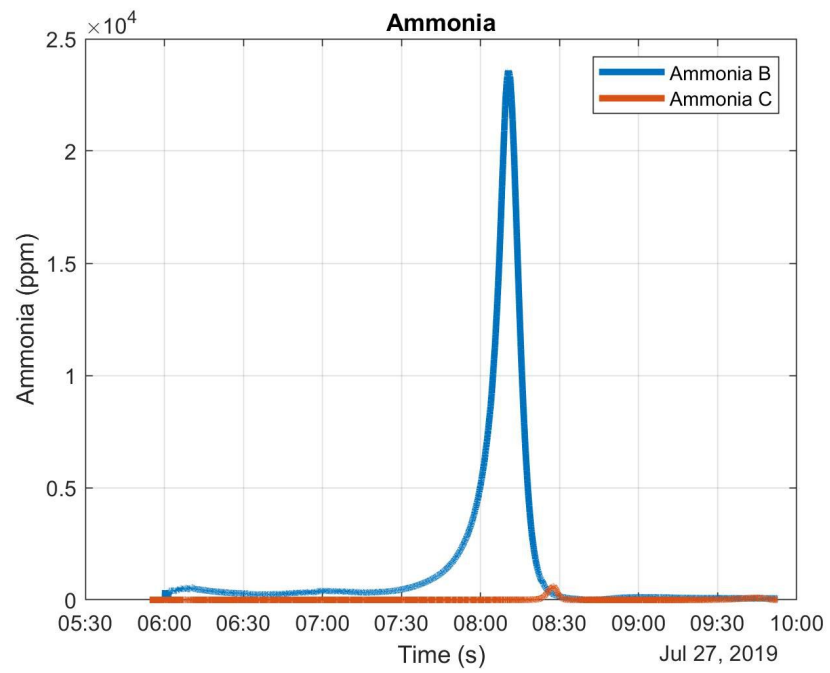
Figure 26: Ammonia Concentration (ppm) during Launch

The ammonia graph in parts per million is specifically shown in figure 26, and the raw ammonia data is shown in figure 27

Comparing these graphs to the pre-launch testing shows that the *E. coli*, tested by ammonia sensor C, produced more ammonia during the launch.

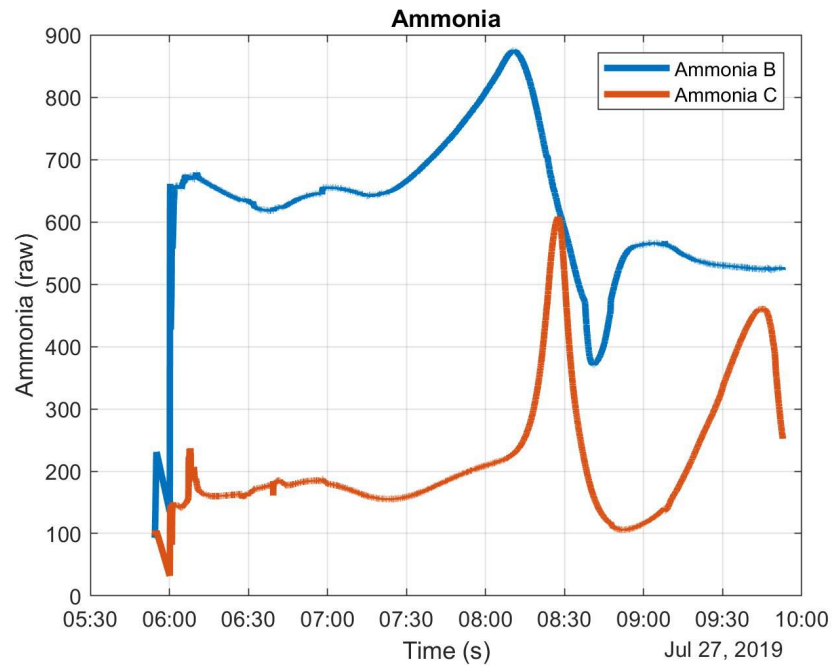
Figure 27: Ammonia Concentration (raw) during Launch

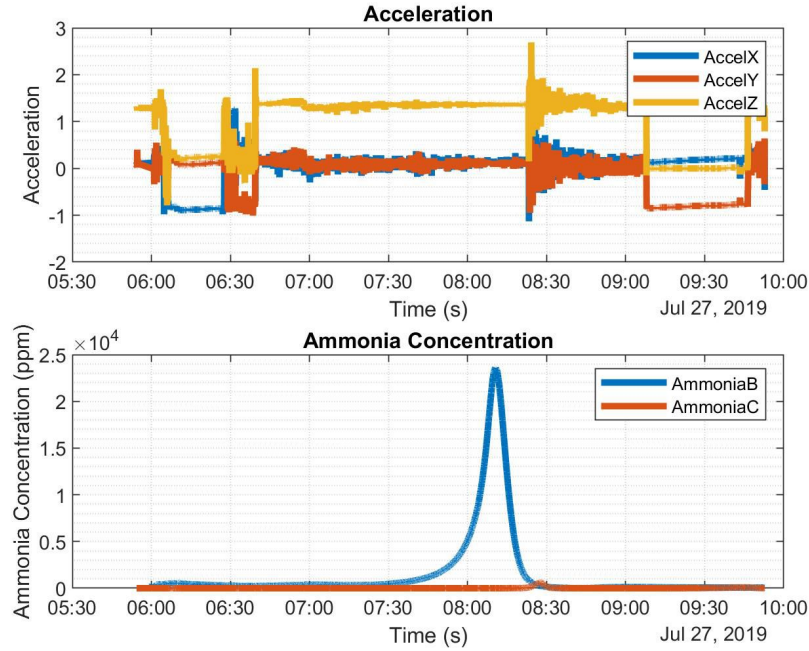
Figure 28: Ammonia compared to acceleration

The ammonia versus acceleration graph is shown in figure 28. The large spikes in the ammonia are around the same time as burst, between 8:00 and 8:30.

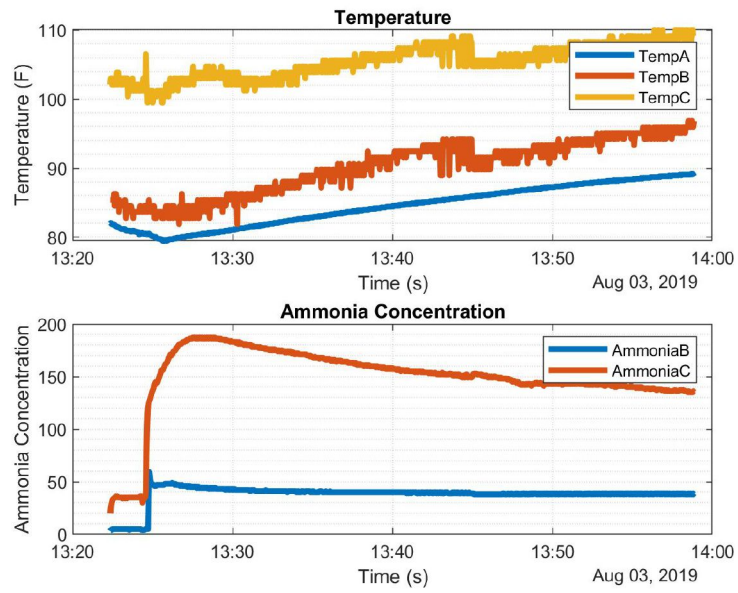
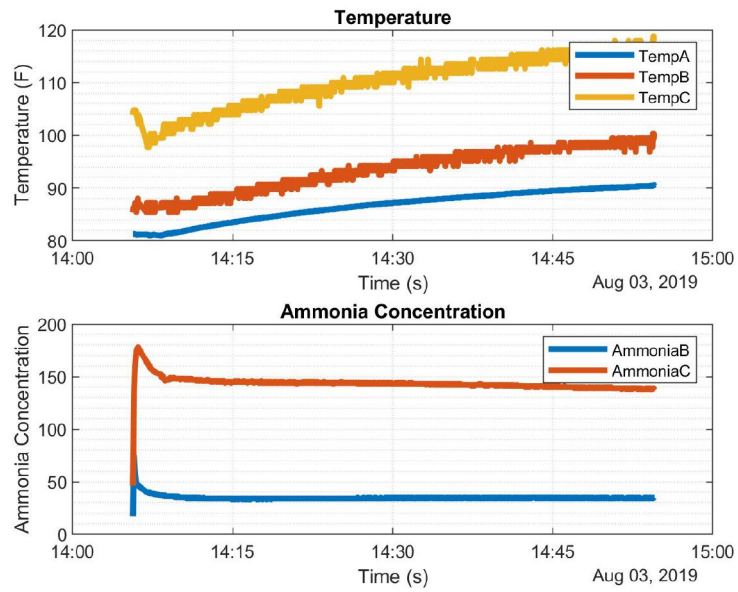
Figure 29: Temperature Test 1

Figure 30: Temperature Test 2

Figure 31: Temperature Test 3

None of the tests yielded in significant changes in the ammonia sensor readings. The code for the conversion from the raw ammonia data to parts per million was not working, so the graphs below show raw ammonia concentration.

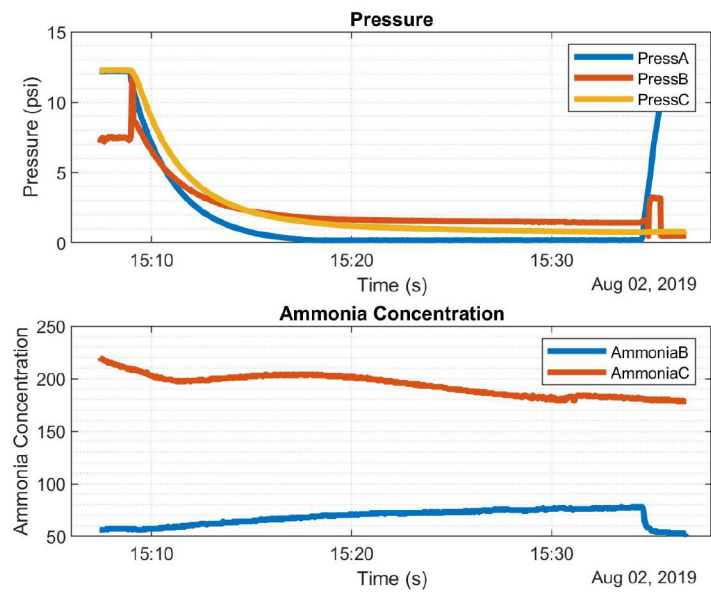
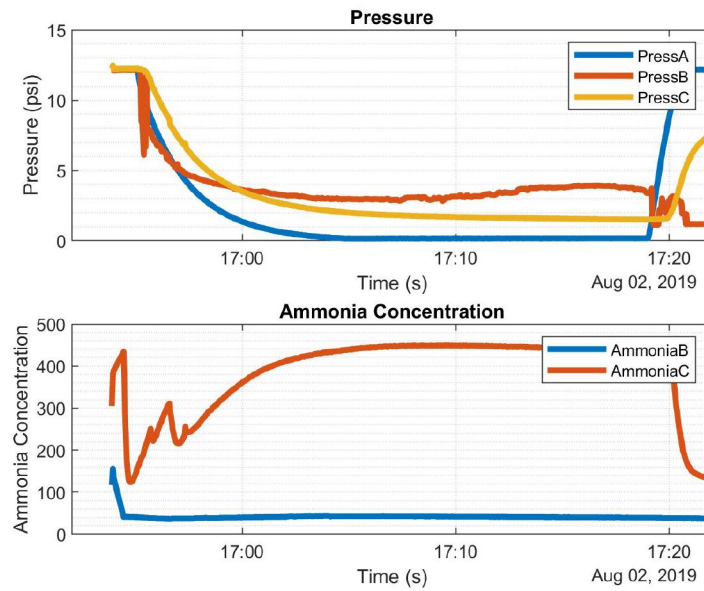
Figure 32: Pressure Test 1

Figure 33: Pressure Test 2

Figure 34: Pressure Test 3
