# Colorado Space Grant Consortium

## Exposing Nanofibers to Increased Radiation Flux

Amber Bekkali, Ryan Fabian, Donovan Anderson

April 28<sup>th</sup> 2015

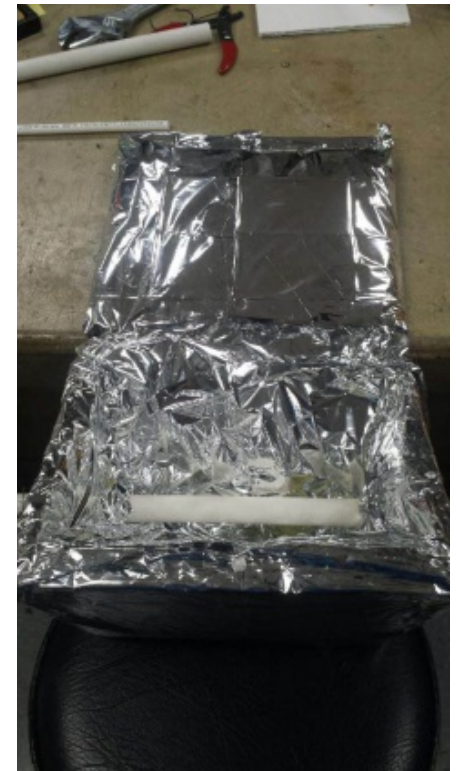
- Our box is pictured to the right.
- The nanofibers were in suspension in distilled water, which was held in a plastic test tube. The tube was surrounded by 2-inch thick foam tubing. The open ends of the tubing were sealed using hot glue so any leaks will be contained. The tube was also placed in a plastic bag in the event the tube exploded or leaked.
- A heater was used to try and ensure that the water did not freeze. The heater was constructed from batteries and resistors, is shown at the lower right.
- An HOBO Temperature Data Logger collected temperature data. Knowing the ambient temperature in the box gave us a good idea what was happening during the flight.

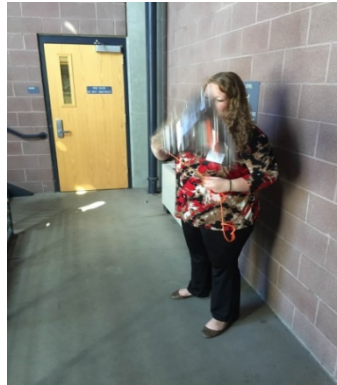
- Passed swing test
  - Box was forcefully swung for about 5 minutes.
