# Typhoon Haiyan Shelter Case Studies

January 2017

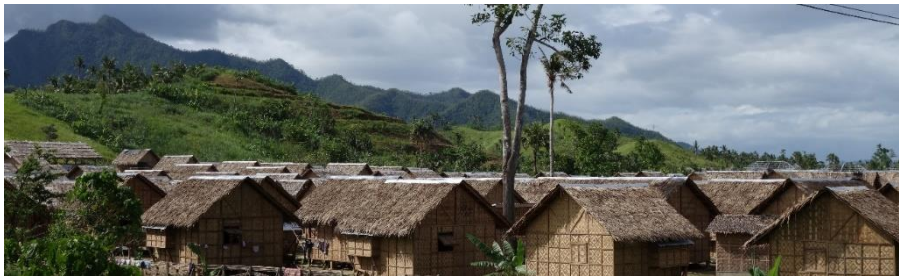
A transitional shelter site is shown in northern Tacloban. The urban center has plans to relocate 20% of its population to resettlement sites north of the city center.

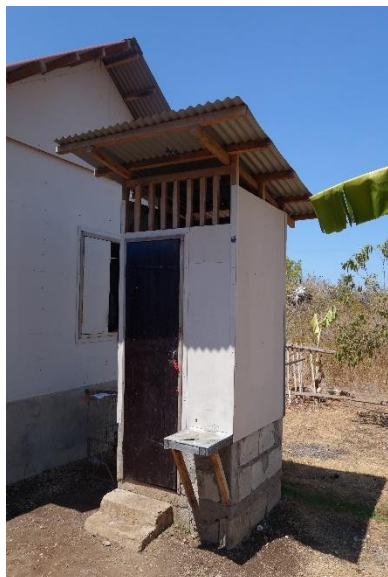
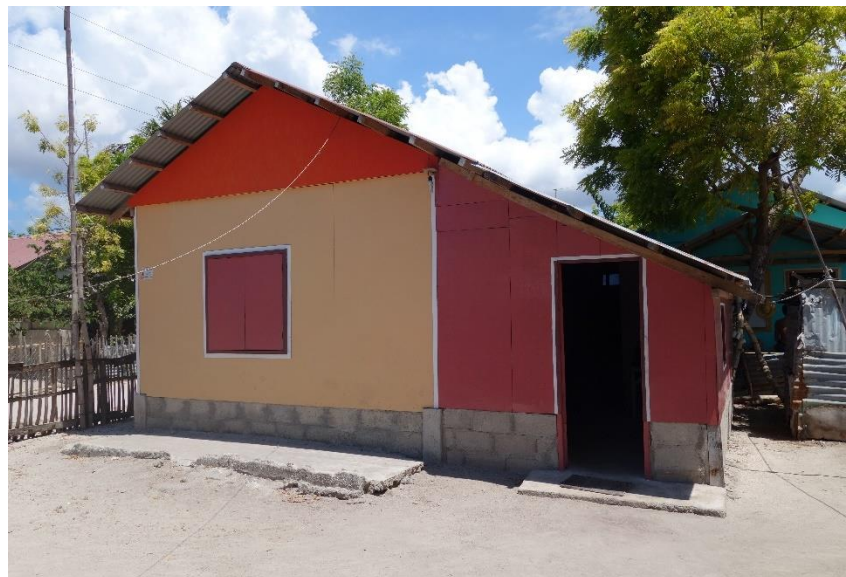
**Left: Latrines were also included in the construction package offered to beneficiaries.**

**Right: A beneficiary expanded using similar materials and building techniques as well as painted the original structure for aesthetics and maintenance reasons.**

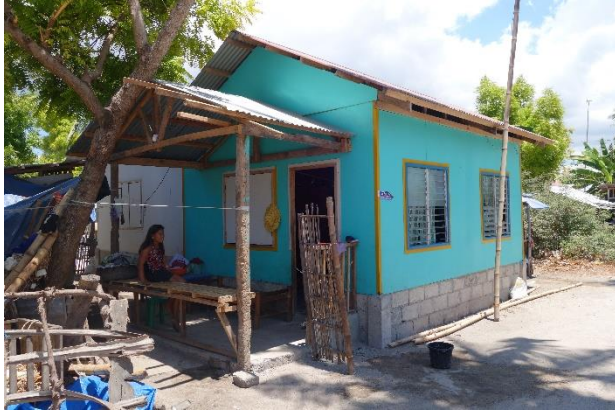
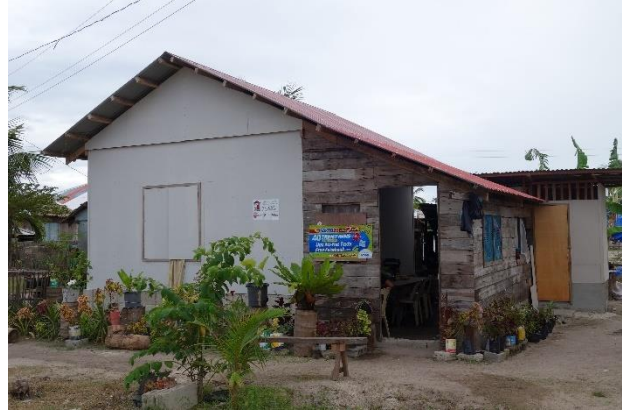
**Left:** An example of a porch added to a core shelter. The beneficiary also painted the original structure.

**Right:** Another example highlights the variety of materials used for expansions, in this case, the exterior of coconut trees.

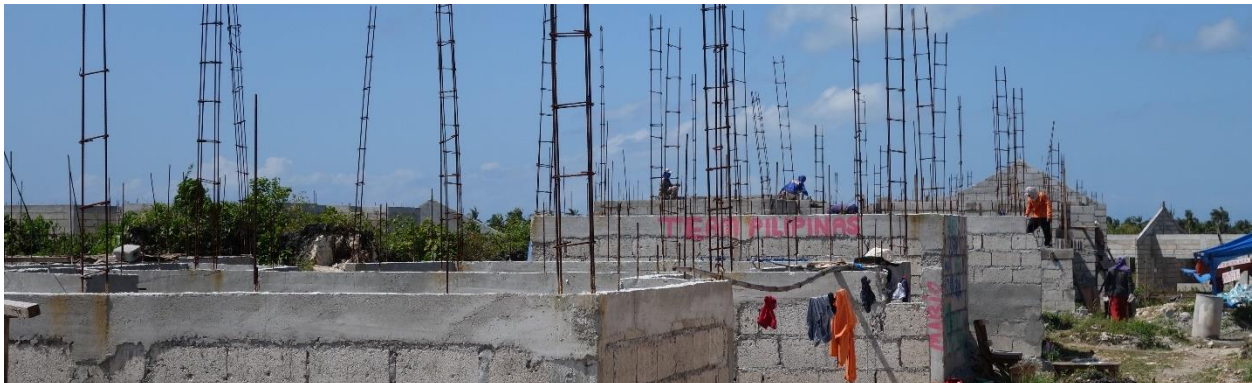
**Left: A housing unit takes shape.**

**Bottom: Construction of housing using confined masonry provided an exemplar standard.**

- ✓ The use of confined masonry provided a sense of security for beneficiaries and the houses provide a viable evacuation center for neighboring areas.
- ✓ The duplex design used saved on cost by sharing a central wall.
- ✓ The local government led the beneficiary selection process in collaboration with the shelter organization, leading to greater awareness of long term vulnerabilities that existed within the municipality.

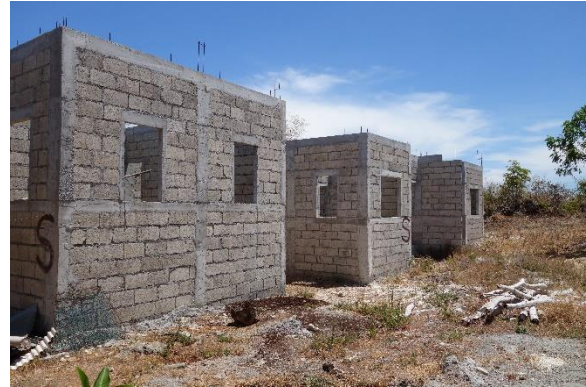
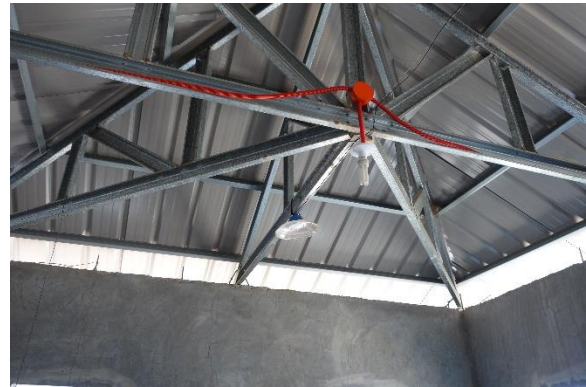
**Top:** Uncompleted units scatter the site pending completion due to delays.

**Middle:** Steel girders welded together were used in roofing. In some cases, these were also painted for corrosion protection.

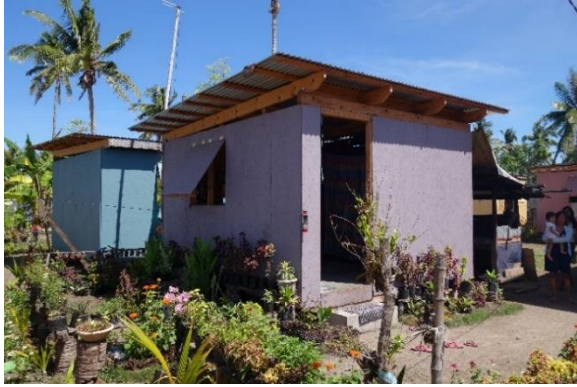
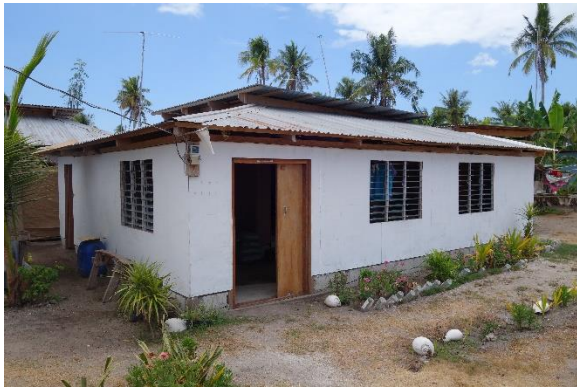
**Top:** An original shelter is shown. Each beneficiary was able to choose their own paint color.

**Middle:** A beneficiary has expanded, more than doubling the size of the original structure.

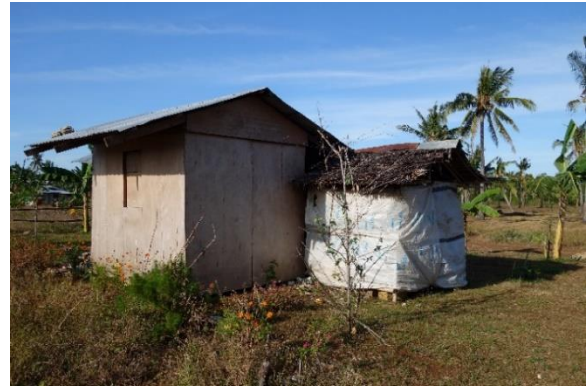
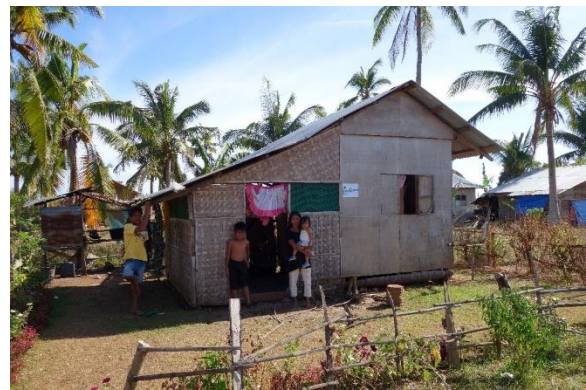
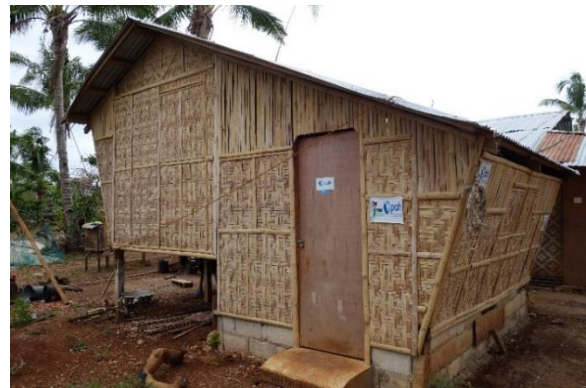
**Top:** Initial temporary shelter package that was provided to households. Storage areas were commonly added for seaweed and crab livelihoods.

Following an initial batch of shelter distributions, designs evolved, eventually leading to a dramatically different structure which included amakan walling, coconut lumber members, and pre-cast concrete foundations. This design integrated other typhoon-resistant design features to improve on the first shelters constructed. A relatively small number (less than 10) were constructed in Sungko, however the designs were used in several other communities later in recovery. The ability to iterate designs in later phases was unique and showcases an effective strategy to improve beneficiary satisfaction as lessons are learned, before waiting for the next response.

One feature that enabled improved living conditions was the use of flared walls, increasing interior space, without increasing floor area and cost. The use of a raised second room added privacy and improved ventilation for the sleeping area. Column posts were specifically designs so that they could be dug up and moved if needed given the complex land rights of the island. Connections could also easily be removed, relying on two steel plates and bolts to connect the shelter posts and foundations. In place of embedding steel plates, bolt holes were precast into footings using pipe sleeves.

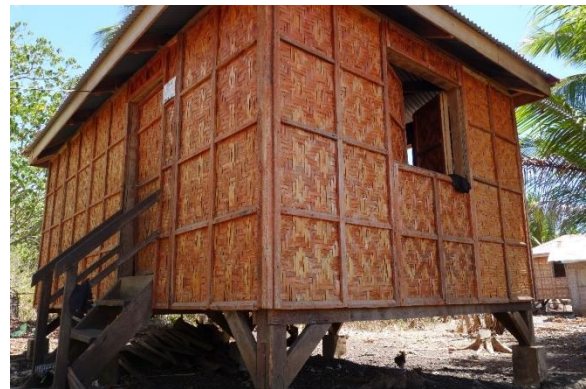
**Top: Termite and weathering protection included the use of solignum, a chemical protectant, that was applied to amakan walls. Used motor oil was also applied to posts for protection.**

- ✓ Complementary livelihood program, in particular livestock, was able to boost income for households and enable transition to long term recovery.
- ✓ Weatherproofing and protection measures, including solignum coating of walls, used motor oil coating of lower posts, and raised concrete footings, were found to be an effective combination in limiting termite damage.
- ✓ Shelters were well ventilated and provided large livable space.

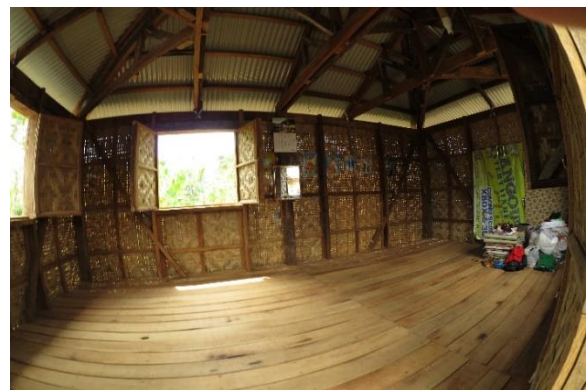
**Bottom: Interiors were spacious, allowing beneficiaries to place partitions to fit individual household needs.**

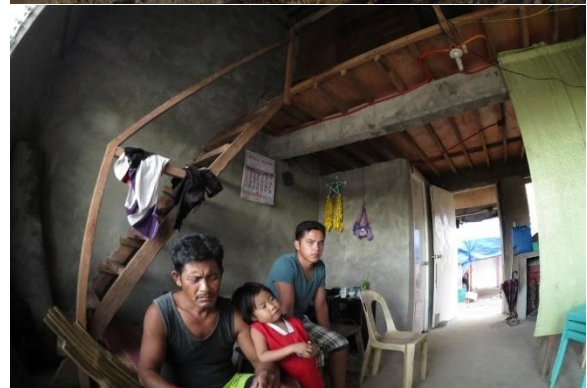
**Bottom:** A beneficiary has added a second floor using remnants of their previous house and from a previously received shelter repair kit.

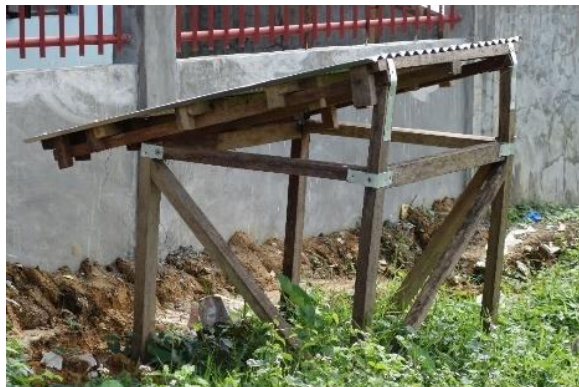
Scale model used to demonstration key messages for safer building construction.

A one-day training on building practices led by the organization was provided to hired carpenters. Any household members were able to participate, and approximately 20 individual attended the training. In order to demonstrate concepts, the organization demonstrated skills on a scale model.

- ✓ Training program used active demonstration to show safer building concepts using a scale model.
- ✓ Blanket coverage of 3 packages of shelter repair kits reduced conflicts of beneficiary selection and better fit individual needs.
- ✓ Despite having low incomes, households had some of the highest savings, attributed in part to control over prioritizing individual recovery needs.

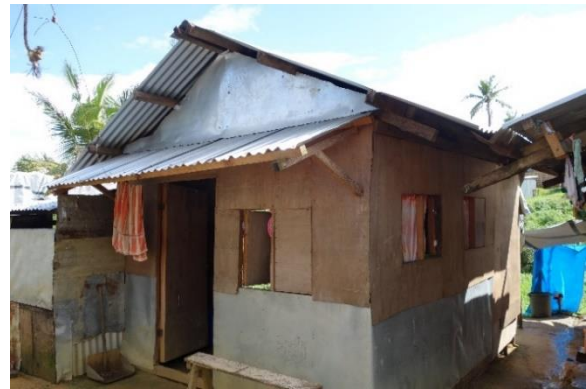
Materials were used for variety of purposes suited to the needs of each household.

Material packages with fewer items were commonly used to extend houses. Intermediate packages were most frequently used for roofing repairs and minor walling, while the largest package was used for new construction. The materials included nails, corrugated galvanized iron (CGI) sheets, several coconut members, and plywood. In place of using sawn coconut members for posts, most households opted to reuse hardwood timber. As concrete was not included, posts were typically buried 1 meter into the ground for stability.

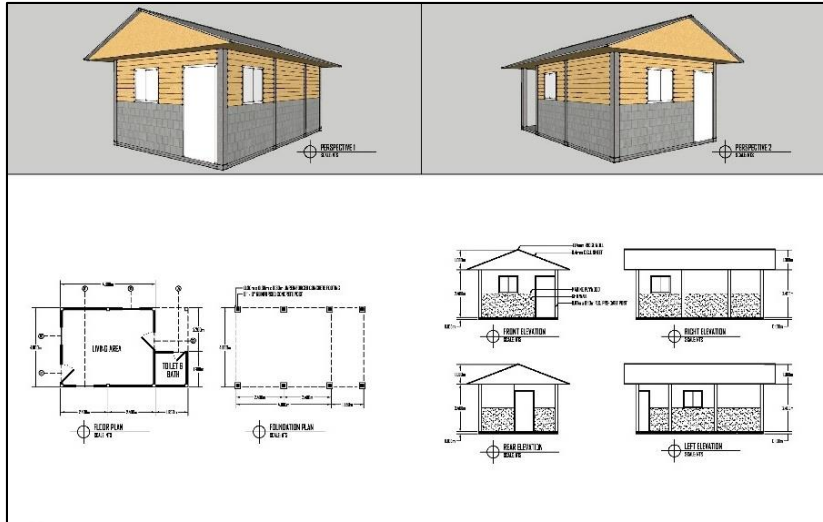
The core shelter design used a masonry skirt wall with timber frame, providing added strength with reduced cost.

featured concrete columns, a masonry skirt wall, and plywood walling. The large interiors were well suited to future addition of partitions and the place of doors and windows enabled easy expansion on to the front and back of shelters. Toilets and septic tanks were integrated into each shelter design; however, a kitchen area was not. Kitchens were usually the first expansions observed. A training on safe housing construction and disaster risk reduction was conducted for all beneficiaries on a weekly basis before the start of construction.

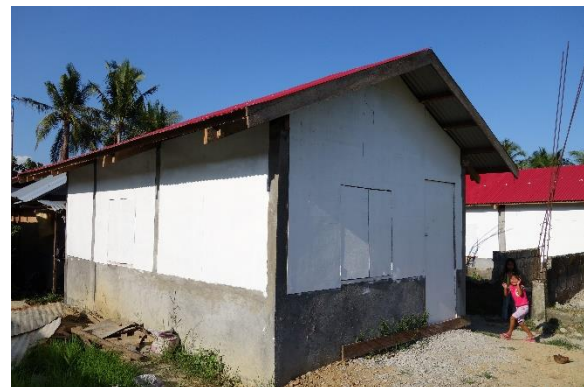
A completed core shelter after completion.

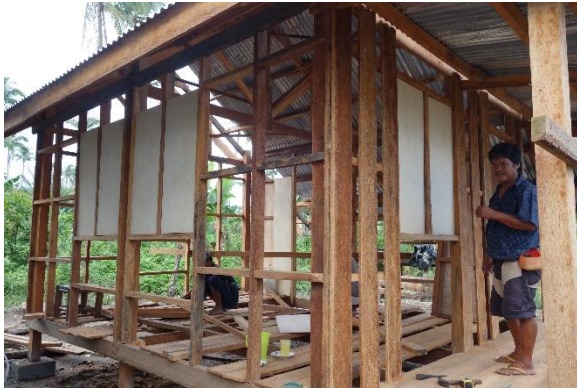
Construction of shelter walls.

shelter. The organization selected to use vertical or horizontal timber planks for exterior walls. This was found to significantly improve the weatherproofing and proved better protection from rain over other alternatives such as amakan (woven thatch) or plywood. In comparison to other shelter assistance, the structures were much larger for household sizes, and several beneficiaries noted that they would plan to downsize the structures as future maintenance was required, in place to replacing elements due to cost constraints.

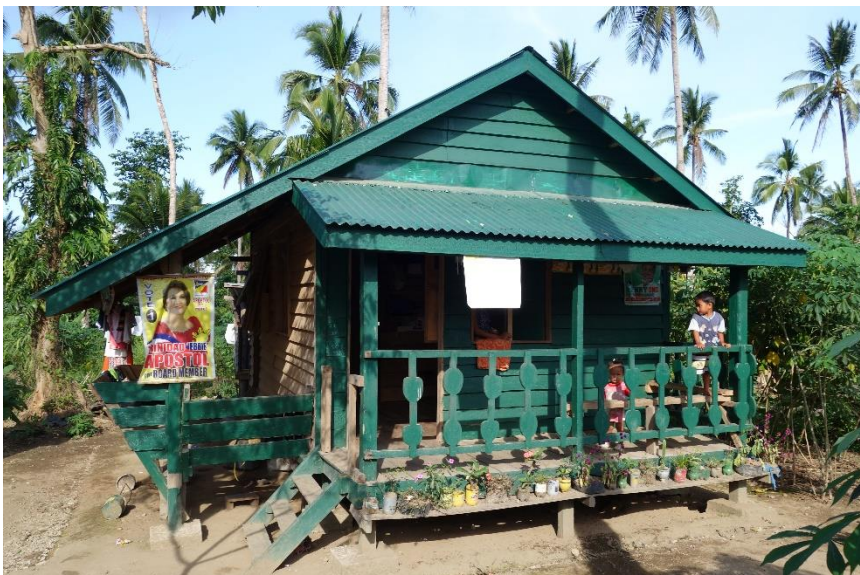
The incorporation of covered, open air spaces into shelter designs allowed for more livable conditions that increased beneficiary satisfaction.

Designs were developed from an earlier recovery project in another barangay in Jaro. The shelters featured large covered porches, and extended roofing to allow for significant open air covered spaces. To protect from weathering and termites, paint was provided, although not sufficient to cover the entire

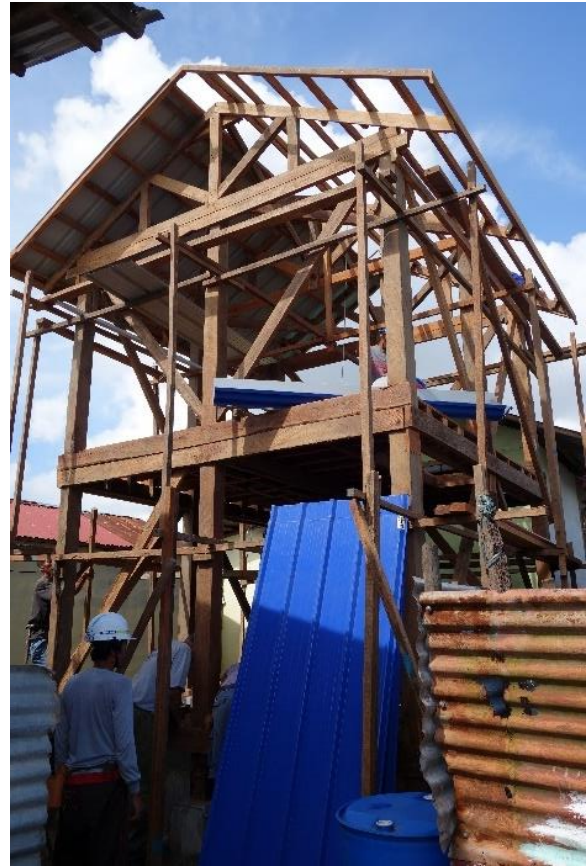
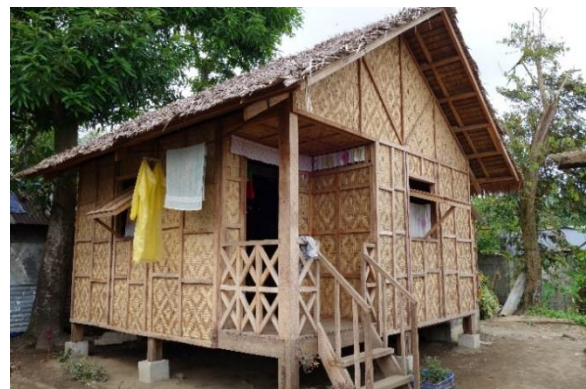
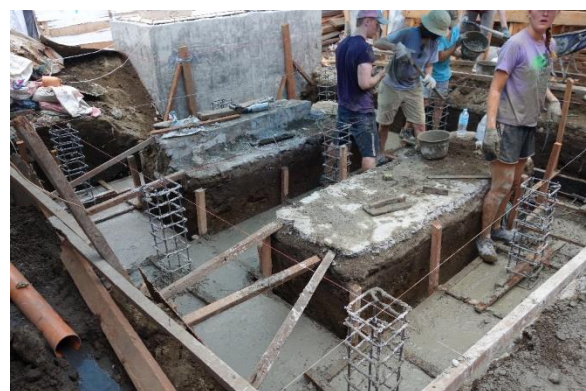
**Bottom:** Shelters included extensive concrete foundations to support overturning forces of wind on two story structures.

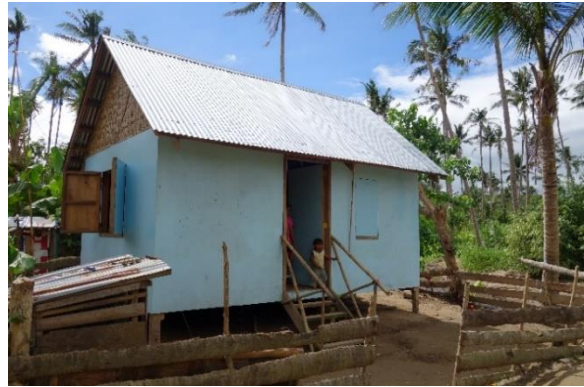
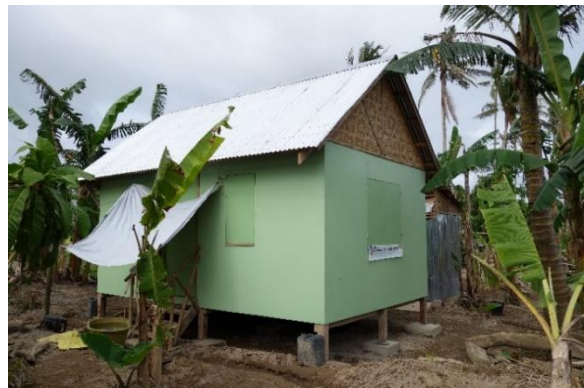
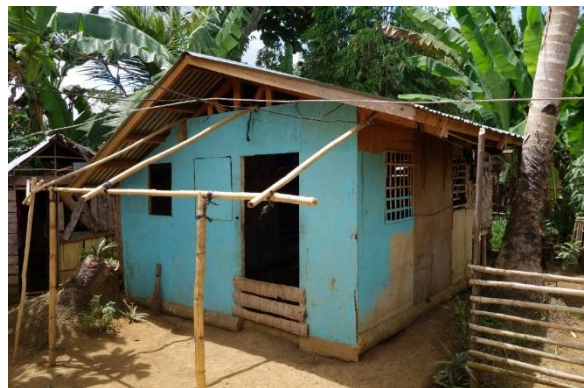
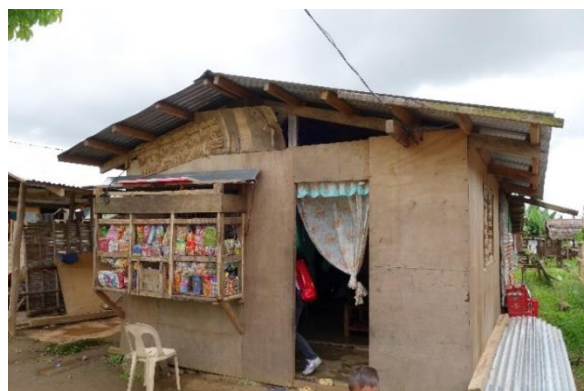
**Top (2 photos):** A limited number of core shelters shown were constructed for the most vulnerable families.

**Bottom (2 photos):** Shelter materials kits were used in a variety of ways including repairing damaged houses and adding sari-sari storefront to existing houses.

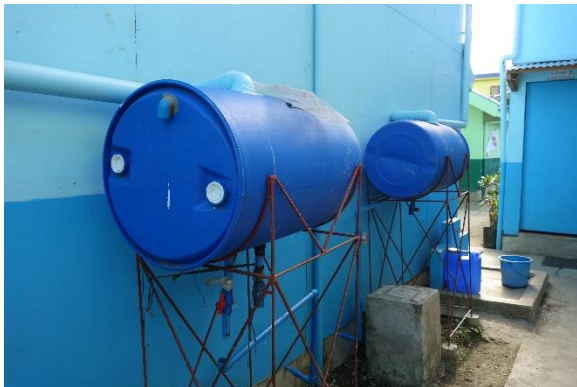
**Top:** Duplexes, two story shelters, and a variety of alternatives assisted meet the complex urban environment of Saghakan.

**Bottom:** A pair of broken and unused rainwater collection tanks highlight one of the few flaws of assistance provided.

- High water table in community led to the failure of over 50% of septic tanks; raised tanks may have been an alternative solution to improve performance.
- Rainwater collection systems were not used by households because of other sustainable sources of water; failure to fix pipe breaks were another reason these were not used.

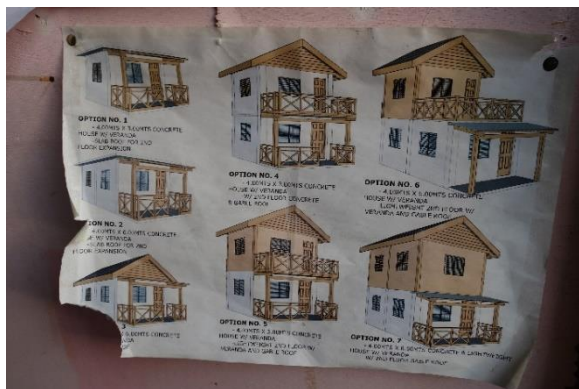
Poster of available design options available.

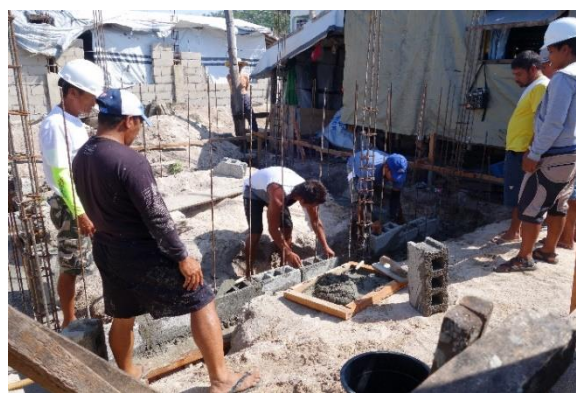
Demonstration training for block laying.

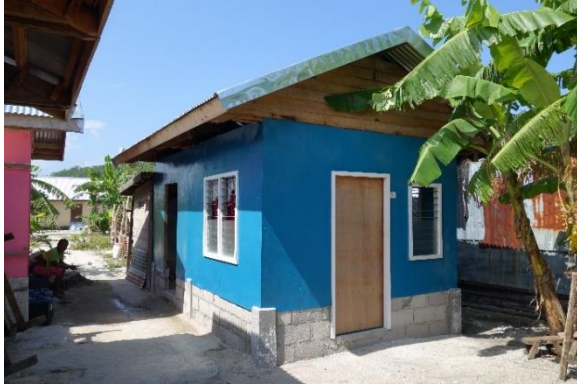
Alternative timber design house with masonry skirt.

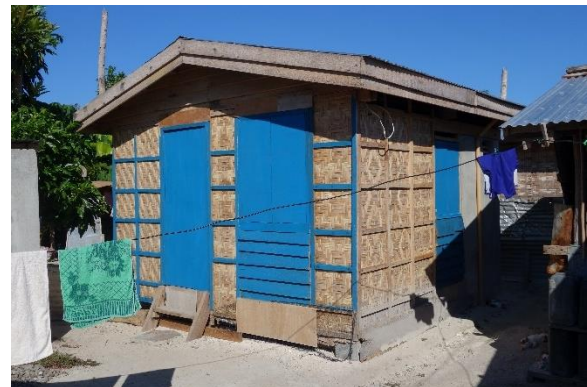
Shelter design developed in later phase under reduced budget.

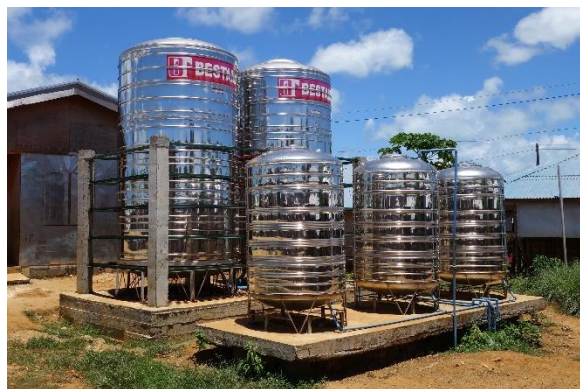
The site water storage and pump system that has gone unused.

Following completion of all transitional shelters, two partner organizations provided water and sanitation infrastructure to support the new site. One organization targeted water infrastructure through the installation of a central well with electric pump and several storage tanks. Despite the investment of this infrastructure, the cost of use and maintenance was prohibitive for most households who refused to pay the needed operational costs of P100/month. As a result, the system has not been used and nearby wells have become the primary source of water.

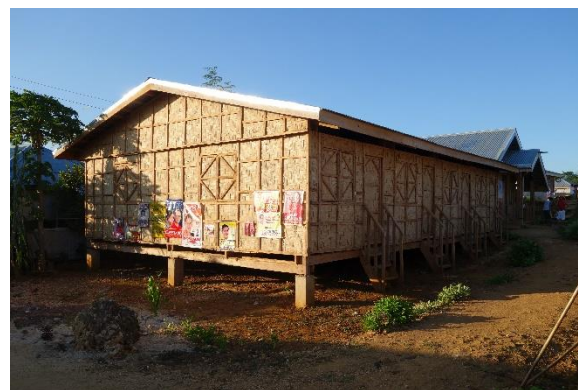
Transitional bunk house to be used while permanent houses are constructed.

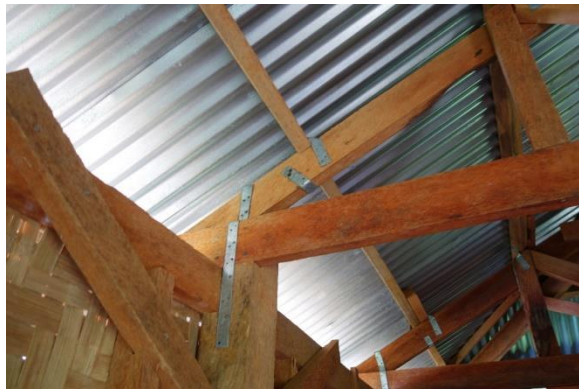
Strapping was one of several design features emphasized in training sessions.

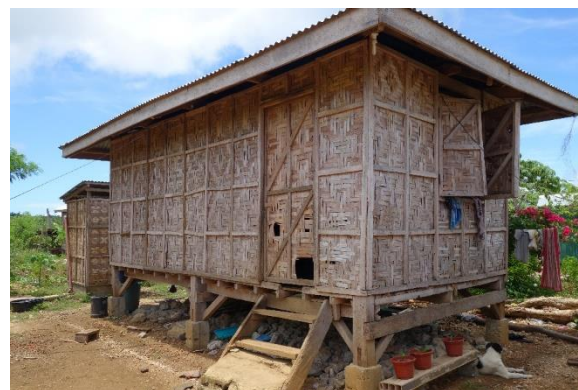
Shelter materials show signs of wear.

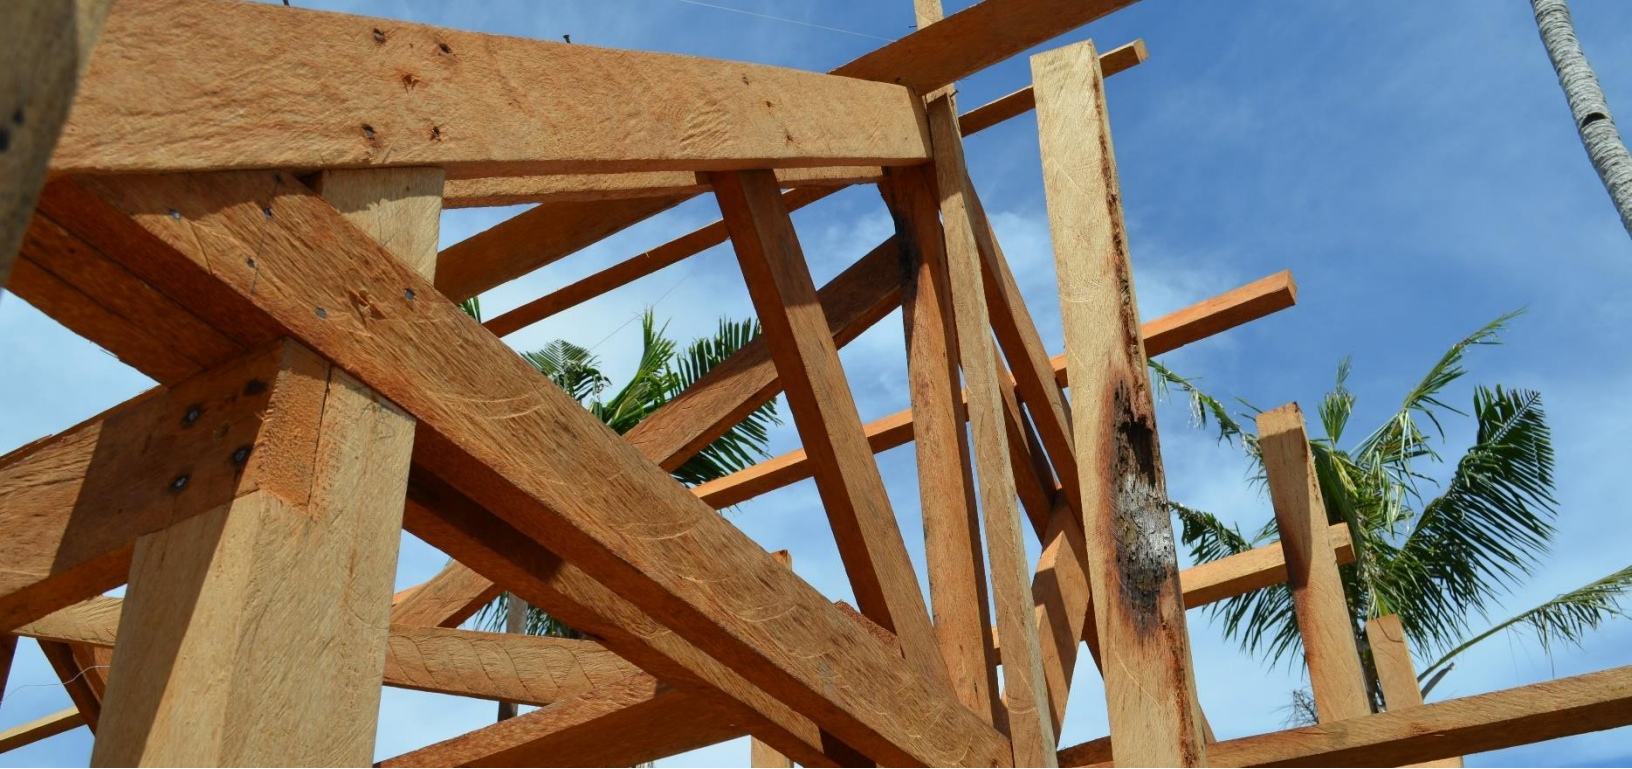
Trusses and roofing take shape during shelter construction, applying key messages emphasized by shelter partners

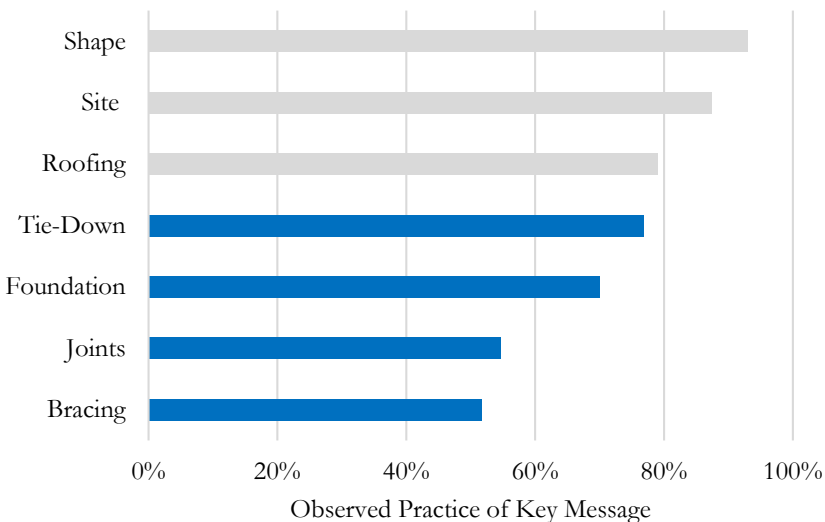
New foundations and post straps were several improvements laid out in the Shelter Cluster '8 key messages.'

Using components outlined in the 8 key messages, we rated the level of adhering to standards, aggregating any sub-messages (e.g. truss bracing, roof bracing, silt bracing, wall bracing, and brace angle). We excluded the last message, preparedness, as evidence was found for all programs. Below is a summary of messages that were found to be most prevalent in shelter across the studied programs.

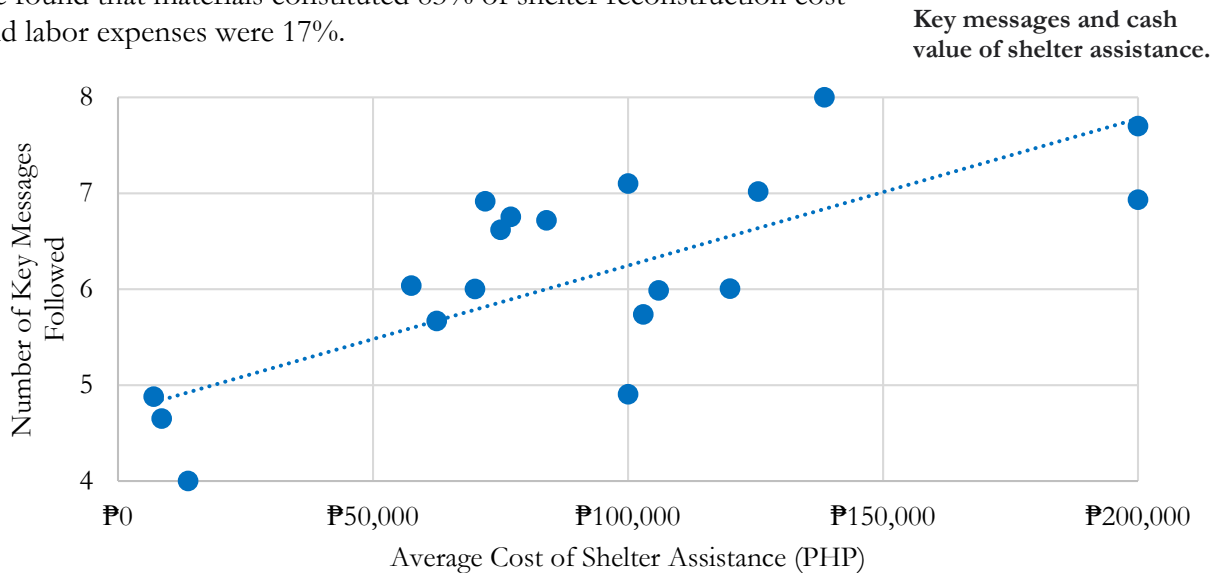
From the plot, a clear relationship emerges between the number of key messages followed and value of shelter support provided. The programs at the bottom left were commonly repair and retrofit or temporary shelter assistance. Programs at the top right were permanent shelter.

In addition to comparing the documented rates of each theme, our evaluation also looked at the average cost of shelter packages provided in order to map cost vs. benefit. The average number of key messages followed within each studied shelter program are plotted against the average cash value of materials and labor assistance below. On average, we found that materials constituted 83% of shelter reconstruction cost and labor expenses were 17%.

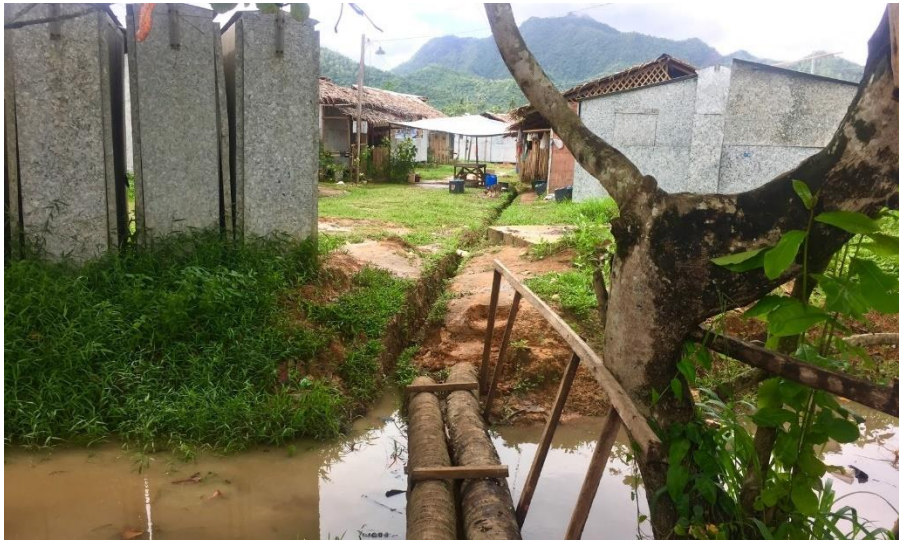
**A transitional relocation site floods after heavy rains.**
