Dam Failure

John T. Christian¹ and Gregory B. Baecher²

[September 9, 1999 DRAFT]

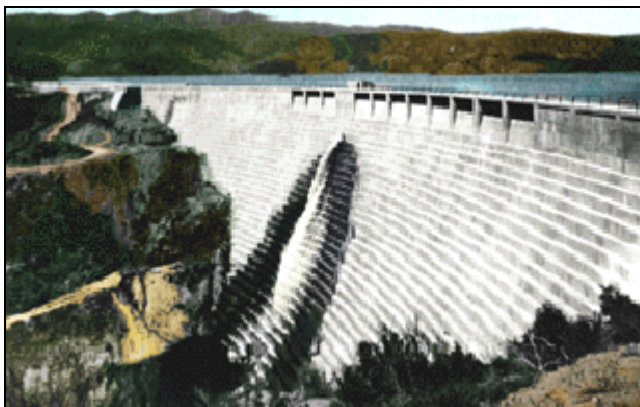
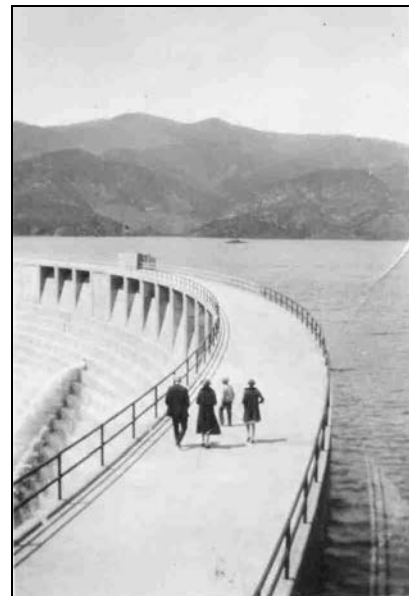
St. Francis Dam at full pool

The seepage at the bottom of the right end of the dam that had been of growing concern to Tony Harnischfeger, Assistant Damkeeper for the LA Department of Water and Power, continued to get worse. More troubling, the water was muddy. To the engineer, muddy water means erosion somewhere and probably from deep in the abutment.
