# Axial Capacity of C900 PVC Pipe with Reinforced Gasketed Joints

Final Report

Katie Ross  
Denver Water

August 2020

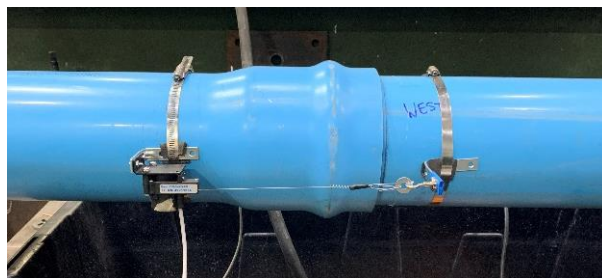
North American Pipe Company (NAPCO) C900 pipe (PC235, DR18) with a RieberLok gasket installed in the bell and spigot joint was used for this test. Joint displacement was measured using a string potentiometer on the springline as shown in Figure 3.1(a). The string potentiometer body was mounted on the pipe about 2 in. (50 mm) from the start of the bell. The string attachment point was on the spigot pipe approximately 3 in. (75 mm) from end of the bell.

Figure 3.1. Images of PT17, (a) before testing and (b) after failure

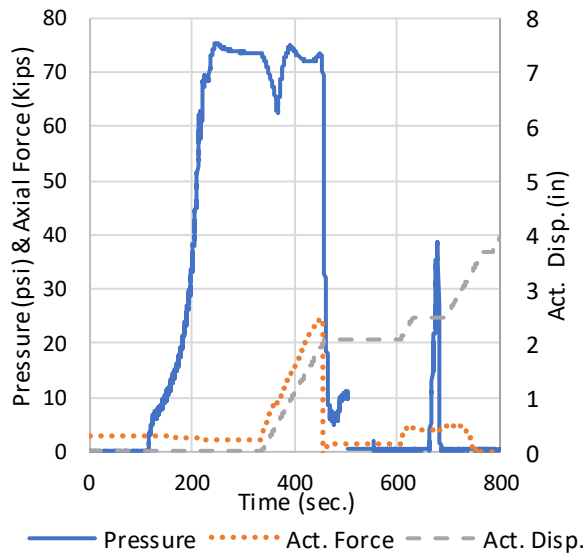
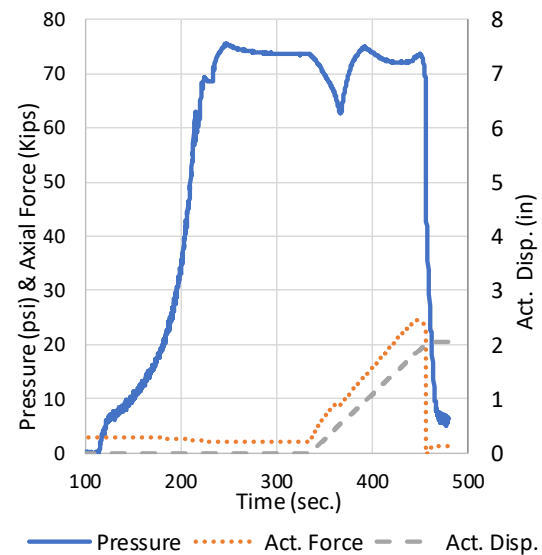
Figure 3.2. PT17 results for internal pressure, actuator force, and actuator displacement, vs. time: (a) entire test run, (b) detail data from start of loading to failure.

Figure 3.2 shows the pressure, actuator force, and actuator displacement relative to time during the test. Water pressure was held in the range of approximately 65 –75 psi (450 – 520 kPa) for the duration of the test prior to the failure of the joint. Pressure fluctuations before joint failure are due to increasing internal volume of the pipe during tensile loading and manual valve adjustments of the water supply. Tensile load was applied until the gasket failed to hold the spigot pipe in place. Failure was indicated by a loud pop, a sudden increase in joint displacement, drop in force, and significant water leakage from the joint. Images of the joint before and after the test are shown in Figure 3.1. The joint continued to leak significantly after failure. Additional displacement was applied to the specimen by the hydraulic actuator after the initial failure, shown in Figure 3.2(a), to pull the joint apart for inspection. However, the pipe was unable to hold pressure beyond ~450 sec, which was determined to be the termination point of the test.

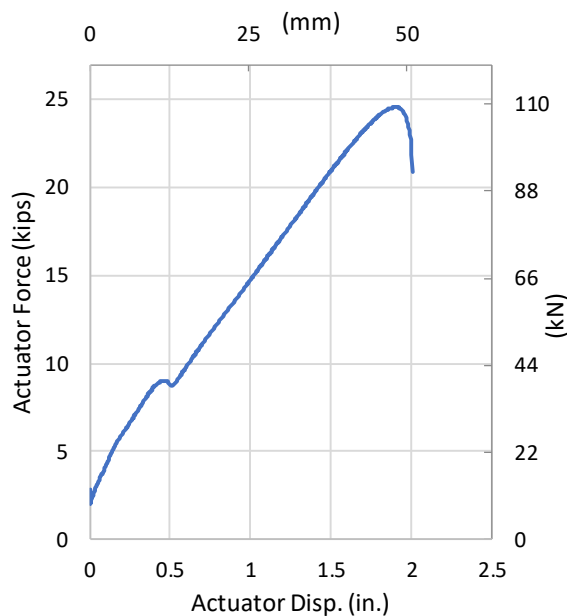
Figure 3.3. PT17 force vs. actuator displacement

Figure 3.3 shows the relationship between the actuator force and actuator displacement during the test. The maximum force was 24.6 kips (109 kN), which occurred just prior to the failure of the joint. The displacement of the actuator at failure was 2.01 in. (51.1 mm). Figure 3.4 shows the actuator force vs. the joint displacement. The joint displacement was 1.12 in. (28.4 mm) at the time of failure. The figures show

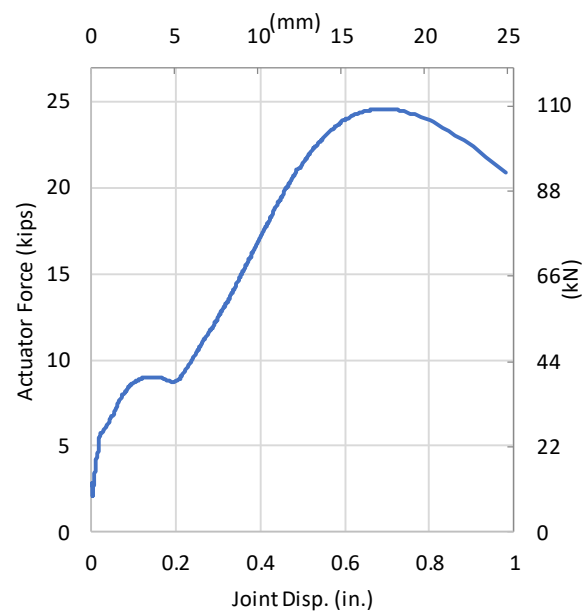
Figure 3.4. PT17 force vs. joint displacement

there was approximately 2 kips (9 kN) of axial tension load applied prior to the start of data acquisition due to the tightening of end restraint rods, which was captured in the load cell reading.

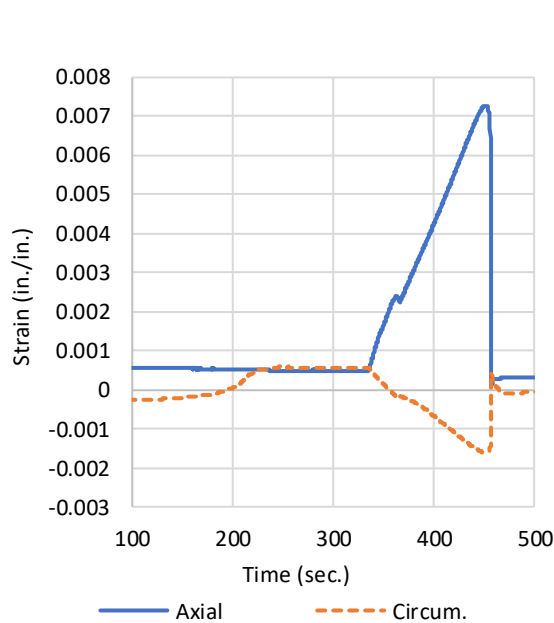
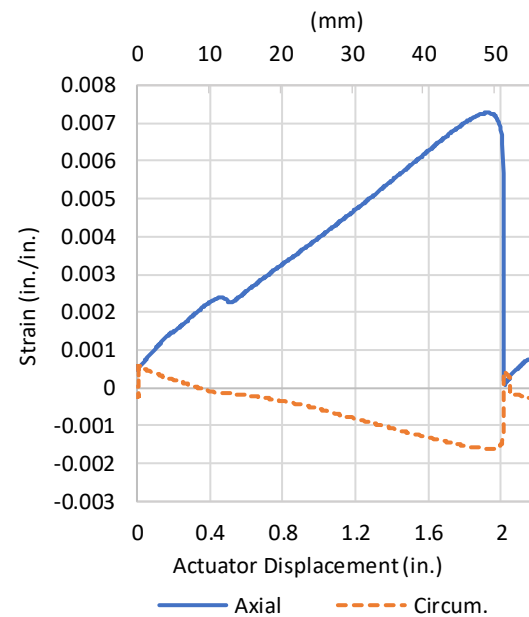
Figure 3.5 and Figure 3.6 show the axial and circumferential strains. Valid readings were obtained from only one strain gauge rosette. At the start of the test, the pipe was pressurized, and a resulting increase in circumferential strain was observed. Increasing tensile loading on the pipe resulted in increasing axial strain and reducing circumferential strain. The maximum axial strain at failure was 0.73% and the minimum circumferential strain was -0.16%.

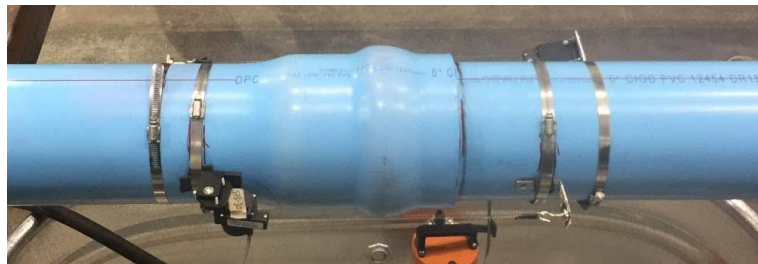
Figure 3.7. Pretest image of PT18

Diamond Lok-21 PVC pipe with the as-received restraining-gasketed bell and spigot joint at the midpoint was used for this test. Joint displacement was measured using two spring pots located on the north and south pipe spring lines, as shown in Figure 3.7. The string pots and the string anchor points were fixed to the pipe approximately 3 - 6 inches (75 - 150 mm) on either side of the ends of the bell section. Water pressure was held at approximately 66 psi (460 kPa) during the application of load until failure. Tensile load was applied until the spigot pipe broke suddenly. An image of the joint after failure is shown in Figure 3.8 and Figure 3.9.

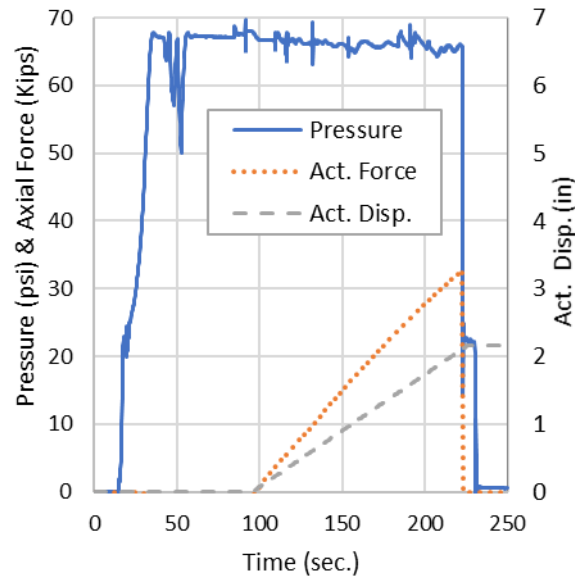
Figure 3.10. Specimen PT18 results for pressure, axial force, and actuator displacement vs. time

Figure 3.10 shows the actuator force, internal pressure, and actuator displacement relative to time. The maximum force was 32.6 kips (145 kN) at an actuator displacement of 2.11 in. (53.6 mm). Figure 3.11 shows the actuator force relative to actuator displacement. Figure 3.12 shows the actuator force relative to joint displacement. The average joint displacement was 0.37 in. (9.4 mm) at the time of failure. Failure occurred when the spigot pipe broke at the gasket with cracks propagating outwards from the joint. Figure 3.9 shows the failure of the spigot pipe inside the joint.

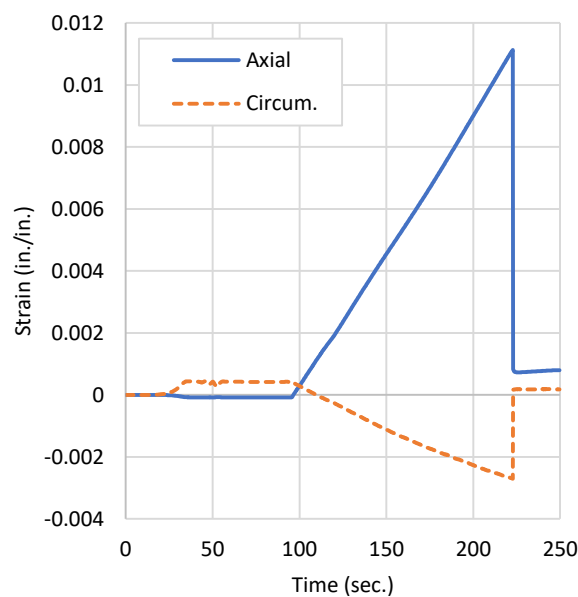
Figure 3.13. PT18 axial and circumferential strains vs. time

Figure 3.13 shows the axial and circumferential strain relative to time. Strain data is shown only from the strain gauges on the crown of the pipe. The gauges on the invert did not give valid data. At the start of the test, the system was fully pressurized, and an increase in circumferential strain was observed. Once loading began, the circumferential strains began to decrease, while the axial strains increased. Figure 3.14 shows the axial and circumferential strain relative to actuator displacement. The maximum axial strain at failure was 1.113% and the minimum circumferential strain was -0.270%.

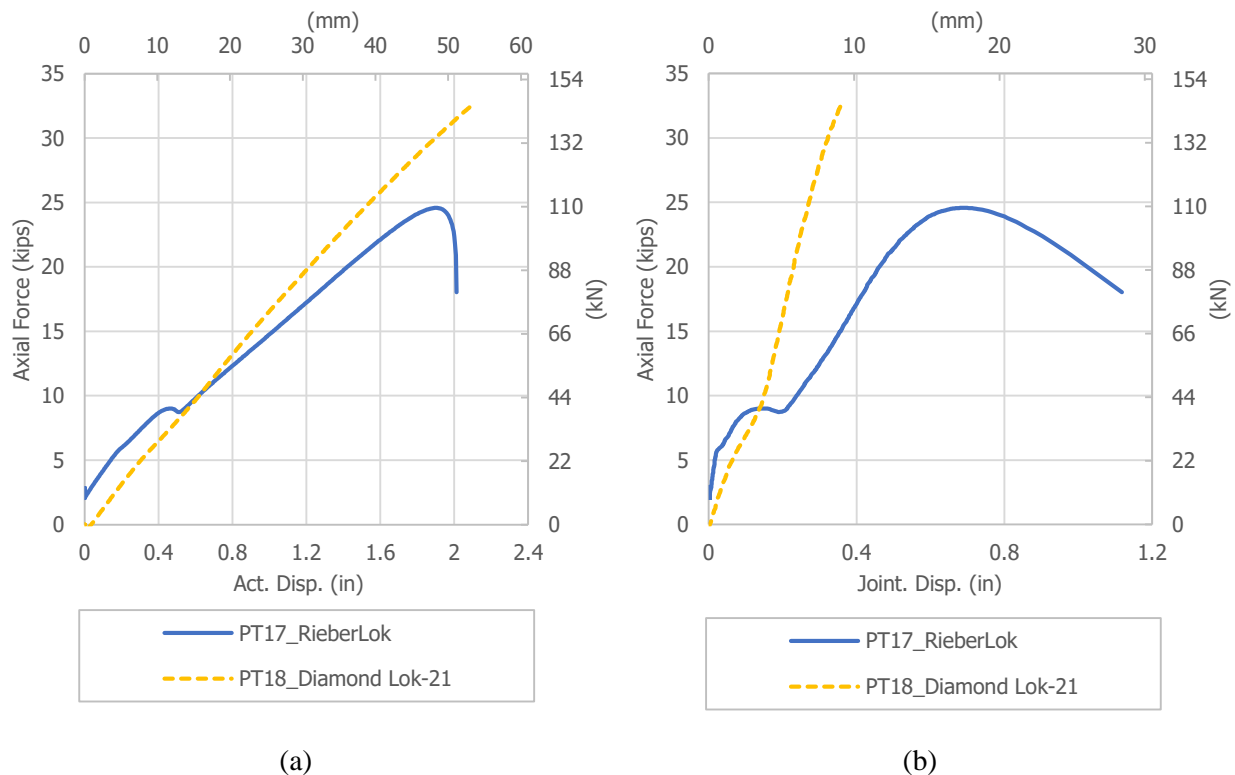
Figure 3.15. Axial tension tests PT17 and PT18, force vs. (a) actuator and (b) joint displacements

Table 3.1 shows a summary of the axial tests performed. The Diamond Lok restrained bell was able to withstand greater axial tension force and joint displacement before failure than the RieberLok gasket. The Diamond Lok-21 joint failed by fracture of the spigot, whereas the NAPCO joint with a RieberLok gasket failed by movement of the pipe through the gasket, without pipe breakage.

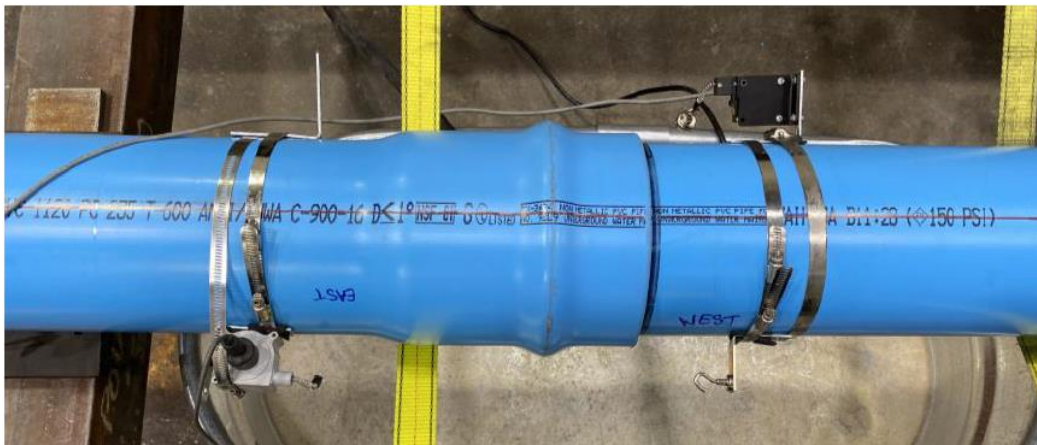
Figure 4.1. PS19 joint before testing

B-Vinyl C900 pipe (PC235, DR18) with a RieberLok gasket installed in the bell and spigot joint was used for this test. Joint displacement was measured using two spring pots located on the north and south pipe spring lines, as shown in Figure 4.1. The string pots and the string anchor points were fixed to the pipe approximately 4 - 6 inches (75 - 150 mm) on either side of the ends of the bell section. Figure 4.2 shows the water pressure, actuator force, and actuator displacement relative to time during the test. The average water pressure during testing was approximately 68 psi (470 kPa), although changing the internal volume with cyclic loading and manual valve adjustments caused the pressure to fluctuate over the range of approximately 50 – 85 psi (340 – 590 kPa). An initial 9 loading cycles were performed with the actuator displacement inadvertently set too low by a factor of 10. The error was corrected (at approximately 600 seconds of test time as shown in Figure 4.2), and the test was started from the beginning following the load protocol listed in Table 2.1.

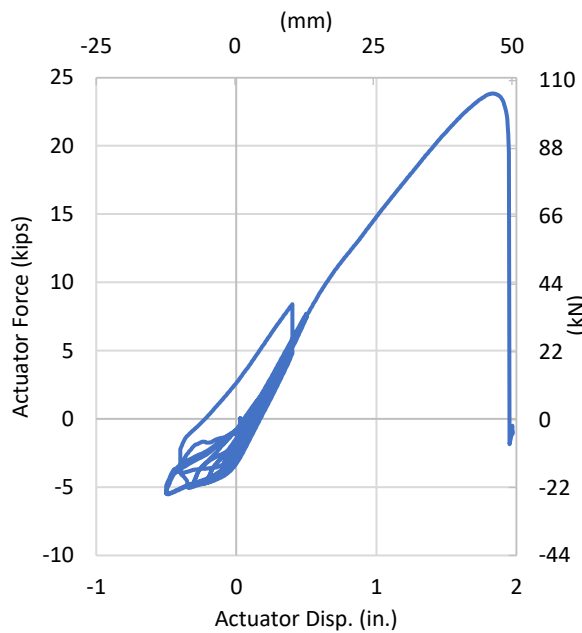
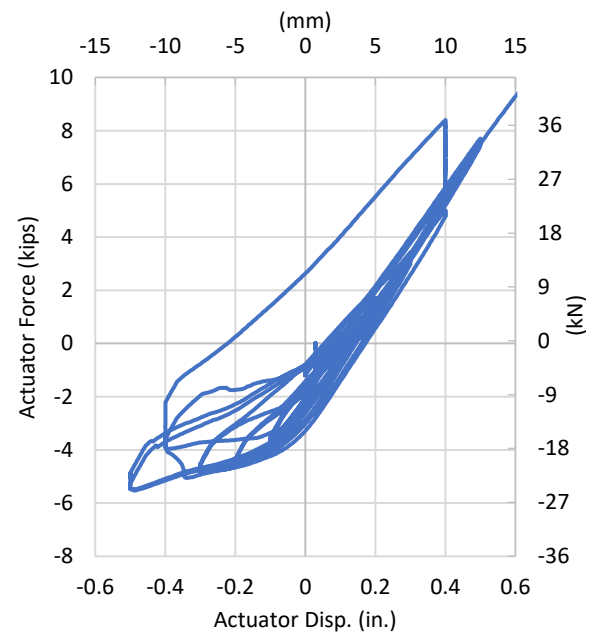
Figure 4.4 PS19 force vs. actuator displacement

Figure 4.4 shows the relationship between the actuator force and actuator displacement. The maximum force was 23.8 kips (111 kN) and the maximum actuator displacement was 1.97 in. (50.0 mm). Figure 4.5 shows the actuator force vs joint displacement. The string potentiometer on the south side of the joint rotated during the final loading of the specimen, so data from this sensor was not included in the results.

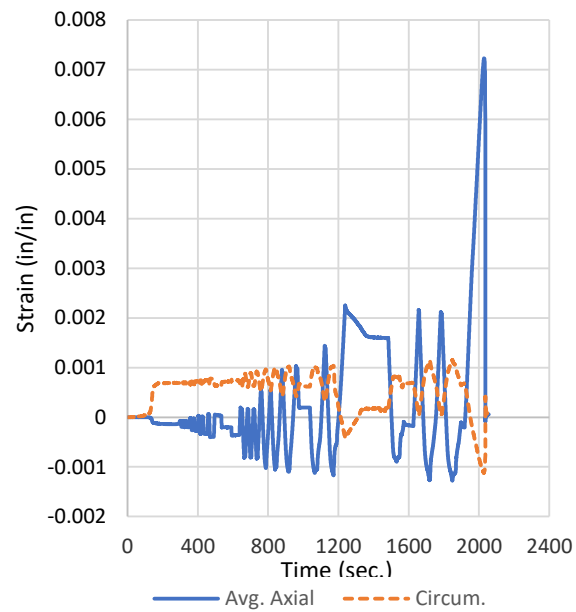
Figure 4.6. PS19 average axial and circumferential strains

Figure 4.6 shows the axial and average circumferential strains for the duration of the test. The data from the crown circumferential strain gauge appeared to indicate a faulty gauge or installation, so data from this channel was excluded. At the start of the test, the system was fully pressurized, and an increase in circumferential strain was observed. The frame also resisted the axial expansion of the pipe from the pressurization, resulting in a measured compressive force and a decrease in axial strain.

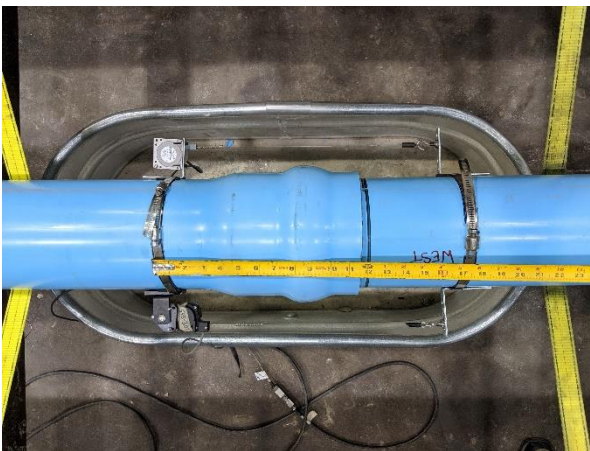
Diamond Plastic's C900 pipe (PC235, DR18) with a Diamond Lok-21 gasket installed in the bell and spigot joint was used for this axial cyclic test. Joint displacement was measured using two string potentiometers on the spring line as shown in Figure 4.7(a). Each string potentiometer body was mounted on the pipe about 2.5 in. (60 mm) from the start of the bell. The string attachment point was on the spigot pipe approximately 6 in. (150 mm) from end of the bell. Water pressure was held in the range of approximately 60 –75 psi (410 – 520 kPa) for the duration of the test prior to the failure of the joint. Pressure fluctuations before joint failure are due to changing internal volume of the pipe during alternating tensile and compressive loading and manual valve adjustments of the water supply.

Figure 4.7. Images of PS20, (a) before testing and (b) after failure.

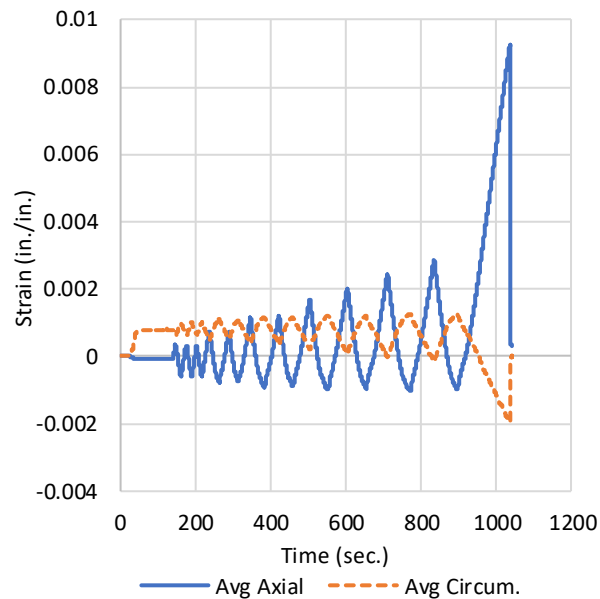
Figure 4.11. PS20 average axial and circumferential strains

Figure 4.11 shows the average axial and circumferential strains for the duration of the test. At the start of the test, the system was fully pressurized, and a resulting increase in circumferential strain was observed. The maximum axial strain was 0.925% and the minimum circumferential strain was -0.193%.

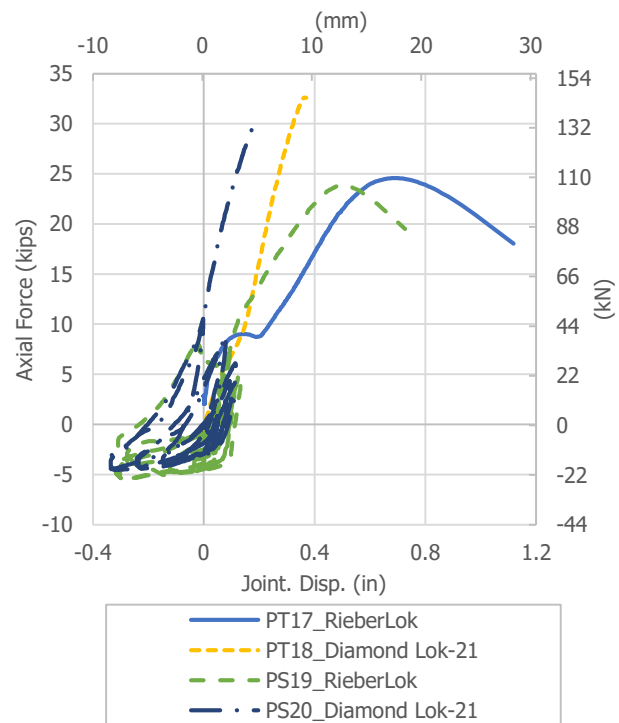
Figure 5.2. Force vs. Average Joint Displacement, all four tests

Axial Displacements: The average maximum joint displacement of the RieberLok specimens at failure [0.93 inch (24 mm)] was about 3 times greater than the Diamond Lok-21 joint displacement at failure [0.28 inch (7.1 mm)] (Figure 5.2). On the contrary, the Diamond Lok-21 specimens reached larger levels of axial strain in the pipe barrel (Table 5.1), due to the greater axial force capacity of the Diamond Lok-21 joint. The summation of these two mechanisms, both axial displacement accommodating strain and joint displacement, resulted in ultimate failure at relatively consistent values of imposed actuator displacement (Figure 5.1). In other words, the two specimen types were able to accommodate the imposed demand (actuator displacement) through a combination of two different primary pipeline capacities: joint displacement (RieberLok) and axial strain (Diamond Lok-21). Had the test specimens been shorter, the superior displacement capacity of the RieberLok gasket would have allowed the specimen to reach a larger imposed (actuator) displacement before failure relative to an identically sized Diamond Lok-21 specimen. On the contrary, if the test specimens were longer, (e.g., 18 ft on either side of the joint, similar to standard installation) the additional joint force capacity of the Diamond Lok-21 specimen would serve to develop axial strains over the entire pipe barrels and, therefore, based on the test results herein, outperform an identical RieberLok specimen.
