# Experimental Assessment of PVC Pipe Joint with RieberLok Gasket under Axial Loading

## Testing Report

Timothy C. Lango  
Northern Pipe Products

September 2024

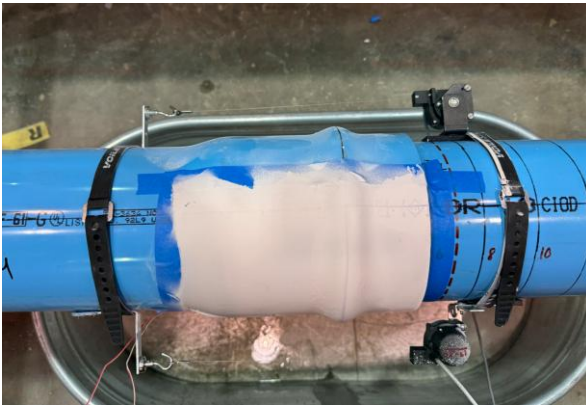
Images of bell-and-spigot connection before and after the test are shown in Figure 3.6. The dot marks are for digital image correlation (DIC) measurement on the white surface. While the DIC measurements captured 3D displacement and strain fields that correlated well with standard measurement techniques, this measurement technique is beyond this project report scope. Joint displacement was measured using two string potentiometers located 3 in. (75 mm) away from the joint on both ends of the coupling, shown in Figure 3.6 (a). The reported joint displacement does include the elongation of the pipe barrel over 3 inches (75 mm) on either side of the joint, which is practically negligible compared to the displacement between bell and spigot in these tests. Failure occurred on the West side (spigot) of the bell-and-spigot connection. Fracture occurred in the spigot section of pipe at the location where the gasket teeth penetrated into the pipe barrel, as shown in Figure 3.6 (b).

Figure 3.6. Image of PT44 (a) before the start of testing and (b) after failure

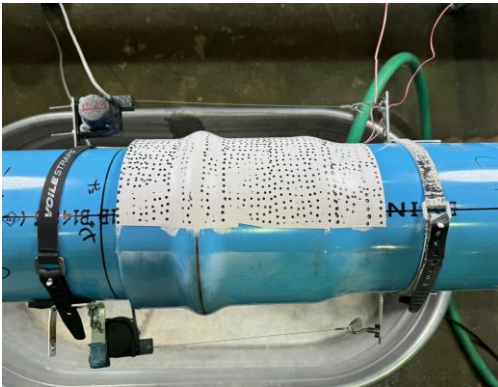
Figure 3.10. East and west side for PT45

The material and instrumentation used for this test were consistent with the previous test (PT44). Figure 3.7 shows the relationship among actuator force, internal pressure, and actuator displacement relative to time. A constant internal water pressure of  $63 \pm 2$  psi ( $434 \pm 13$  kPa) was provided during the test. At  $t=120$  sec, displacement was applied at a rate of 1.0 in./min. (25 mm/min.), and the force feedback of the load cell was recorded. When the specimen lost its force capacity ( $t=260$  sec), the pressure dropped to about 30 psi and then increased again to 65 psi (448 kPa). After pausing to confirm the capacity of the specimen to sustain the target internal pressure, application of axial displacement was continued. At an applied axial displacement of a substantial leak occurred as the spigot pulled out of the bell and the specimen lost pressure integrity. Figure 3.8 shows that the maximum force recorded in the load cell was 25.9 kips (115.3 kN) at an actuator displacement of 2.25 in. (57.2 mm). Figure 3.9 shows the actuator force relative to joint displacement. Joint displacement was measured using two string pots located on the north and south spring lines of the specimen as shown in Figure 3.10. The joint displacement reached an average of about 0.8 in. (20.3 mm) at the maximum force and reached a total of about 0.99 in (25.1 mm) just before failure (23.0 kips). Figure 3.11 shows damage to the gasket post-test, where several of the metal teeth were deformed, reducing the force capacity of the joint, but allowing the gasket to continue to provide containment after the force dropped. Figure 3.12 shows marks of the metal teeth on spigot after the test.

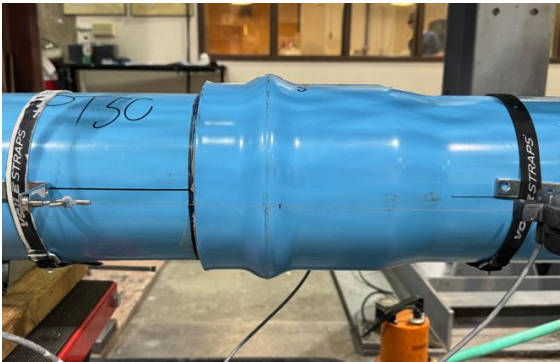
Figure 3.25. East and west side for PT50

Figure 3.22 shows the relationship among actuator force, internal pressure, and actuator displacement relative to time for the first PVC pipe tension test produced by Northern Pipe. Displacement was applied at a rate of 1.0 in./min. (25 mm/min.), and the force feedback of the load cell was recorded. Figure 3.23 shows that the maximum force recorded in the load cell was 26.2 kips (116.6 kN) at an actuator displacement of 2.46 in. (62.5 mm). A constant internal water pressure of  $65 \pm 2$  psi ( $448 \pm 13$  kPa) was applied during loading. Figure 3.24 shows the actuator force vs the joint displacement. The joint displacement reached an average of about 1.02 in. (25.9 mm) just before failure. Figure 3.25 shows the bell and spigot connection before the test. A circumferential fracture occurred where the gasket teeth penetrate on the spigot side of the joint, shown in Figure 3.26.

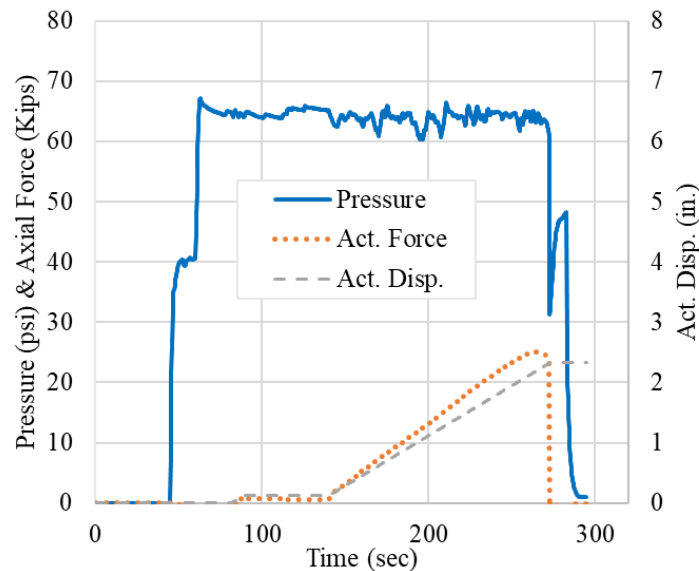
was recorded. A constant internal water pressure of  $65 \pm 2$  psi ( $448 \pm 13$  kPa) was applied during the test. Figure 3.37 also shows that the maximum force recorded in the load cell was 25.2 kips (111.9 kN) at an actuator displacement of 2.20 in. (55.9 mm). Figure 3.38 shows the actuator force vs the joint displacement. The joint displacement reached an average of about 0.7 in. (17.8 mm) at the max force and reached a total of about 0.92 in (23.4 mm) just before failure (22.47 kips). Figure 3.39 shows the bell and spigot connection before the test for PT52. Damage occurred on the gasket, and gasket teeth slipped, as shown in Figure 3.40. Figure 3.41 shows the damage of the RieberLok gasket teeth after the test.

Figure 3.36. Specimen PT52 results for pressure, axial force, and actuator displacement vs time

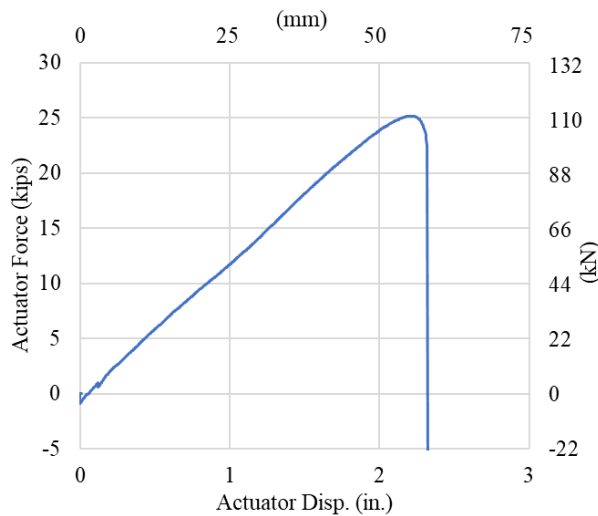
Figure 3.37. PT52 force vs actuator displacement

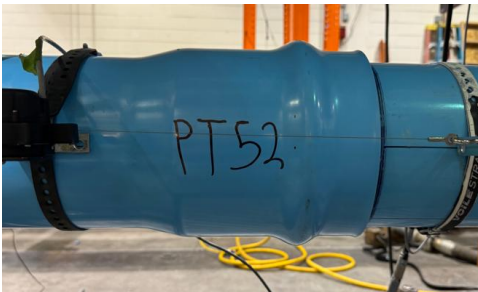
Figure 3.39. East and west side for PT52

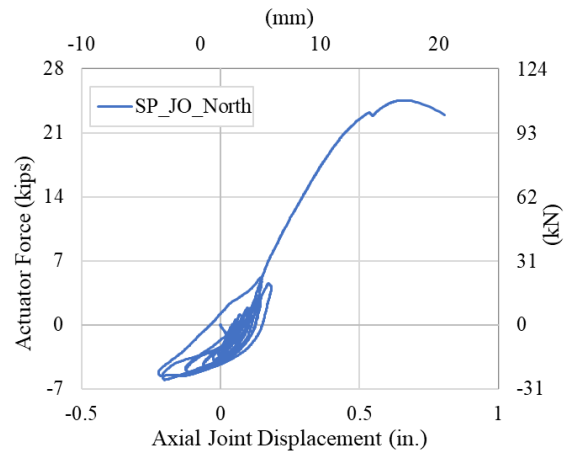
Figure 4.3 shows actuator force vs joint displacement. During cyclic loading, the maximum axial force reached approximately -6.0 kips (26.7 kN) and 5.2 kips (22.9 kN) at the compression part and tension part, respectively. Two string pots were specifically placed on the north and south springlines, precisely 3 inches away from the joint on each side. However, the string pots on the south side malfunctioned during the test, thus only one string pot was used to evaluate joint capacity. After cyclic loading, tensile loading was carried out to failure. There was no leakage observed for PS47 during the loading sequence. The joint displacement measured approximately 0.87 in (22.1 mm) just before failure.

Figure 4.3. PS47 force vs. joint displacement.

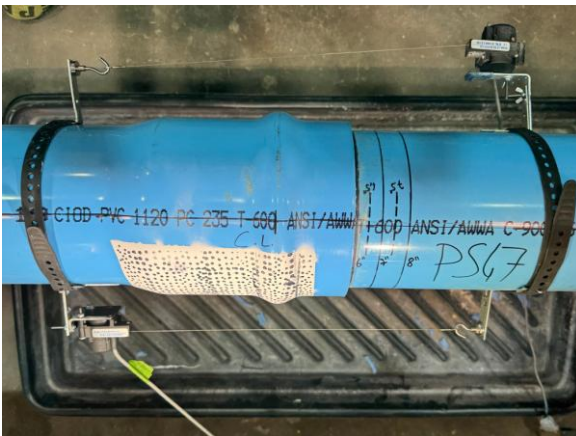
Figure 4.6. PS47 joint before testing

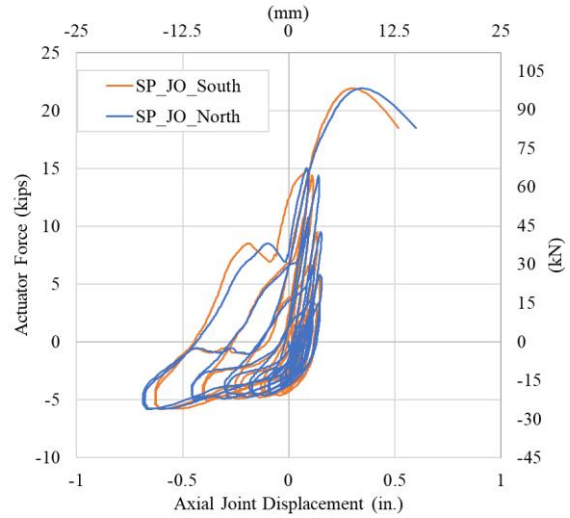
Figure 4.9 shows the relationship between the actuator force and actuator displacement. The maximum force was 21.9 kips (97.5 kN), and the maximum actuator displacement was 1.6 in. (40.6 mm). Figure 4.10 shows actuator force vs joint displacement. During cyclic loading, the maximum axial force reached -5.8 kips (25.8 kN) and 15.04 kips (66.9 kN) in the compressive and tension parts, respectively. After cyclic loading, tensile loading was carried out to failure. The joint displacement measured approximately 0.55 in (13.97 mm) just before failure.

Figure 4.10. PS48 force vs. joint displacement.

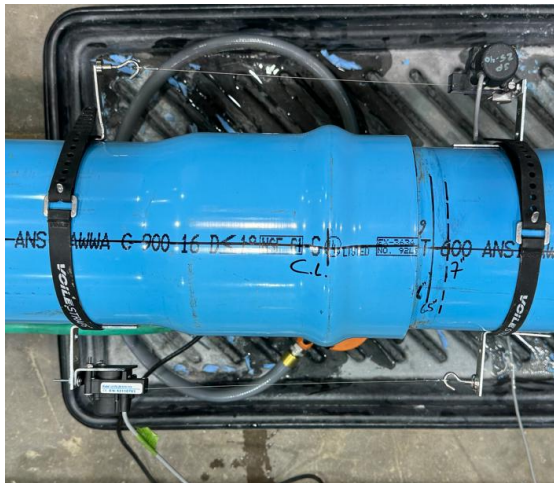
Figure 4.13. PS48 joint before testing

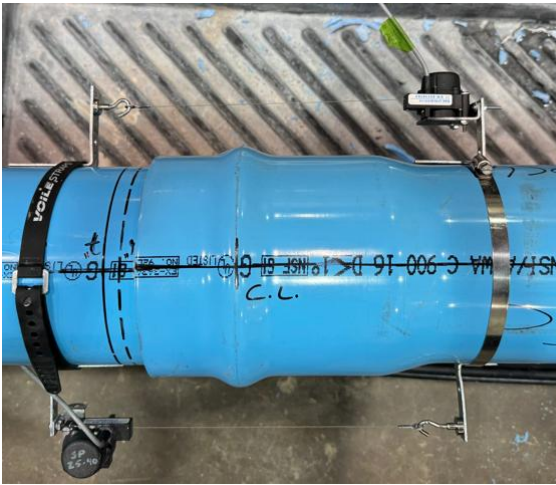
Figure 4.20. PS49 joint before testing

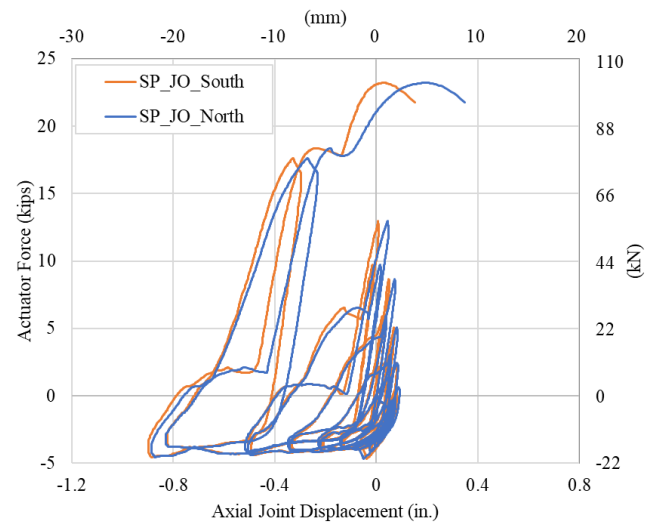
Figure 4.23 shows the relationship between the actuator force and actuator displacement. The maximum force was 23.2 kips (103.3 kN), and the maximum actuator displacement was 1.62 in. (41.14 mm). Figure 4.24 shows actuator force vs joint displacement. During cyclic loading, the max axial force reached -4.5 kips (20.1 kN) and 17.6 kips (78.5 kN) in compressive and tensile loading, respectively. During the cyclic loading process, a steady leak was first observed at the onset of the tension loading phase in the 18<sup>th</sup> cycle and continued throughout this phase. As the loading transitioned into the compressive phase in the 19<sup>th</sup> cycle, the leak persisted and extended through the entire compressive phase and into the subsequent tension phase of the same cycle. This pattern of steady leakage continued into the 20<sup>th</sup> cycle and extended into the start of the pull-to-failure loading. The leakage finally ceased when the gasket teeth engaged the pipe again (t=2000 sec). The tensile loading was carried out to failure. The joint displacement measured averaged 0.30 in (7.62 mm) just before failure.

Figure 4.24. PS53 force vs. joint displacement

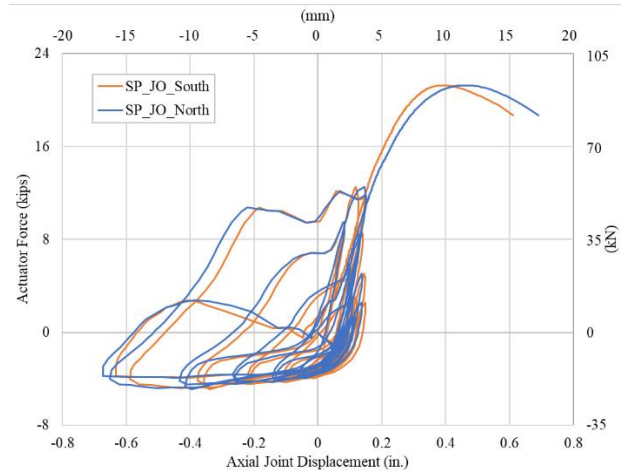
4.30 shows the water pressure, actuator force, and actuator displacement relative to time during the test. The average water pressure beginning of the test was approximately 65 psi (448 kPa). With the initiation of the cyclic loading sequence, water pressure fluctuations were observed within the range of 60-70 psi (415 - 483 kPa). At the start of the final two cycles ( $t=380$  sec), steady leaks were detected, causing the pressure to drop to approximately 55 psi (380 kPa). Figure 4.31 and Figure 4.23 shows the relationship between the actuator force and actuator displacement. The maximum force was 21.3 kips (94.6 kN), and the maximum actuator displacement was 1.85 in. (47.0 mm). Figure 4.32 shows actuator force vs joint displacement. During cyclic loading, the max axial force reached -4.6 kips (20.5 kN) and 12.5 kips (55.8 kN) in the compressive and tension parts, respectively. During the cyclic loading process, a steady leak was first observed at the onset of the tension loading phase in the last cycle (20<sup>th</sup> cycle) and continued throughout this tension phase. At the middle of the compressive phase, a steady leak occurred again and continued to the end of cyclic loading. After cyclic loading, tensile loading was carried out to failure. The joint displacement measured approximately 0.65 in. (16.51 mm) just before failure.

Figure 4.32. PS54 force vs. joint displacement

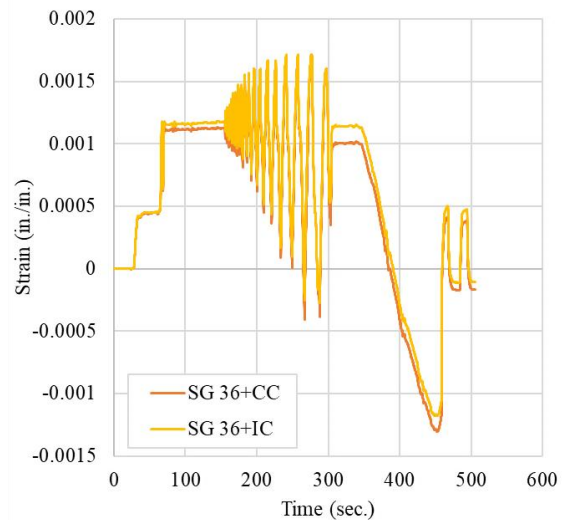
Figure 4.33. PS54 axial strains vs time

Figure 4.33 and Figure 4.34 show the axial and average circumferential strains for the duration of the test, respectively. At the start of the test, the system was fully pressurized, and an increase in circumferential strain was observed. The maximum axial strain was 0.66% and the maximum circumferential strain was -0.13%. Figure 4.35 and Figure 4.36 show the joint before testing and after failure, respectively. There was no damage to either of the joints, but the gasket teeth slipped during the tensile loading, causing the connection to lose its pressure capacity.

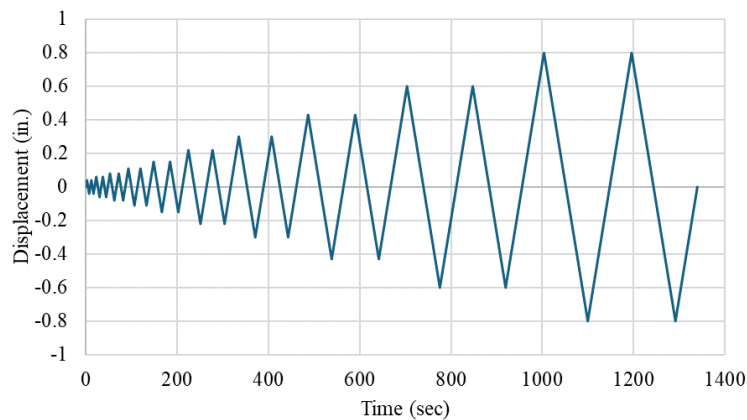
Figure 4.37. The cyclic loading sequence for PS55

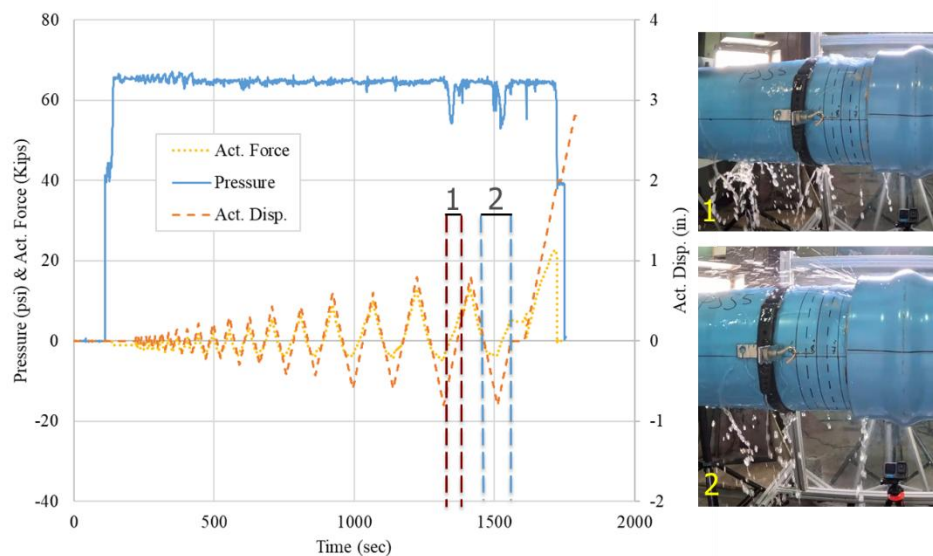
The last cyclic test performed on PVC pipe manufactured by Northern Pipe was PS55. The loading protocol 2 (LP-2) was used at a rate of 1 in. per minute for the cyclic sequence for PS55. By following the same procedure as the previous cyclic test's loading protocol, LP-2 converted the time history loading data. Using the same peak displacement values for the cyclic sequence, a time history of approximately 22.5 minutes was obtained, as shown in Figure 4.37. After the cyclic loading, tensile loading was performed under displacement control at a rate of 1 in. per minute. Figure 4.38 shows the water pressure, actuator force, and actuator displacement relative to time during the test. The average water pressure until the tension part of the last cycle was approximately 65 psi (448 kPa). The water pressure dropped to 55 psi (380 kPa) during the last cycle loading. During the cyclic loading process, a steady leak was first observed at the onset of the tension loading phase in the last cycle (20<sup>th</sup> cycle) and continued throughout this tension phase. At the middle of the compressive phase, a steady leak occurred again and continued to the end of cyclic loading. After cyclic loading, tensile loading was carried out to failure. Figure 4.39 shows the relationship between the actuator force and actuator displacement. The maximum force was 22.7 kips (100.8 kN), and the maximum actuator displacement was 1.93 in. (49.02 mm). Figure 4.40 shows actuator force vs joint displacement. During cyclic loading, the max axial force reached -3.7 kips (16.5 kN) and 12.9 kips (57.5 kN) in the compressive and tension parts, respectively. The joint displacement measured approximately 0.63 in (16 mm) just before failure.

Figure 4.38. PS55 results for internal pressure, actuator displacement and axial force vs. time

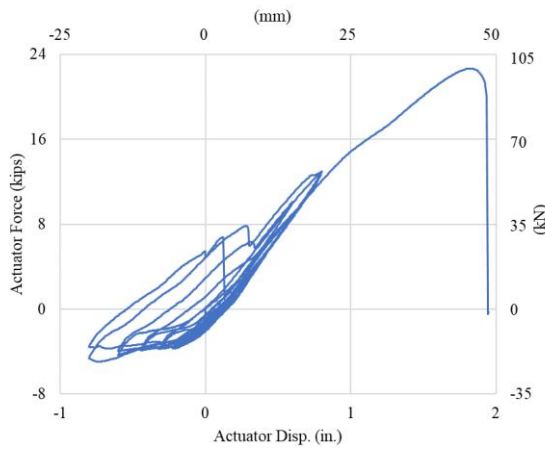
Figure 4.39. PS55 force vs. actuator displacement

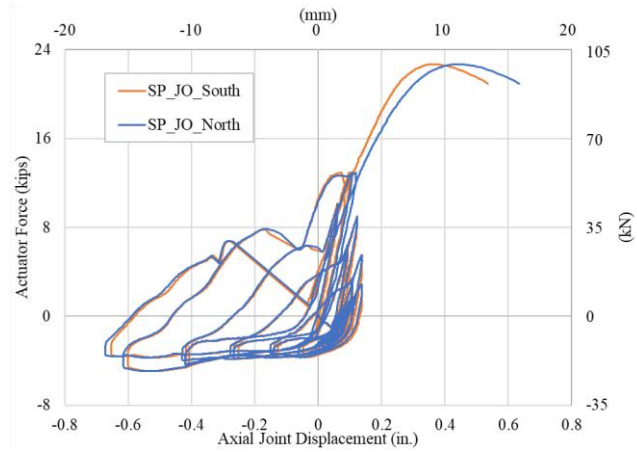
Figure 4.40. PS55 force vs. joint displacement

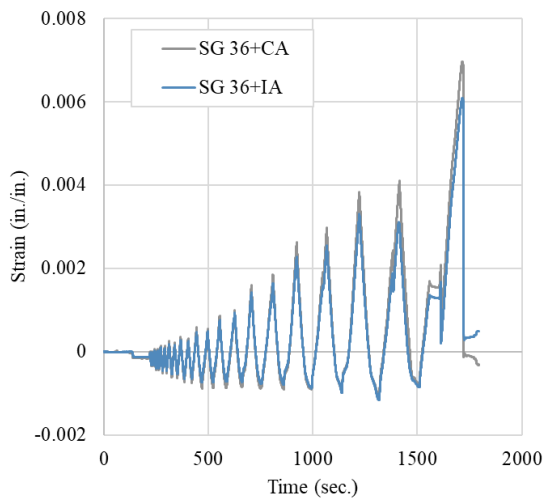
Figure 4.41. PS55 axial strains vs time

Figure 4.41 and Figure 4.42 show the axial and average circumferential strains for the duration of the test, respectively. At the start of the test, the system was fully pressurized, and an increase in circumferential strain was observed. The maximum axial strain was 0.69% and the maximum circumferential strain was -0.15%. Figure 4.43 and Figure 4.44 show the joint before testing and after failure, respectively. The failure was caused by circumferential fracture of the spigot where the RieberLok gasket teeth engage with the pipe.

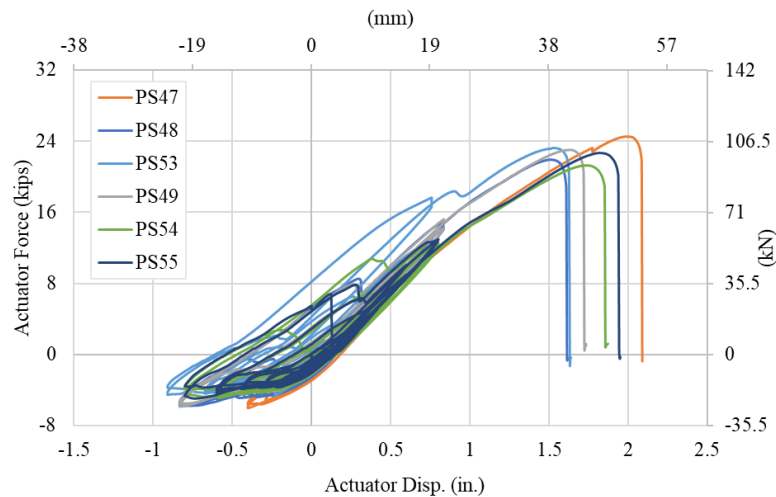
Within this project, the six cyclic tests were conducted on PVC pipes manufactured by VinylTech and Northern pipe. The following section provides a comparison of the cyclic tests performed, starting with Table 4.1 which is a summary of the axial cyclic test results. By using two different loading sequences (LP-1 and LP-2), the axial cyclic tests were performed. The cyclic sequence were performed under displacement control at a rate of 1 in. per minute for all cyclic tests, while the cyclic sequence was conducted at a rate of 9 in. per minute only for PS54. The axial cyclic performance of bell-and-spigot joint capacity was investigated for cyclic loading and tensile loading. Figure 4.45 shows the actuator force relative to the actuator displacement for each cyclic test. The maximum axial forces under cyclic test were an average of 24.5 kips (116 kN) and 23.2 kips (103 kN) for VinylTech and Northern pipes, respectively. The forces and actuator displacements were remarkably similar for all cyclic tests. Figure 4.46 and Figure 4.47 show the joint displacements and axial forces for VinylTech and Northern Pipe, respectively. The maximum joint displacements ranged between 0.3 in. and 0.87 in. (7.6 and 22.1 mm).

Figure 4.45. Cyclic comparison - force vs. actuator displacement

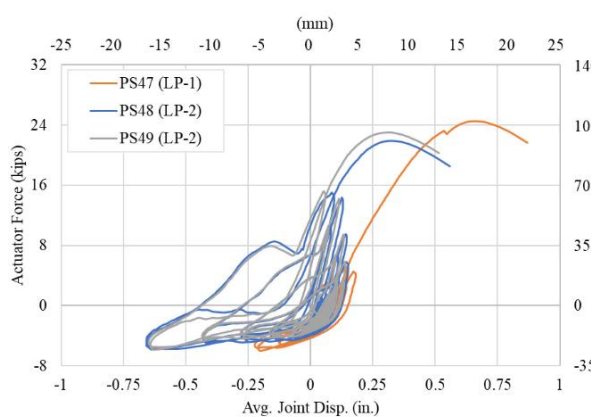
Figure 4.46. Cyclic comparison - force vs. average joint displacement

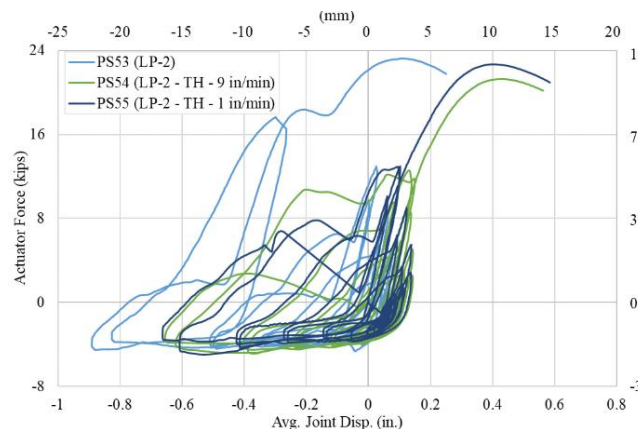
Figure 4.47. Cyclic comparison - force vs. joint displacement

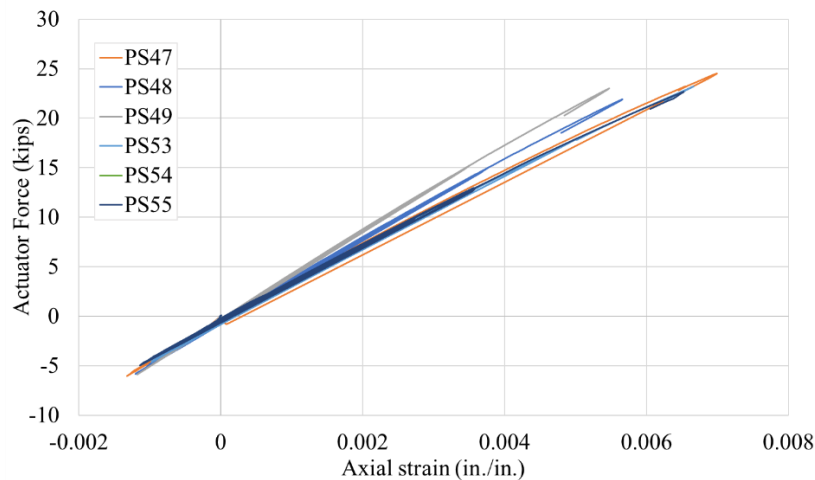
Figure 4.48 shows the comparison for the axial strains. All cyclic tests have maximum axial strain values between 0.64% and 0.71%. When we evaluate the performance of the Rieber shape connection, the Northern pipe and VinylTech products have shown remarkably similar force and joint displacement capacity under axial cyclic tests, however, various failure mechanisms were observed for both types of products. Three distinct failure mechanisms were observed for cyclic tests: circumferential fracture at the spigot (PS48 and PS55), gasket failure (PS47, PS49 PS54), and fracture at the bell side of the joint (PS53).

Figure 4.48. Cyclic comparison - force vs. axial strain
