# **Household Perceptions of Shelter Safety in Typhoons and Earthquakes: Takeaways from Leyte and Eastern Samar Six Years After Typhoon Yolanda**

**March 2020**

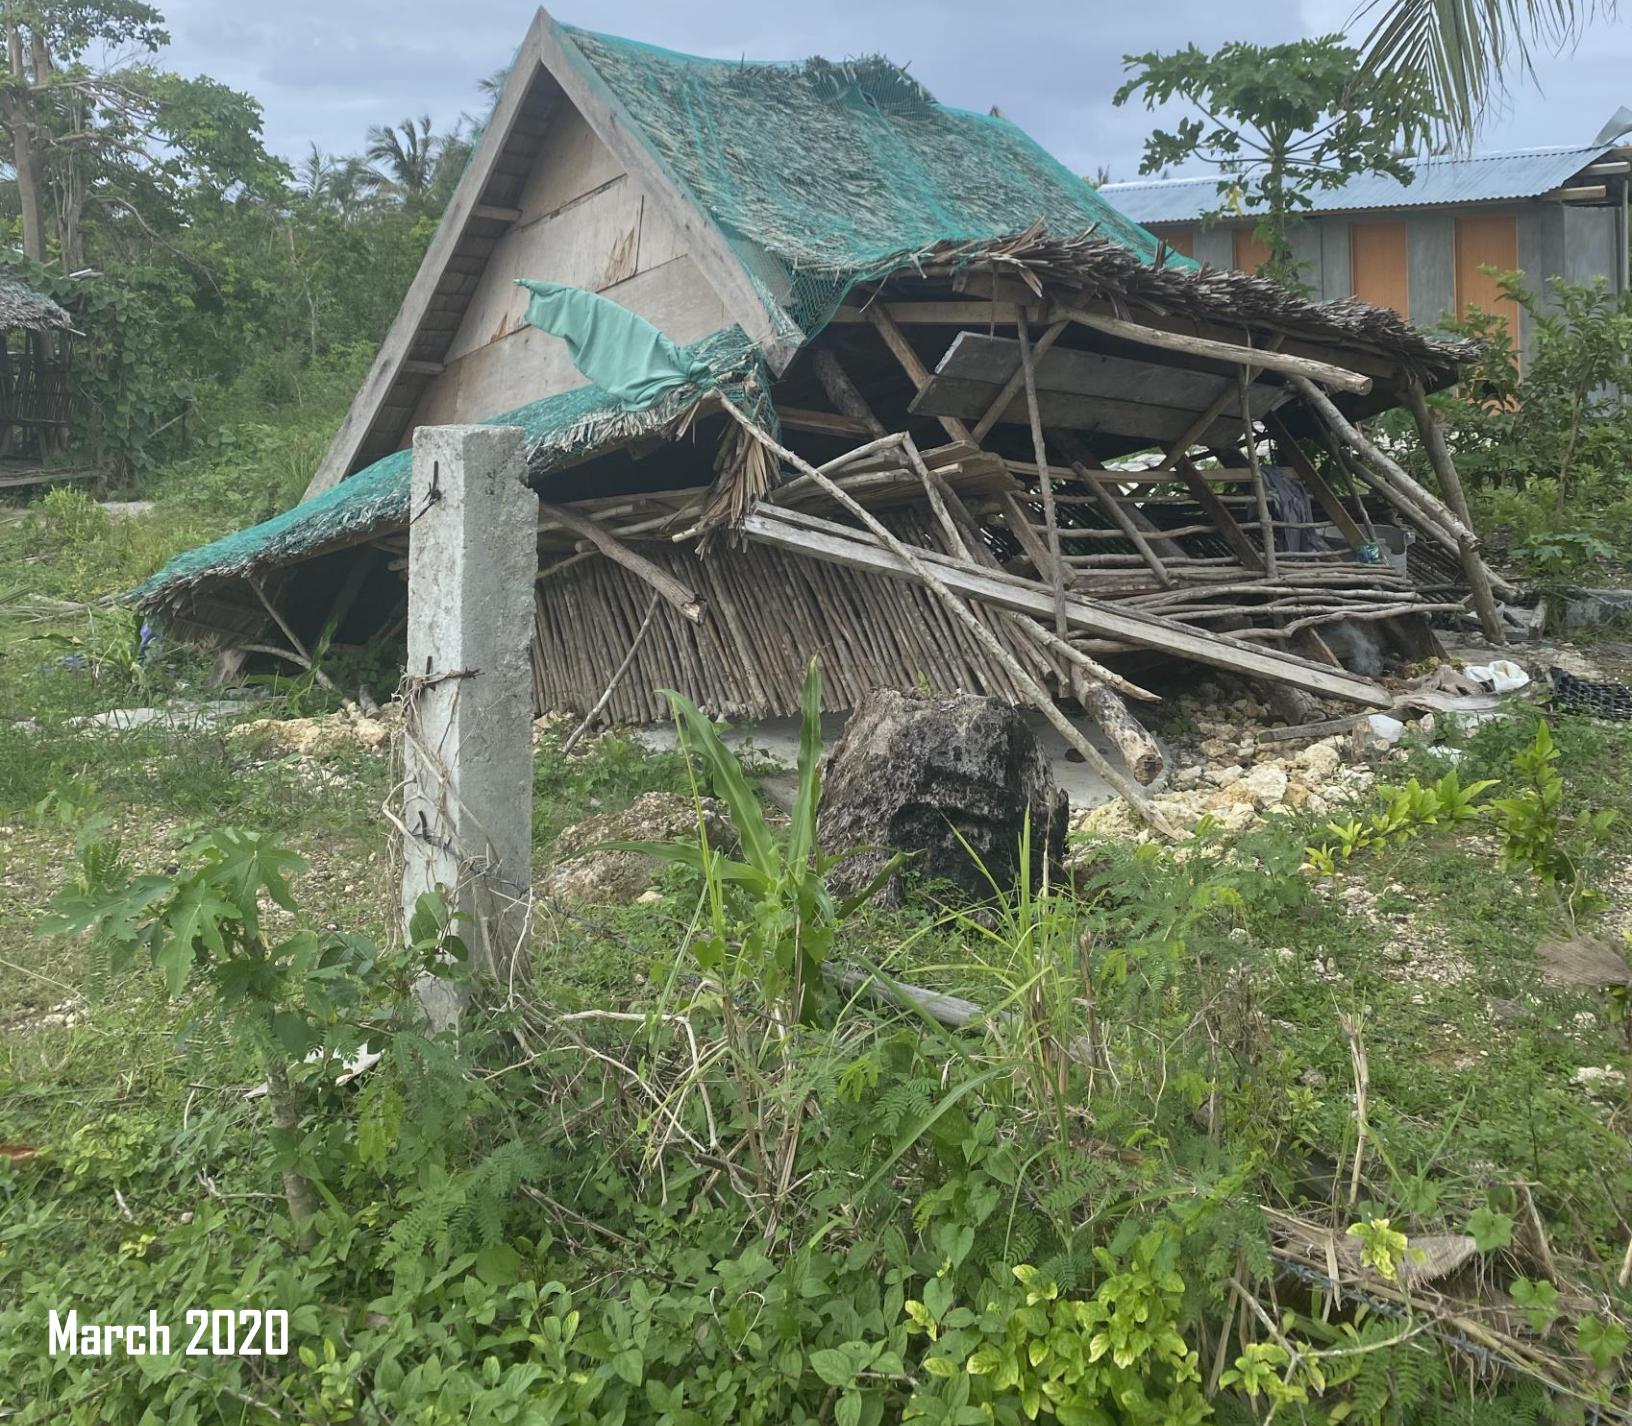
## Cover

A shelter in Eastern Samar which collapsed during Typhoon Ursula in December 2019.

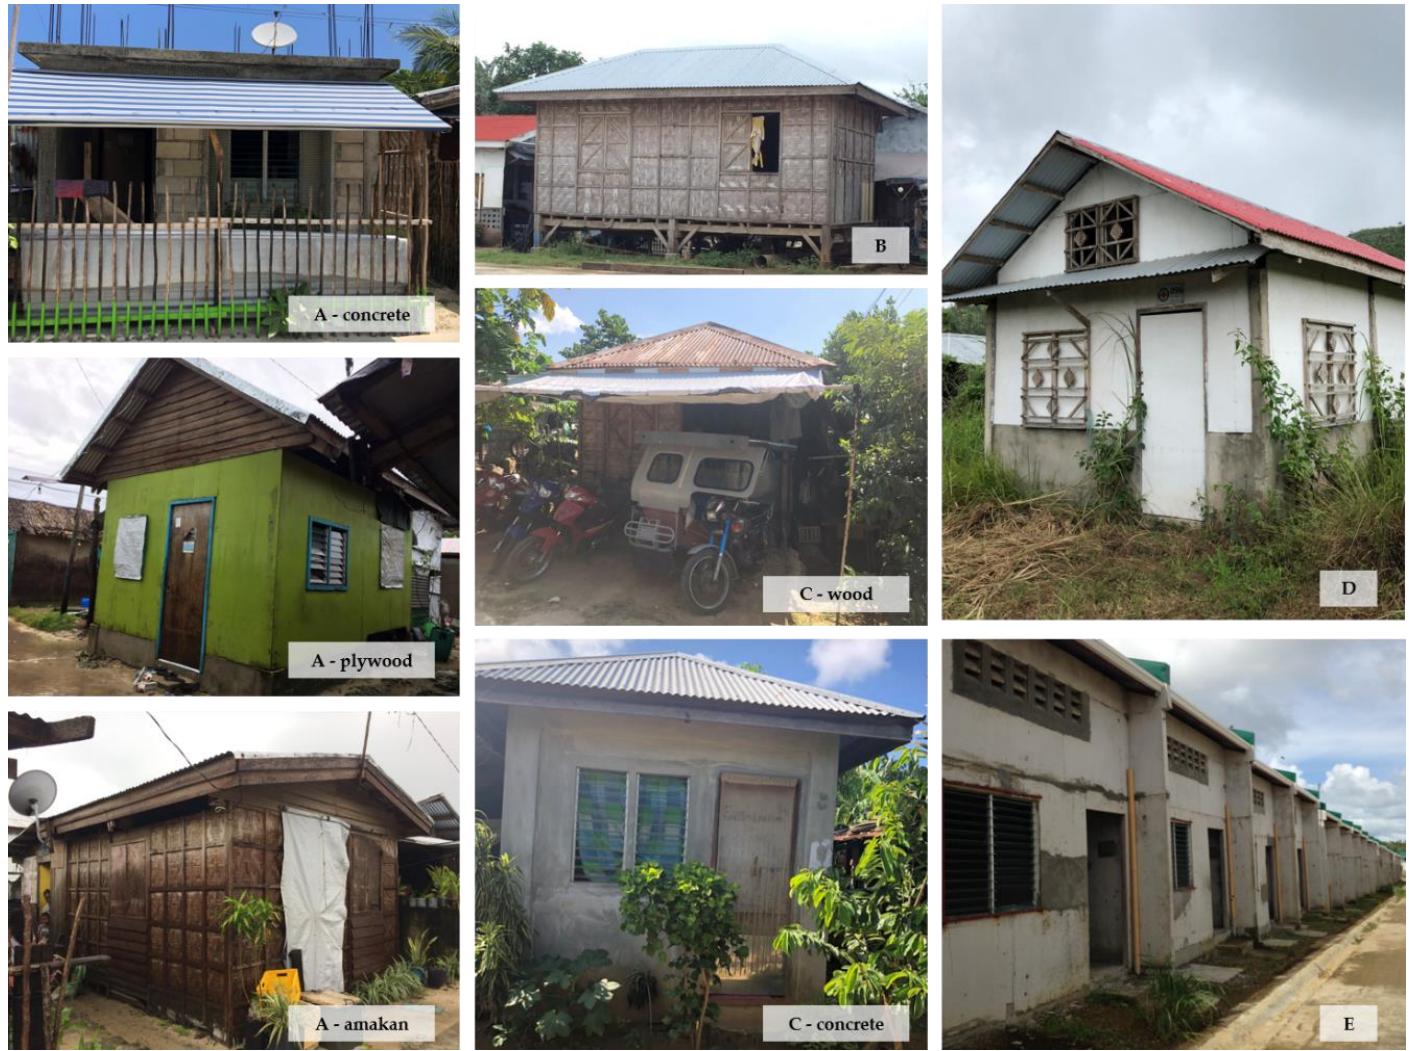
**Figure 2: Examples of shelters built in each community. (3 shelter types in Community A; 2 shelter types in Community C). (Photos A-B by Dina Pelayo).**

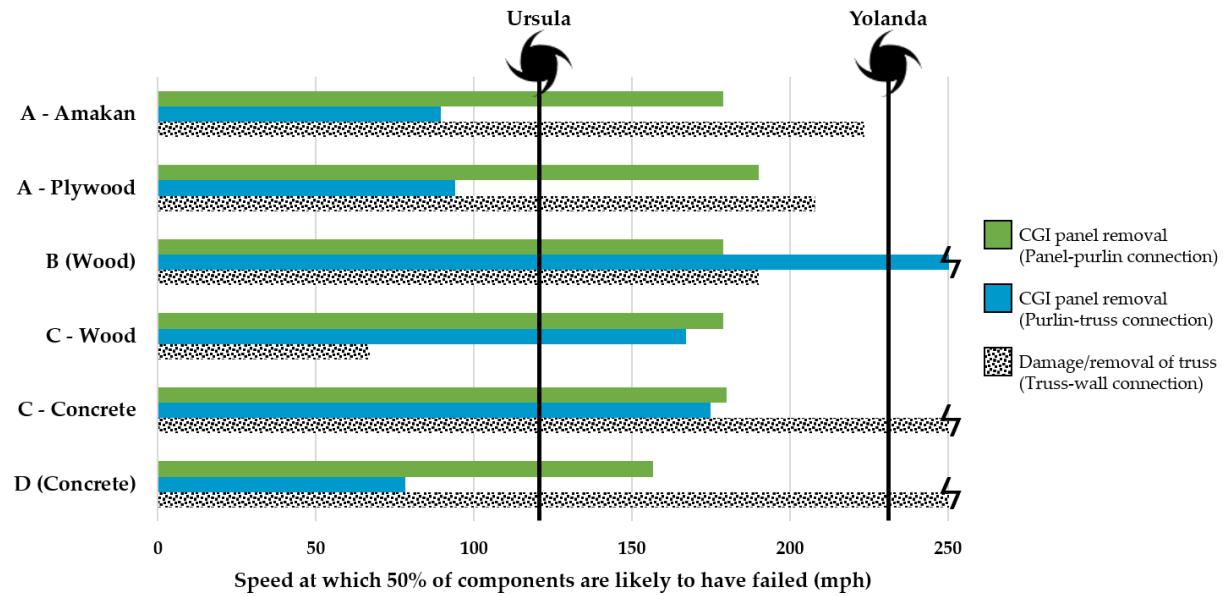
As described in Table 3, we investigated roof failure at three connections: the CGI panel-purlin connection, the purlin-truss connection, and the truss-wall connection. Figure 9 presents the speed at which fifty percent of a given roof component are likely to fail for each shelter design. For example, fifty percent of the CGI-purlin connections on the wooden shelter with amakan walls in Community A are expected to fail by once wind speeds reach 180 mph. The component with the lowest failure speed is expected to fail first. While there is a concrete design for Community A, it is not included in this analysis since the roof is a flat, concrete slab roof that does not have CGI, purlins, or truss elements and was assumed not to fail in wind. Community E is also not included in Figure 9 because it does not have the typical purlin-truss configuration.

**Figure 9: Wind speed at which 50% of roof components are expected to fail. Failure of the panel-purlin or purlin-truss connection at the lowest wind speed results in the removal of the CGI panels. If the truss-wall connection fails at the lowest wind speed, the expected failure is damage or removal of the roof truss. Components that are expected to have 50% failure at wind speeds above 250 mph are represented by a break (↪).**

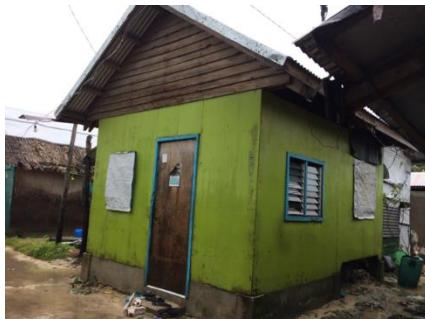
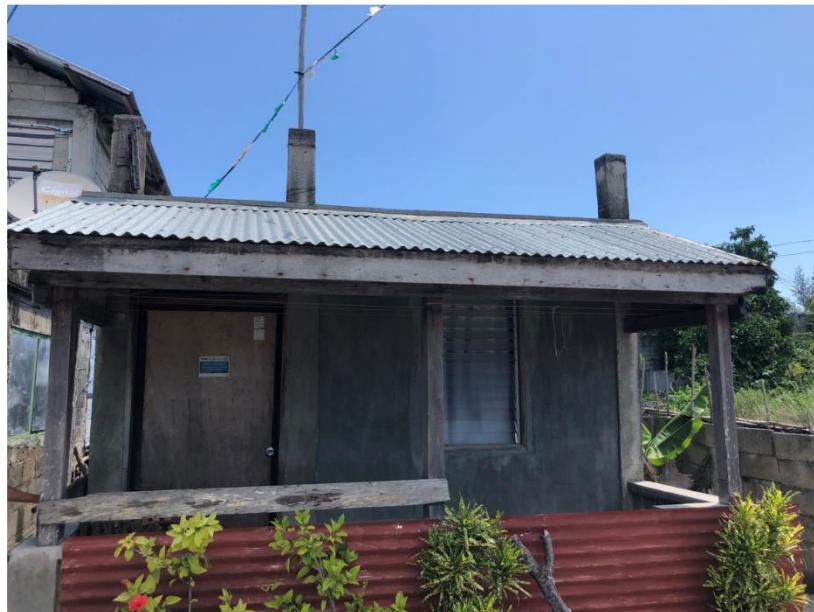
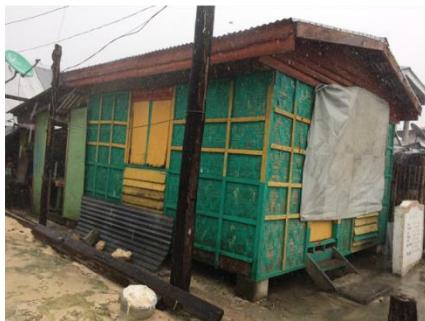
Important (mis)alignments:	Water intrusion was one of the biggest concerns in this community; therefore, the desired changes more often addressed how to stop water from leaking into the shelter instead of how to make the shelter safer from a structural perspective.

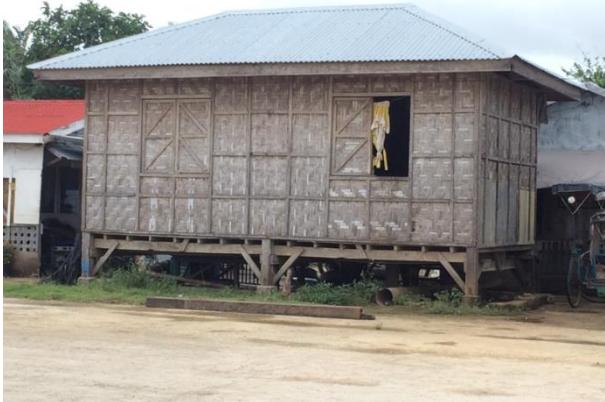
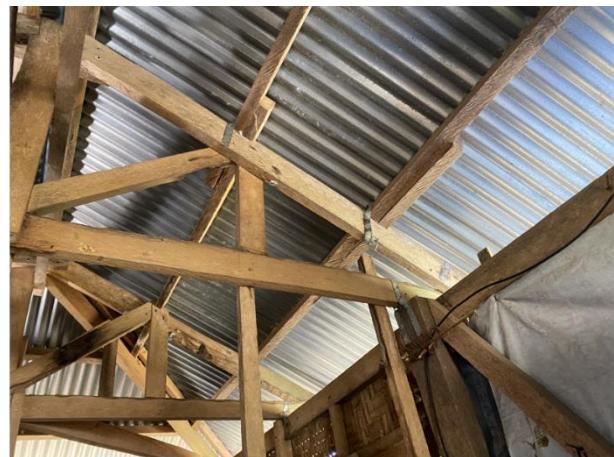
Shelter program details:	Core shelters designed by an INGO. Households participated in procuring coconut lumber and received varying amounts of training on construction and maintenance. Shelters were intended to last for 5 years with community members understanding that permanent houses would be provided after 5 years.
Relocation site?	No
Structural system:	Coconut lumber
Wall material:	Amakan
Roof system:	Hip shape, CGI
Key design elements:	Hurricane straps used to connect purlins to truss and truss to wall
Prevailing perceptions of safety:	Households perceived the entire shelter to be unsafe, particularly in typhoons. There was no confidence in the roof or the walls, driven largely by concerns with the quality of coconut lumber and amakan.
Important (mis)alignments:	Households underestimated the safety of the roofs of these shelters despite the roofs having multiple design elements that make them safe. Concerns with material quality drove perceptions regardless of improved design features.

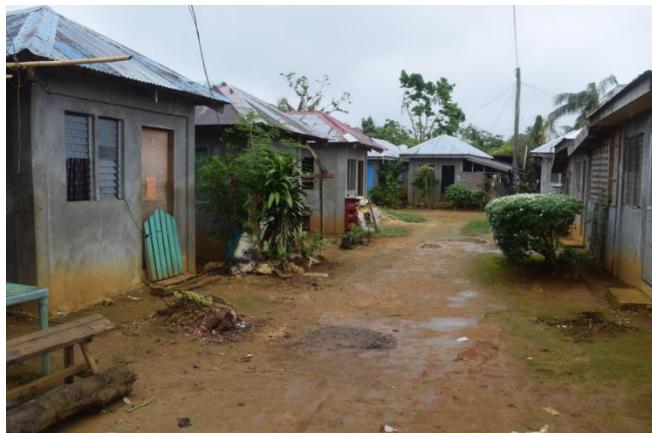
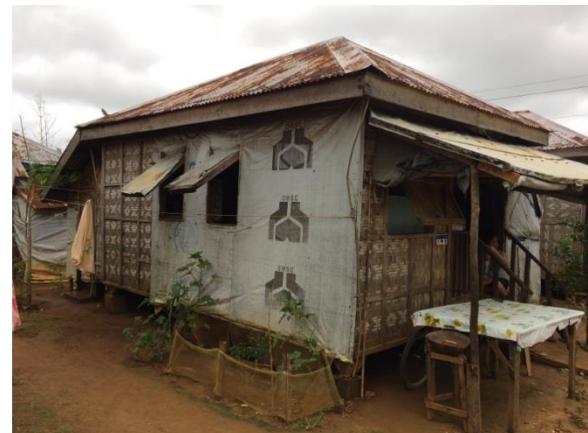
Important (mis)alignments:	In this community it first became clear that there are different concerns with different types of hazards, and because of the duration of and need to stay inside during a typhoon, households preferred concrete to wood. Households acknowledge that concrete can be less safe in earthquakes, but their priority is having a shelter that is safe in a typhoon.

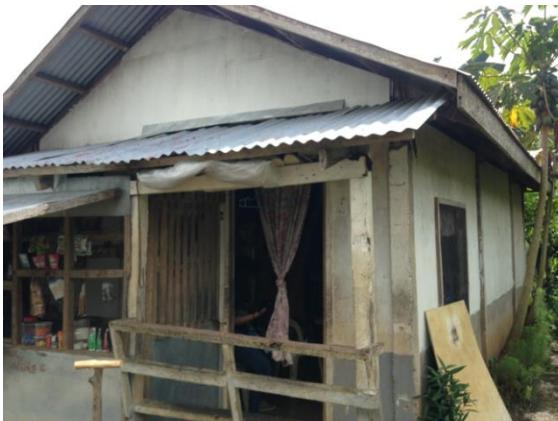
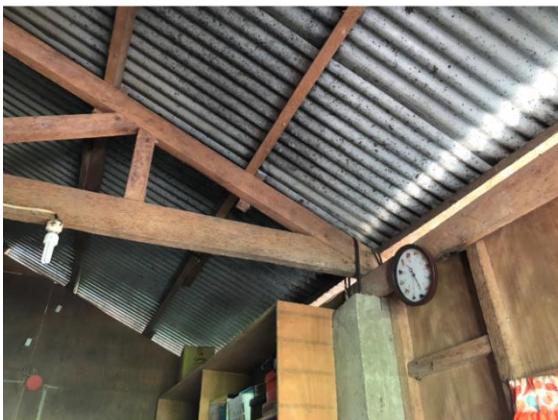
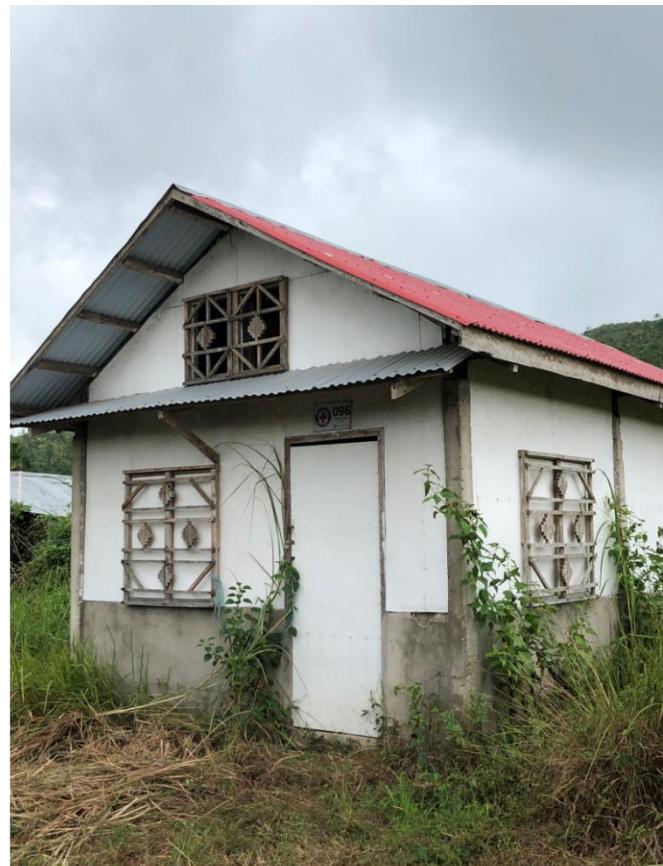
Shelter program details:	Core shelter provided to households who owned or could purchase plot of land. If shelter was not constructed in 10 days, households were responsible for finishing the construction.
Relocation site?	No
Structural system:	Reinforced concrete
Wall material:	Half-height CMU and plywood
Roof system:	Gable shape, CGI
Key design elements:	'Wrapped rebar' connection between columns and trusses. CMU skirt is not tied to concrete columns
Prevailing perceptions of safety:	Perceptions of safety were most divergent in this community. A majority of households expected the roof covering and structure to be damaged but not destroyed in a typhoon, and most did not expect the foundations or walls to be damaged.
Important (mis)alignments:	In this community, perceptions aligned most closely with engineering assessments. A common modification households wished to make was changing the walls of their shelter to full-height instead of half-height CMU. Because of the small columns in this shelter, this change could make the shelters more prone to damage, particularly in earthquakes.

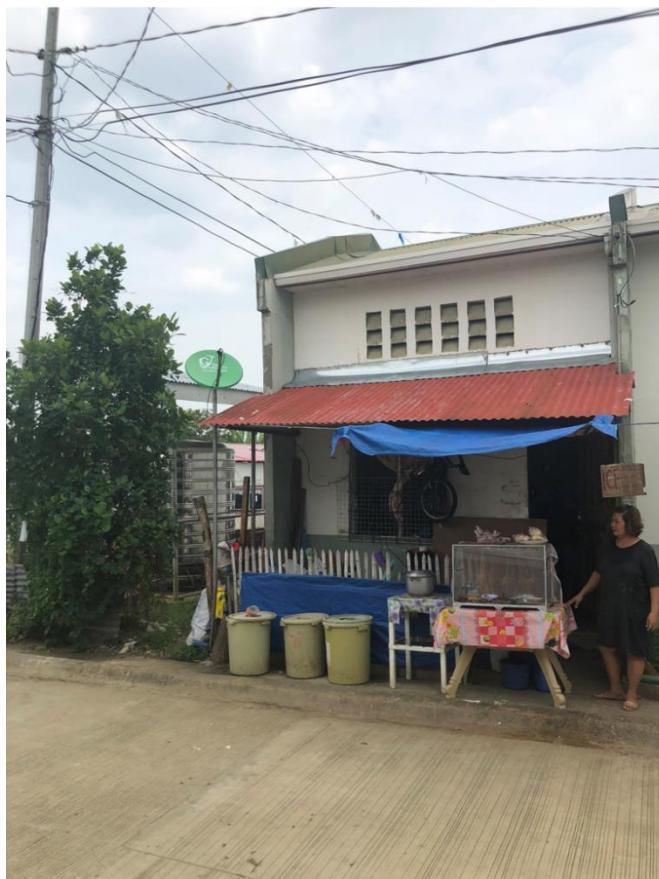
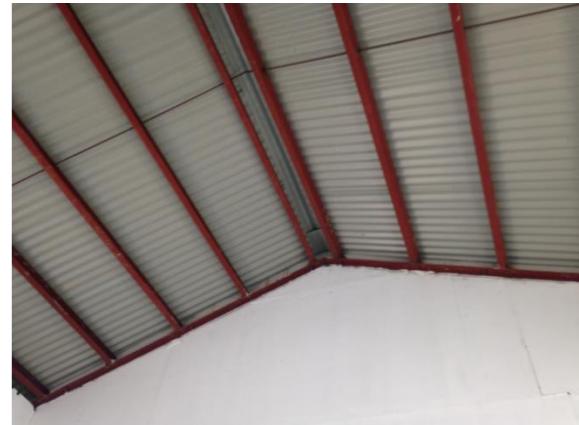
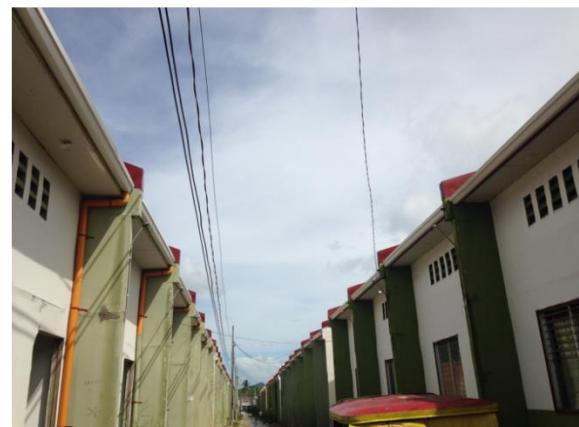
Shelter program details:	Row houses designed by the local government and constructed by government-hired contractor. Households had no participation in the design or construction and were assigned a shelter using a raffle system.
Relocation site?	Yes
Structural system:	Load-bearing walls
Wall material:	Reinforced concrete or hardiflex
Roof system:	Gable shape, CGI
Key design elements:	No roof trusses, steel purlins. Houses designed so that an internal second floor could be added.
Prevailing perceptions of safety:	Nearly all households expected the roof to be destroyed in a typhoon, and most expected the walls to be destroyed. The height of the walls, the shelters being connected to each other, and the construction quality were issues that influenced perceptions of safety. Security from robbery was a top concern.
Important (mis)alignments:	While households' concerns about construction quality and the safety of tall walls agreed with the engineering assessments, households likely underestimated the safety of their roofs. In this community, households were more concerned with damage from earthquakes, which aligns with assessments. Because of the height, poor concrete quality, and being connected to other shelters, earthquakes are more likely to cause damage.
