Background & Impact

- Wabtec's remanufacturing plant rebuilds engines with reused, repaired, and new parts
- Used parts must meet a proprietary cleanliness specification
- The oil strainer is the last line of defense in engine oil lubrication cleanliness
- Dislodged debris from the strainer can cause multimillion-dollar damages

Objective & Requirements

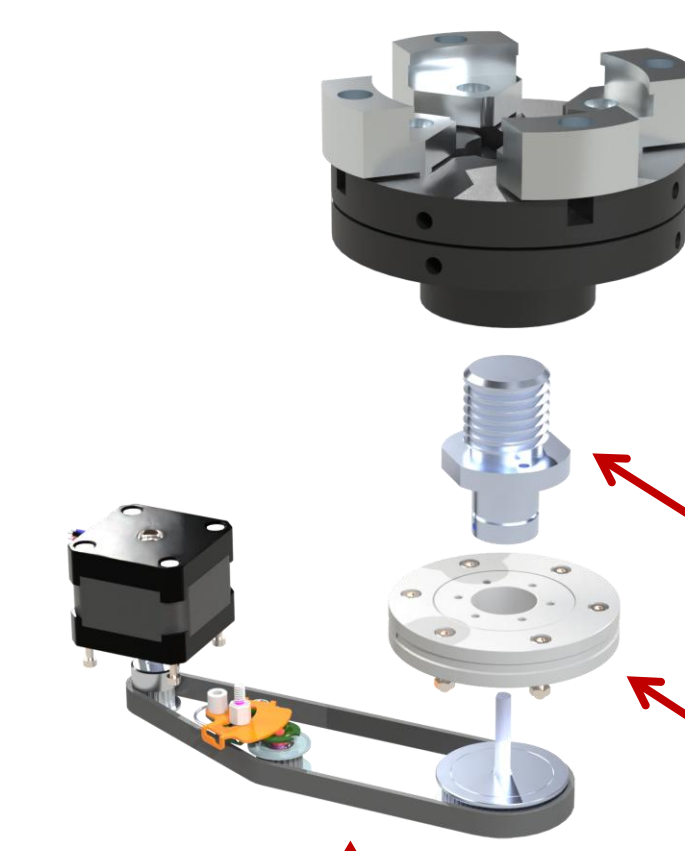
Rotary Assembly

- Secures strainer in place
- Spins strainer 360°

4 custom-machined chuck jaws

Plug shaft

Belt system under plate

Cross-roller bearing:
< 10 μm radial runout

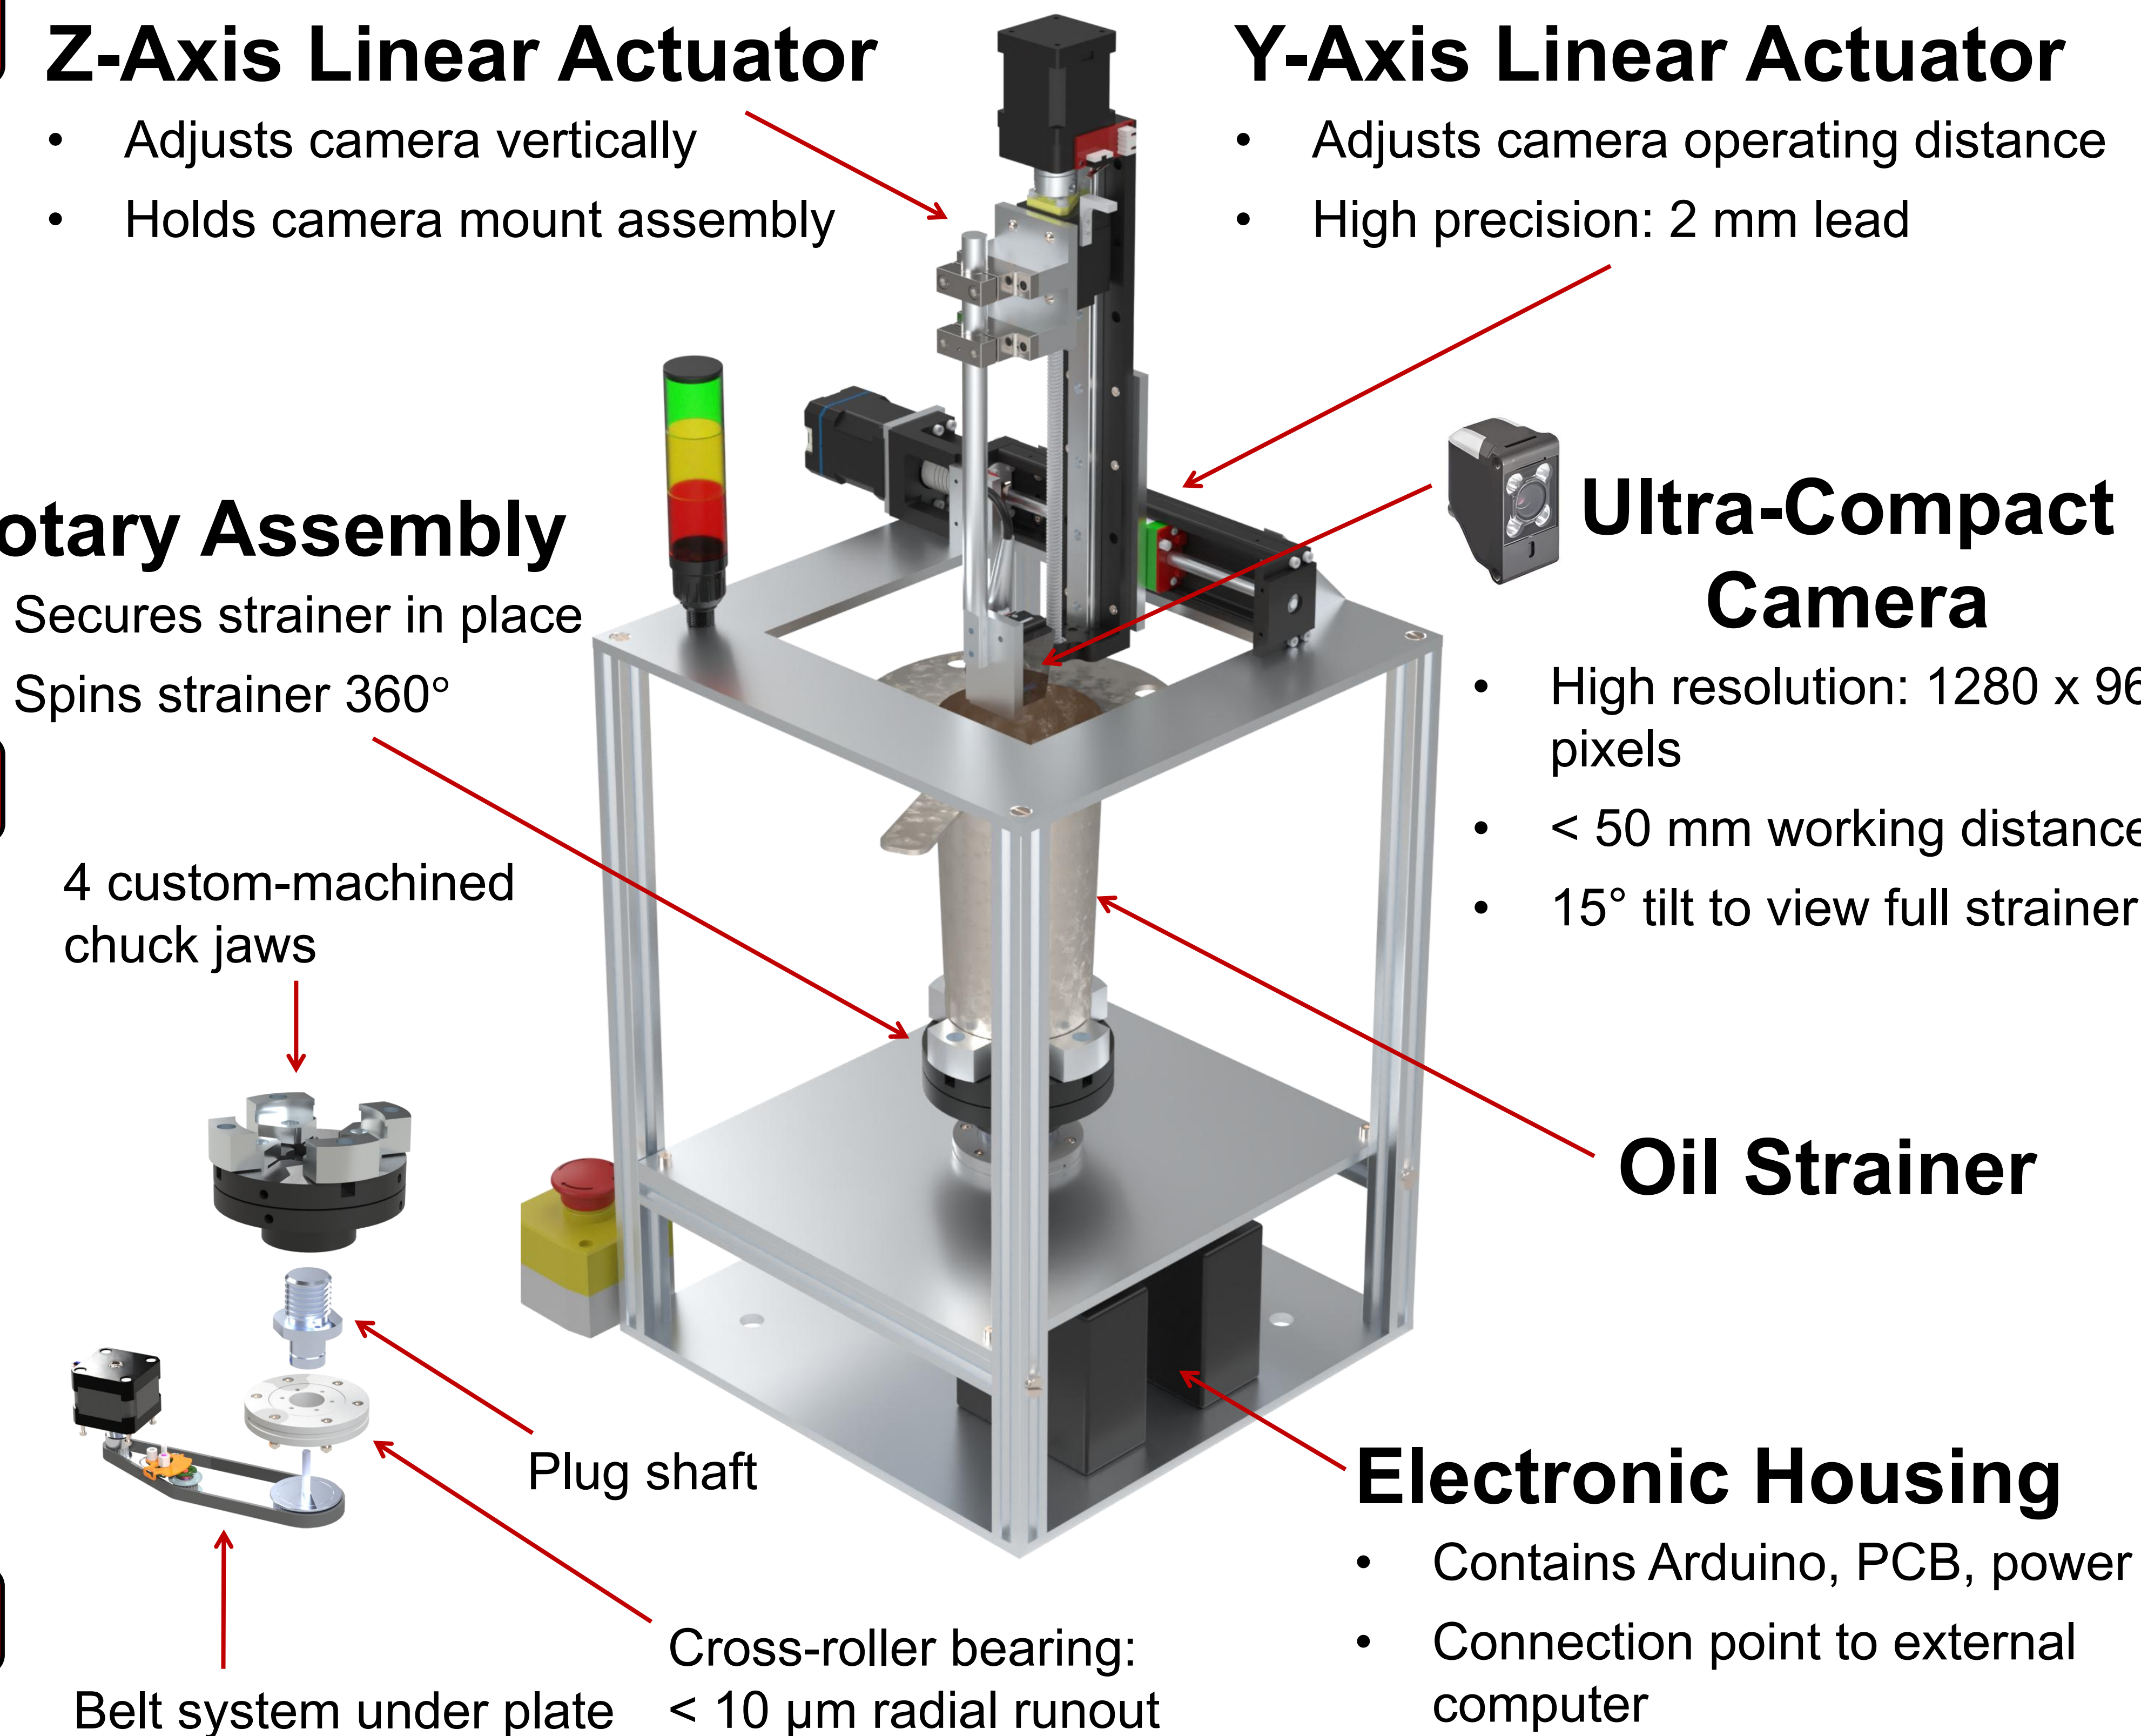
Z-Axis Linear Actuator

- Adjusts camera vertically
- Holds camera mount assembly

Y-Axis Linear Actuator

- Adjusts camera operating distance
- High precision: 2 mm lead

Ultra-Compact Camera

- High resolution: 1280 x 960 pixels
- < 50 mm working distance
- 15° tilt to view full strainer

Oil Strainer

Electronic Housing

- Contains Arduino, PCB, power
- Connection point to external computer

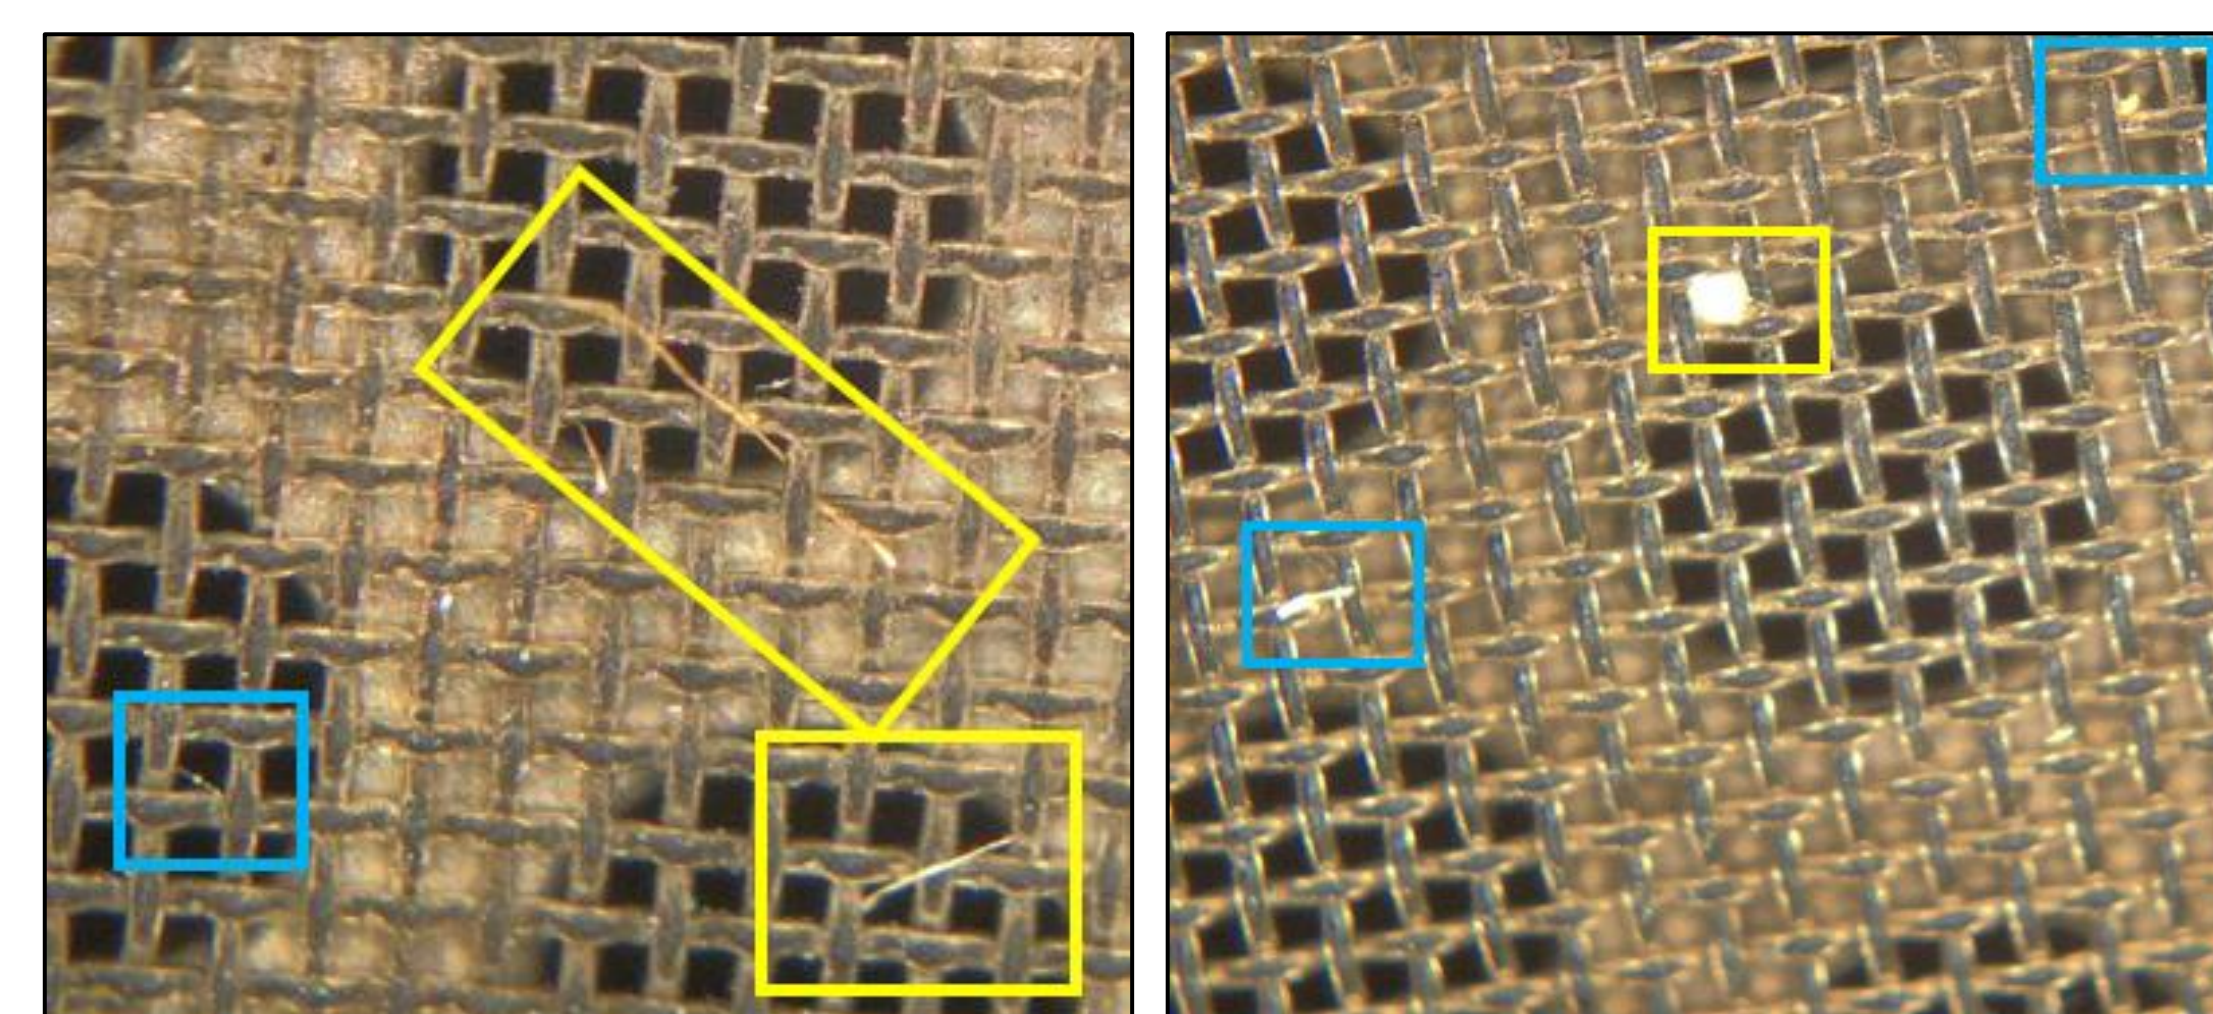
Images with flagged defects

■ Particle does not pass standards ■ Particle is OK

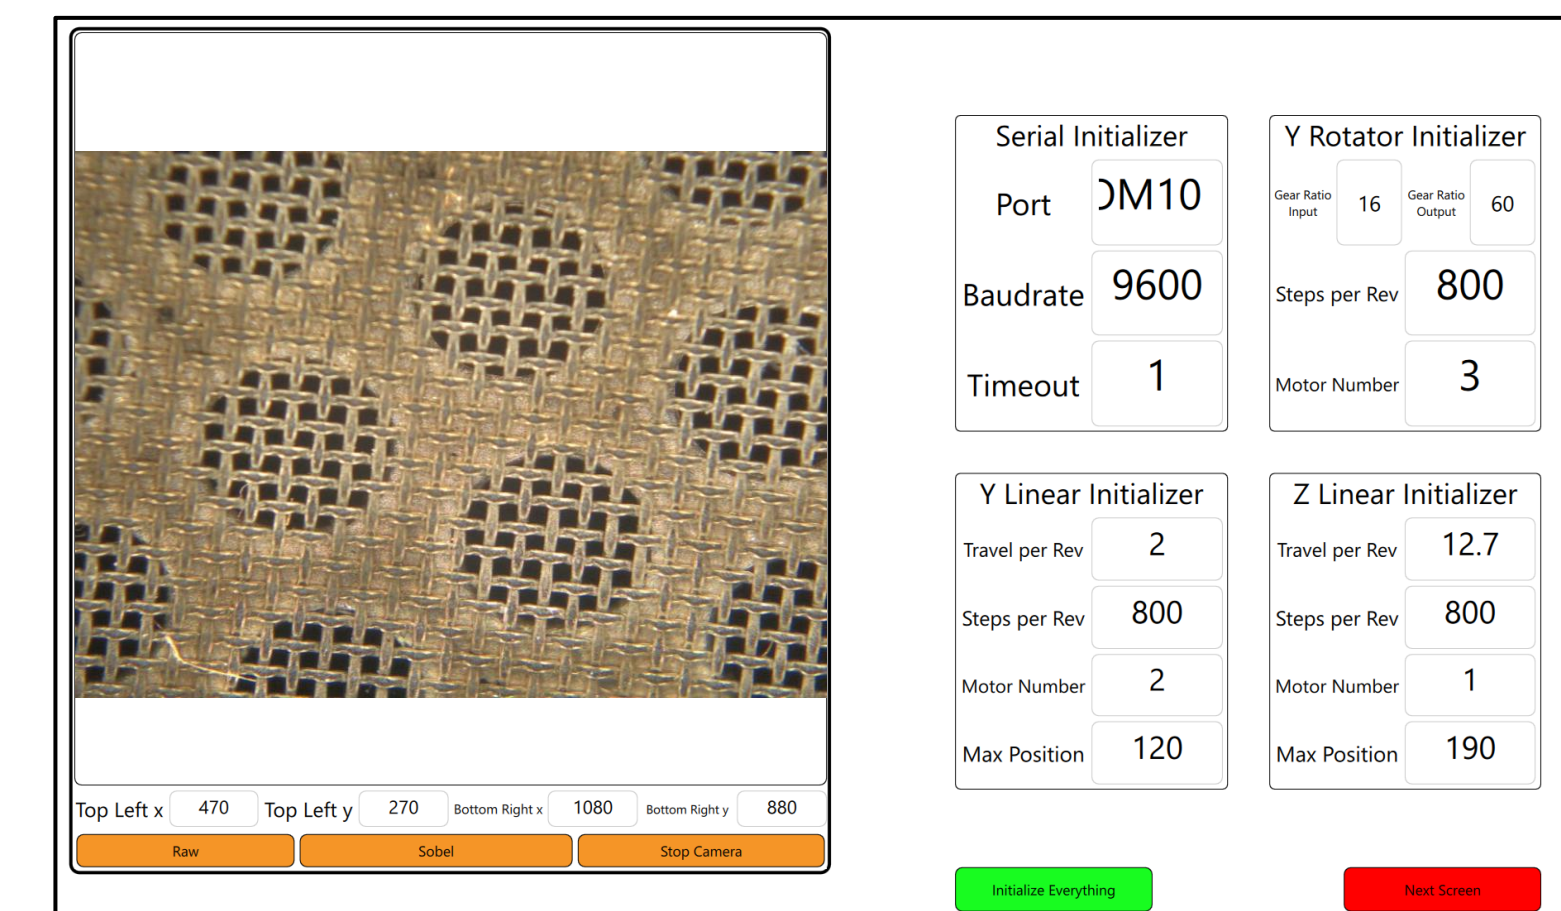
User interface (UI)

- Computer Vision (CV) uses unsupervised training with clean reference images
- Custom UI for easy training and operation
- Motor and camera control automatically collects ~ 500 images, accounting for strainer runout

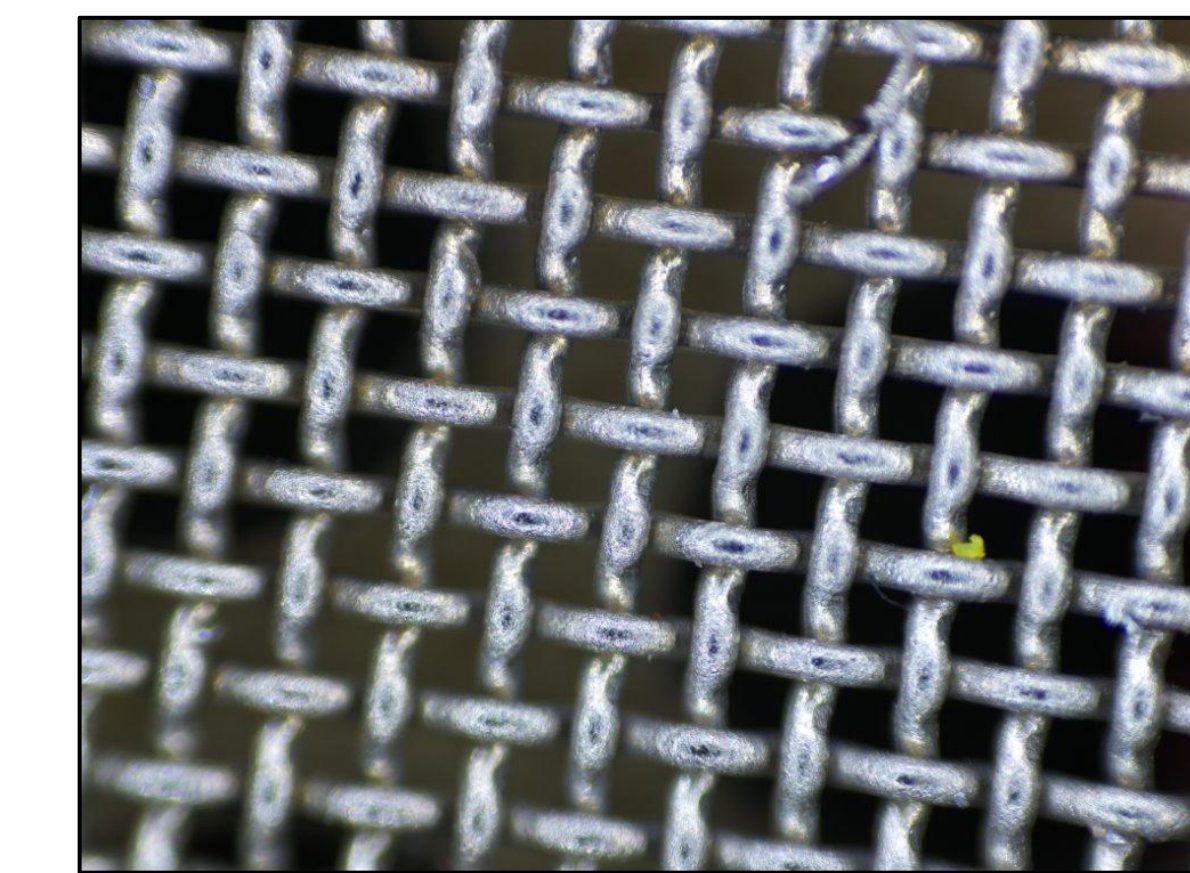
Prototype camera:
incorrect depth of field,
can only see interior mesh

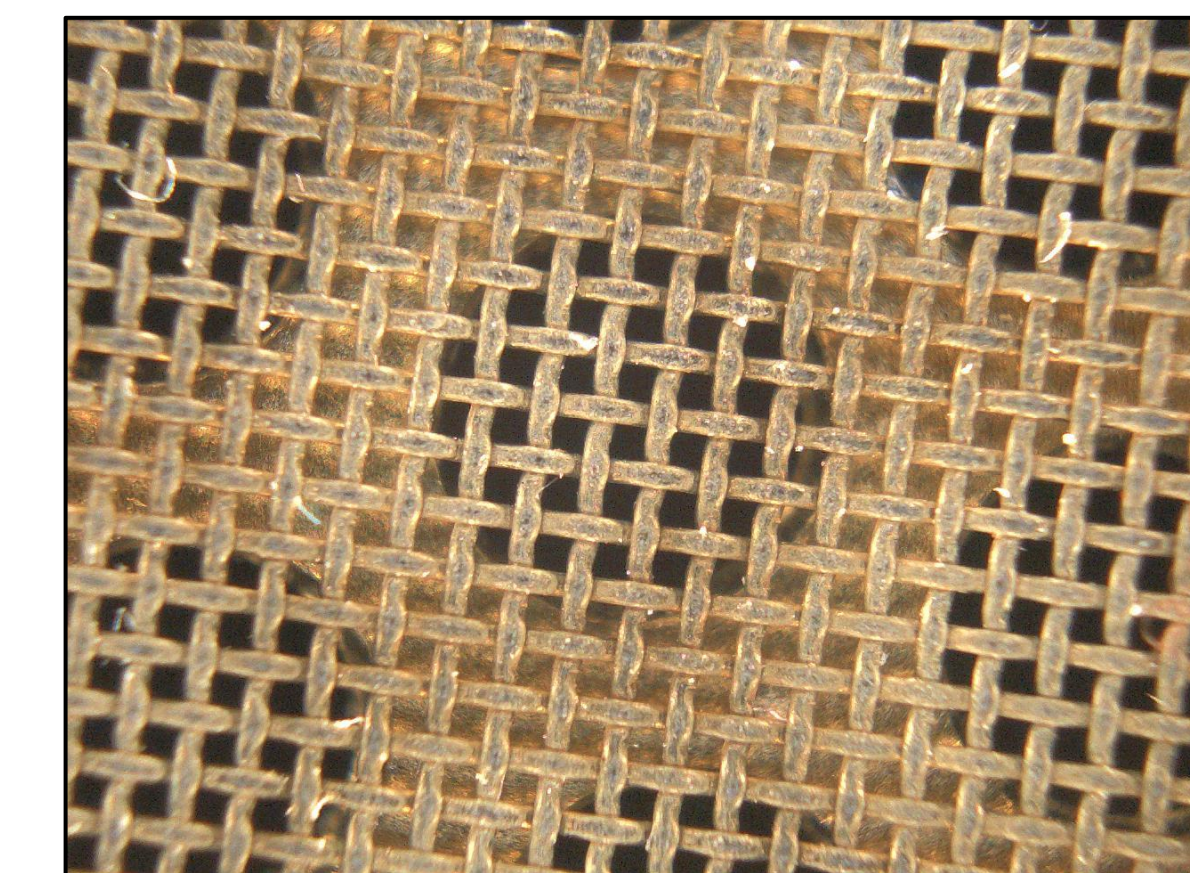
Current camera:
can see both interior mesh
and exterior perforate sheet

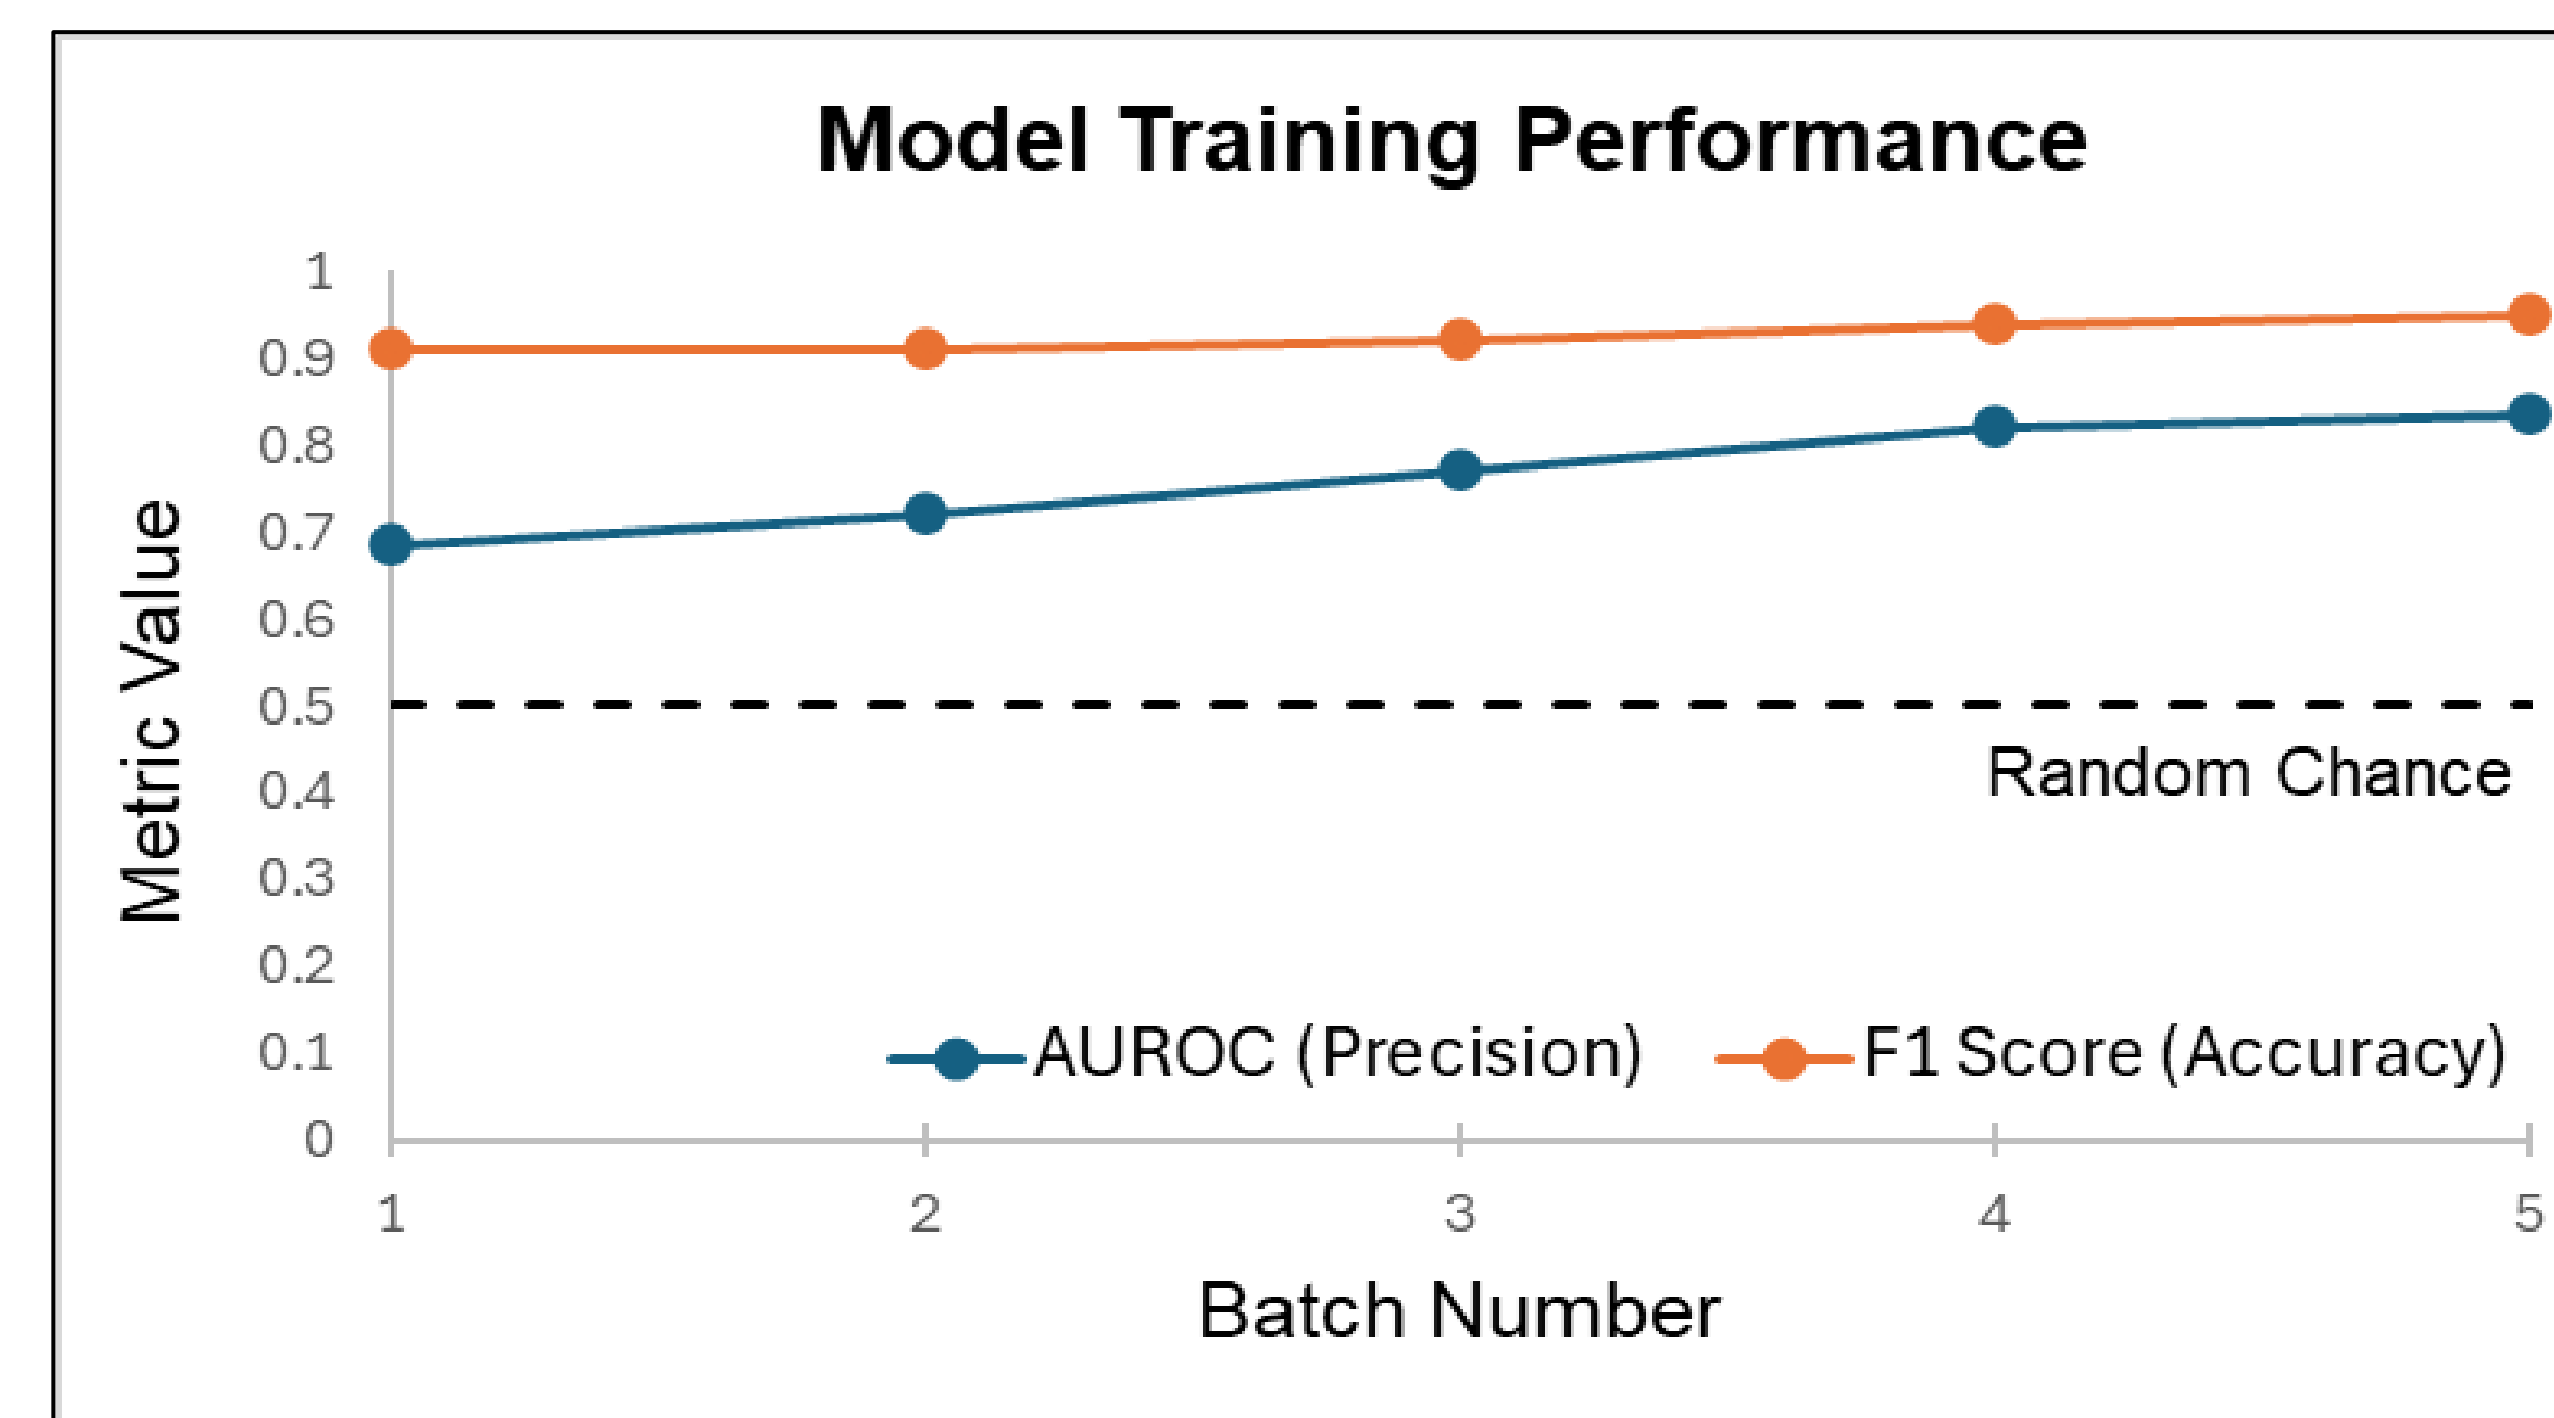
Testing Outcomes

- Tested 5 batches containing varying image quantities and qualities
- Parameter optimization for consistent image results
